**AN ASSESSMENT OF  
STREAM RESTORATION AND  
STORMWATER MANAGEMENT  
RETROFIT OPPORTUNITIES IN  
LOWER BUSH CREEK WATERSHED,  
FREDERICK COUNTY,  
MARYLAND**

**Frederick County  
Division of Public Works  
118 North Market Street  
Frederick, Maryland 21701-5422**

**Versar, Inc.  
9200 Rumsey Road  
Columbia, Maryland 21045**

**August 2003**

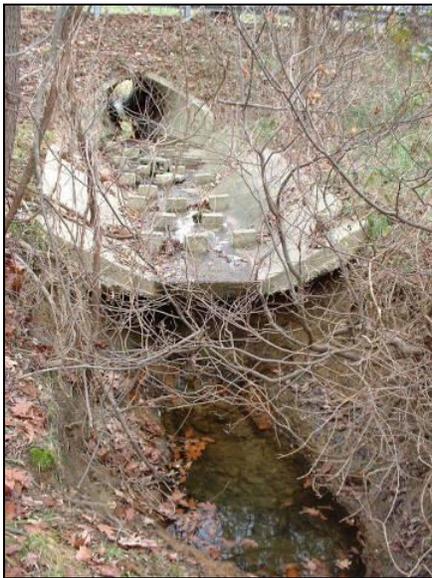
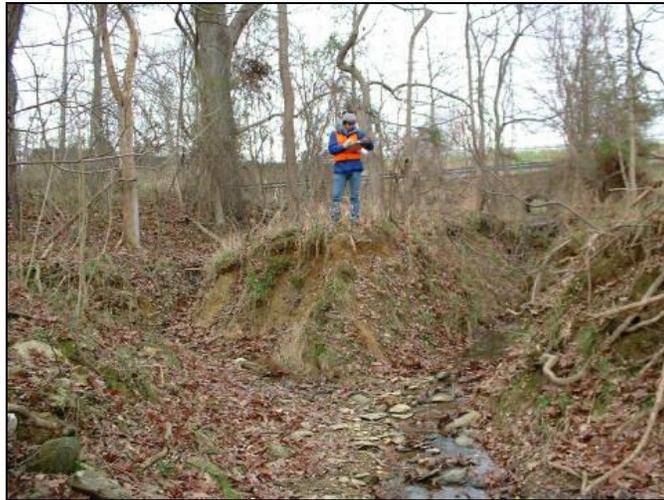
**Site Score:** 45.08 – One of the six most significantly impacted streams observed in the study, the score reflects high Severity of Stream Impacts and damage to Property/Infrastructure.

**Site Description:** This reach receives drainage from a resident's driveway, I-70 (i.e., 6 lanes, median, and concrete swales draining shoulder areas) and MD-144. Concrete apron below culvert beneath Baldwin Rd and I-70 drops off into an approximately 10-foot deep scour hole. Stream below scour hole is eroded and steeply incised down to the confluence with the western branch of Wood Run, approximately 50 feet. Opportunities may exist for the County to work with SHA to improve site conditions.

Contact SHA regarding potential collaboration on stormwater management improvements and stream restoration because stormwater runoff from these roads is causing major channel instabilities at this location. The volume, frequency, and flashiness of runoff should be reduced to prevent further problems with the receiving channel. (1) Structures to control runoff through infiltration, detention, and/or bioretention measures should be constructed within roadside drainage systems (median and edges) or immediately upstream of the road culvert. (2) In addition, restoration efforts in the destabilized channel should include recreation of the stream channel using nearby reference reaches as a template for designing stable channel dimensions, patterns, and profiles,<sup>1</sup> stabilizing the banks with native vegetation, and installing grade control structures to prevent further incision of the channel. Below the culvert, vertical drops in the stream channel formed by headcutting processes should be stabilized by creating a step pool type channel morphology (using large rock to line the bottom of the step pools to diffuse energy).

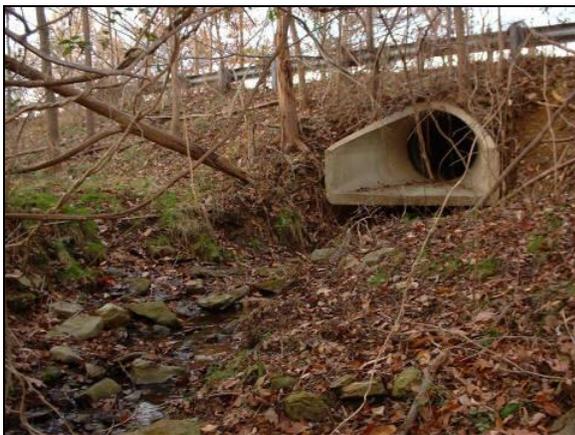
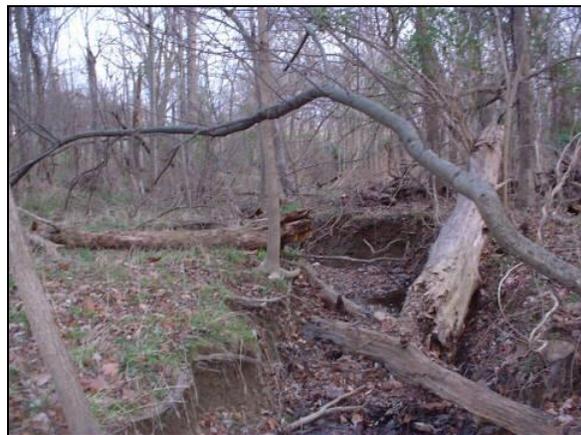
**Site Score:** 41.60 – One of the six most significantly impacted streams observed in the study, the score reflects moderate Severity of Stream Impacts and Extent, and high threats to Property/Infrastructure.

**Site Description:** This reach receives drainage from a resident’s driveway, I-70 (i.e., 6 lanes, median, and concrete swales draining shoulder areas), MD-144, and the New Market Post Office. Streambank erosion, gully formation, and several vertical knickpoints were noted below the road culvert, extends approximately 200 feet down to confluence with eastern branch of Wood Run. Opportunities may exist for the County to work with SHA to improve site conditions.

Contact SHA regarding potential collaboration on stormwater management improvements and stream restoration because stormwater runoff from these roads is causing major channel instabilities at this location. The volume, frequency, and flashiness of runoff should be reduced to prevent further problems with the receiving channel. (1) Structures to control runoff through infiltration, detention, and/or bioretention measures should be constructed within roadside drainage systems (median and edges) or immediately upstream of the road culvert. (2) In addition, restoration efforts in the destabilized channel should include recreation of the stream channel using nearby reference reaches as a template for designing stable channel dimensions, patterns, and profiles, stabilizing the banks with native vegetation, and installing grade control structures to prevent further incision of the channel. Vertical drops in the stream channel, near the confluence with WR-1 and formed by headcutting processes, should be stabilized by creating a step pool type channel morphology (using large rock to line the bottom of the step pools to diffuse energy).

(3) The SWM facility at the New Market Post Office (Structure No. 466) may provide an opportunity to retrofit the current infiltration pond to a rain garden (a more current treatment technology), improve the quality of water discharged from the facility via biological processes, and improve aesthetics at this prominent location.

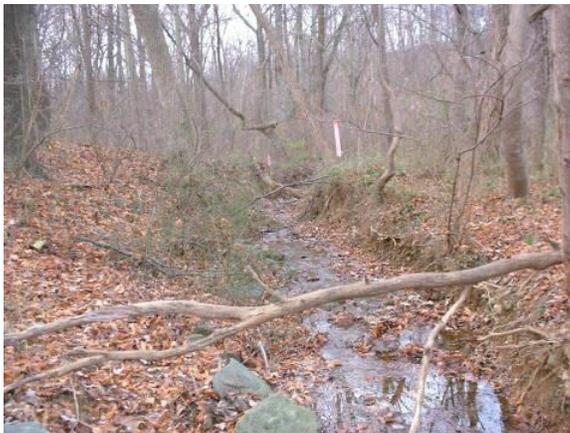
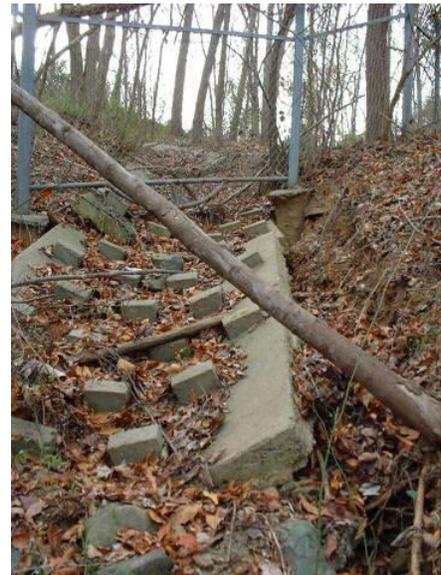
**Site Description:** This reach receives drainage from I-70 interchange at MD-75, agricultural lands, and commercially zoned land. Concrete swales from along MD-75 and culvert beneath MD-75 are eroded and undermined. Approximately 500 linear feet of stream below these structures has widened and eroded banks, undercut trees, and unstable substrate. Wetland delineation flags and other markings indicate that the site may be developed soon, providing a potential opportunity for the County to work with the developer to improve site conditions. Opportunities for collaboration may also exist with SHA.

**Restoration Approach:** Contact SHA regarding potential collaboration on stormwater management improvements and stream restoration because stormwater runoff from these roads is causing major channel instabilities at this location. The volume, frequency, and flashiness of runoff should be reduced to prevent further problems with the receiving channel. (1) Structures to encourage infiltration and detain runoff through wet pond, bioretention or other measures should be constructed in the roadside ditches, and, if necessary, within the cloverleaf, to control runoff. (2) In addition, restoration efforts in the destabilized channel should include recreation of the stream channel using nearby reference reaches as a template for designing stable channel dimensions, patterns, and profiles, stabilizing the banks with vegetation, and installing grade control structures to prevent further incision of the channel. (3) The concrete swales conveying drainage from MD-75 should be redesigned and replaced with structures capable of conveying water and dissipating sufficient energy as to avoid impacts to the stream below the swale's discharge point. Because land use in the immediate area is likely to change in the near future, it is important to work in conjunction with future development plans before appropriate solutions can be specified.

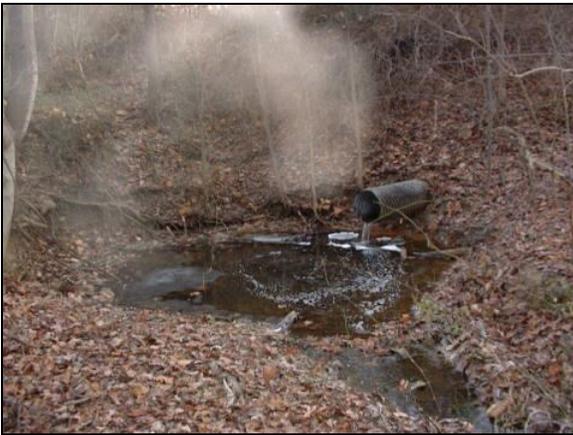
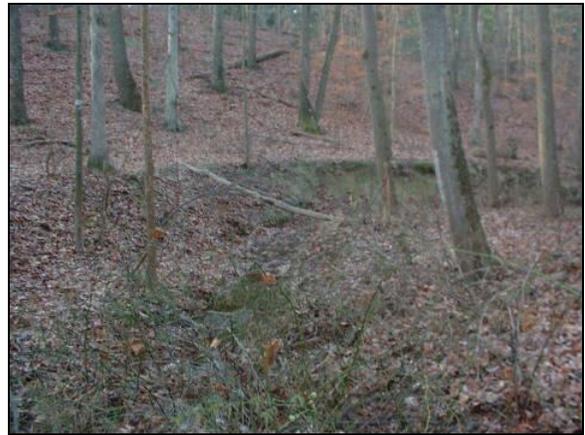
**Site Description:** This reach drains woods, rural residential areas, and a small farm. An area adjacent to the stream has been cleared for the Doubletree Estates development at this location (developer office trailer on-site). An old pond and sediment basin were present at the site, with erosion observed below both structures. The culvert from the old pond has created a scour hole in the stream channel and has a 12” drop. Approximately 200 linear feet of stream below the pond outfalls is eroded and needs stabilization. Development of this site may provide the County with an opportunity to work with the property owner to improve site conditions.

**Restoration Approach:** (1) Native species of shade tolerant grasses and shrubs should be planted along the stream to help stabilize stream banks, filter runoff, and increase the density and diversity of vegetation within the existing forested riparian buffer. (2) If not already protected, the buffer should be protected through easements or other long-term conservation measures. In addition, future development designs and construction activities should prevent concentrated flows from entering or passing through the buffer.

Any other action here would depend on what the developer plans to do at the site. That may either mitigate the problem, or worsen it. (3) The minimum action recommended is restoring stable channel dimensions and profile by filling the scour pool and regrading the culvert outlet to match the final channel slope and elevation (approximately 50 linear feet). (4) The channel below requires minor bank stabilization along about 200 feet of stream. If the development above is going to put more water into the stream at or below the pond location, then this strategy will have to be reassessed to account for hydrologic influences on long-term stream channel stability and morphology. (5) It may be desirable to redesign the pond to provide additional flow and water quality benefits.

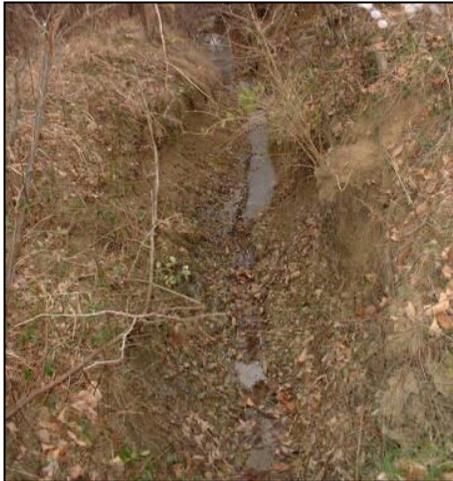
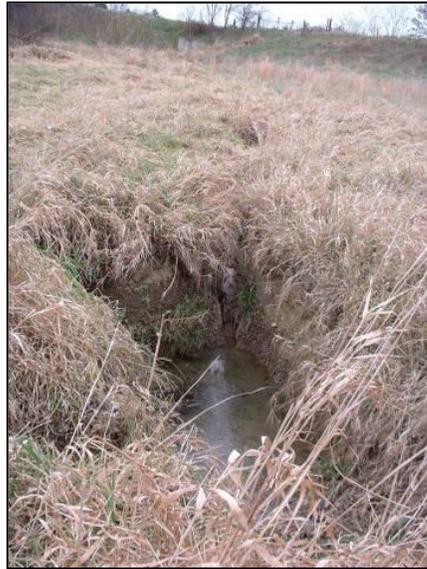
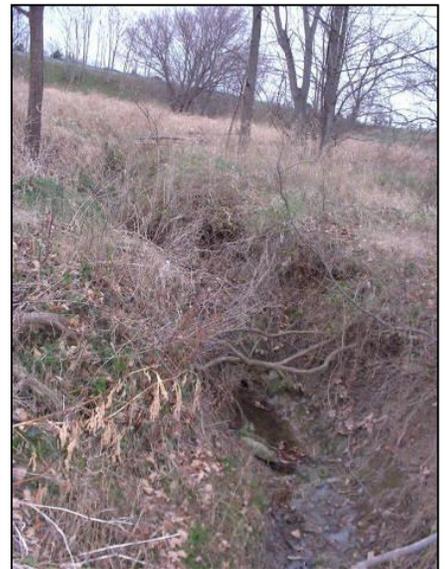
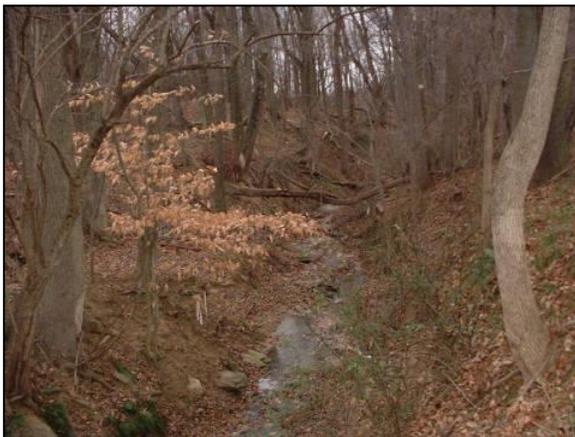
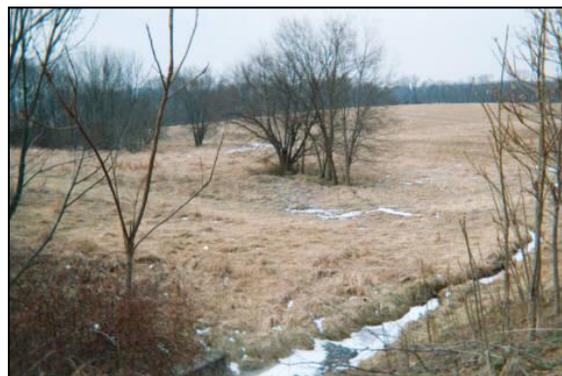
**Site Description:** This reach receives drainage from the parking lot at Hahn Trucking, portions of western New Market, and I-70 (i.e., 6 lanes, median, and concrete swales draining shoulder areas). Located in the Intercoastal Industrial Center, public notice signs at the site indicate that 24-acres will be developed as a family entertainment center. Runoff from two road culverts has eroded a 6-inch by 6-inch gully in the meadow below Baldwin Road, which rapidly increases in size (via headcutting and lateral erosion) to become approximately 10-feet by 10-feet within about 300 feet. This gully has near vertical banks that are rapidly eroding. Banks along lower sections of this stream widen out into a broader valley, forming abandoned terraces. Side tributaries to this stream are also headcutting to match the grade of School Run as it continues to downcut. This reach is experiencing on-going planform, slope, and cross-sectional channel adjustments in response to the upstream hydrologic disturbances. Development of this site may provide the County with an opportunity to work with the property owner, and perhaps Hahn Trucking, to improve site conditions. Opportunities for collaboration may also exist with SHA.

**Restoration Approach:** To determine whether additional controls are possible for existing impervious areas, SHA, Hahn Trucking, and the developer of the family entertainment center should be advised that stormwater runoff from the roads and parking areas is causing major channel instabilities at this location. The volume, frequency, and flashiness of runoff should be reduced to prevent further problems with the receiving channel. Structures to encourage infiltration and detain runoff should be constructed along or near the roads and parking areas to control runoff. While opportunities may exist to control runoff from the Hahn Trucking parking areas prior to passing beneath I-70, and runoff from I-70 before it passes beneath Baldwin Road, (1) construction of a small wet detention pond below Baldwin Road may be the best opportunity to reduce stormwater peak flows because of economies of scale and available space. (2) If space allows, an alternative would be to construct an infiltration gallery to allow for accelerated dissipation of runoff as it moves through the field. Before a solution can be finalized, future development plans for the site (i.e., entertainment complex) should be considered further.

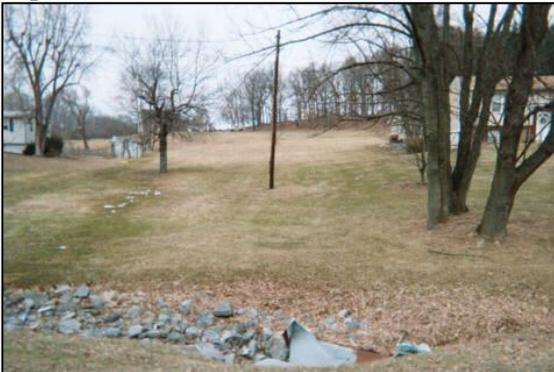
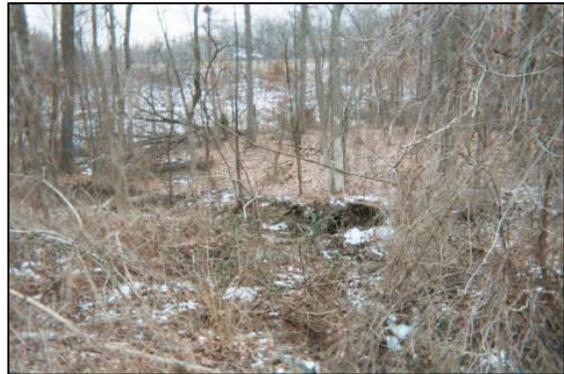
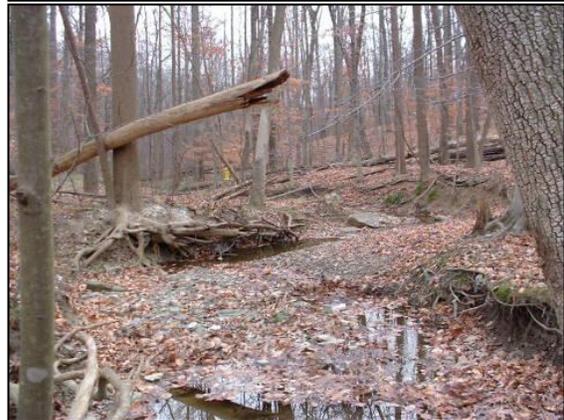
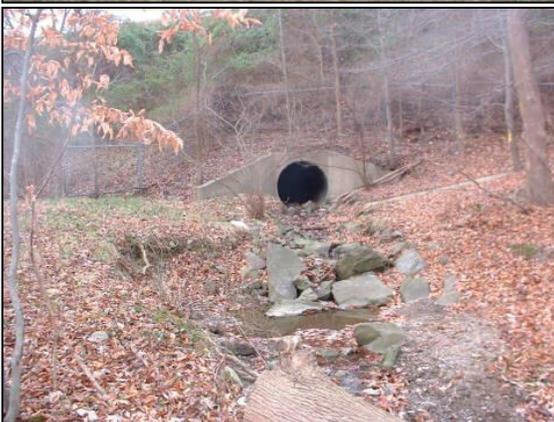
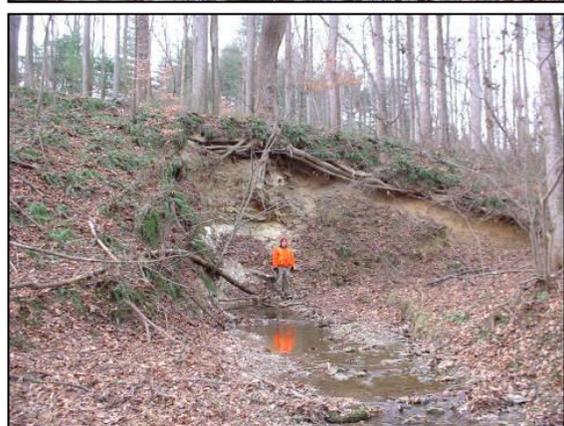
**Site Description:** This reach receives drainage from I-70 (i.e., 6 lanes, median, and concrete swales draining shoulder areas), along MD-144, and residential area north of MD-144. Drainage flows beneath MD-144 through galvanized apron (displaced) and corroded metal pipe, with a transition to a vertical, rectangular concrete/stone culvert (approx. 18” wide and 36” tall), outletting into an eroded stream with undercut banks and trees. Stream flows through woods for about 250 feet, receiving drainage from concrete swales from I-70 and adjacent hillsides before flowing through a 64” culvert beneath I-70. The stream below I-70 has significant bank erosion, unstable substrates, and is undergoing planform and cross-sectional adjustments along approximately 4,000 linear feet in response to increased runoff. Opportunities may exist for the County to work with SHA to improve site conditions.

**Restoration Approach:** This area appears to be under a severe volume strain, with runoff coming from both I-70 and the residential area north of MD-144. SHA should be contacted regarding potential collaboration on stormwater management and stream restoration improvements because stormwater runoff from the roads is causing major channel instabilities at this location. The volume, frequency, and flashiness of runoff should be reduced to prevent further problems with the receiving channel. (1) Structures to encourage infiltration and detain runoff should be constructed along both the north and south sides of I-70 to control runoff (e.g., creation of small detention pools where the concrete swales feed highway runoff into the mainstem channel).

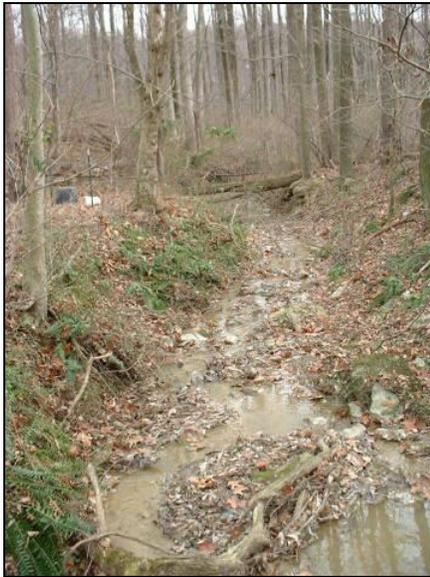
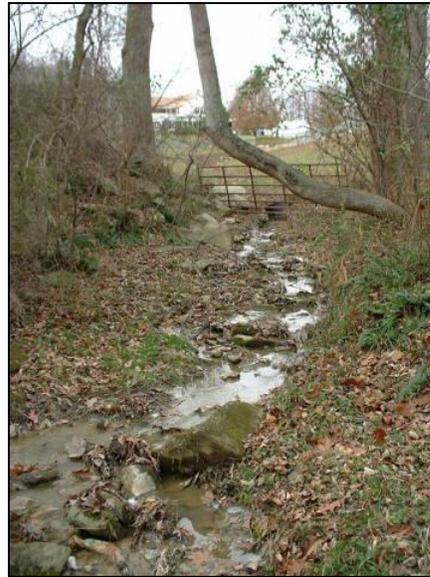
**Site Description:** Small stream flows from spring through barnyard and pasture. Extensive bank trampling has destabilized stream banks, caused bank erosion, and downstream sediment deposition along approximately 175 linear feet of channel. Livestock wastes also threaten water quality.

**Restoration Approach:** Agricultural BMPs – work with landowners along this reach to (1) plant riparian buffer using native vegetation; (2) provide long-term protections for riparian buffers through easements; (3) construct livestock exclusions from stream, (4) dedicated stream crossings, and (5) alternate watering sources; and (6) utilize conservation plans.

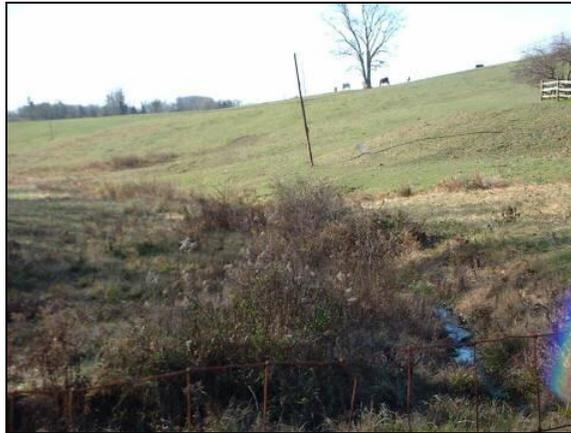
**Site Description:** Stream flows through approximately 1,300 linear feet of livestock pasture without riparian buffer. Minor streambank erosion was noted at this site.

**Restoration Approach:** Agricultural BMPs – work with landowners along this reach to (1) plant riparian buffer using native vegetation; (2) provide long-term protections for riparian buffers through easements; (3) construct livestock exclusions from stream, (4) dedicated stream crossings, and (5) alternate watering sources; and (6) utilize conservation plans.

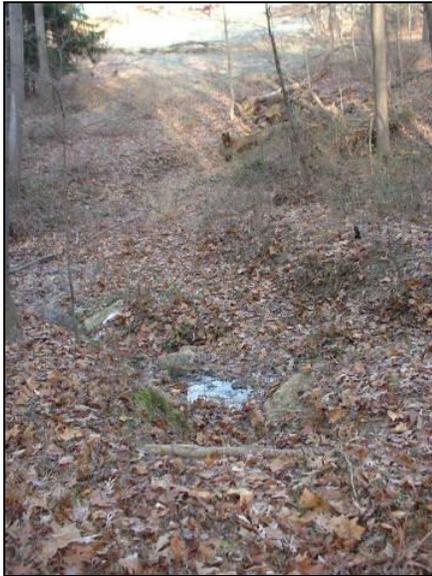
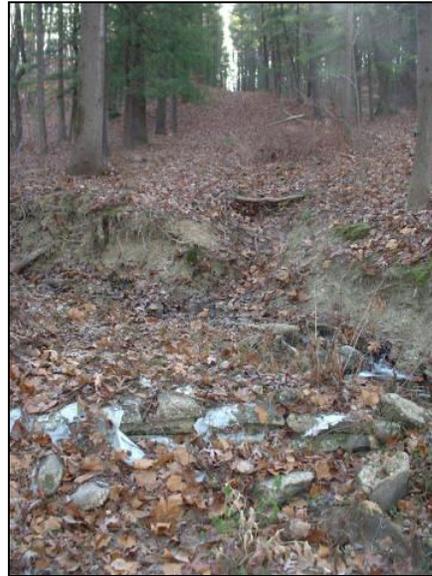
**Site Description:** This site is adjacent to a small farm and is located downstream from the new development at Doubletree Estates. A gas pipeline crosses the stream and runoff down the pipeline rights-of-way (ROW) has eroded a gully into the stream. The pipeline has also caused localized scour and deposition.

**Restoration Approach:** (1) To allow for adequate transport of both water and sediment through approximately 35 linear feet of stream channel at the pipeline crossing, perforated geogrid filled with riprap should be placed flush with the bed of the stream channel, with the finished crossing matching the dimensions of stable reaches located immediately above and below the crossing (i.e., same bankfull width/depth ratio, bankfull cross-sectional area, and slope). (2) To further protect the eroding streambanks, the eroded gully running down the pipeline ROW (approximately 100 feet) should be filled and stabilized (e.g., using vegetated geogrid or other suitable erosion control fabric) to provide a more stable slope.

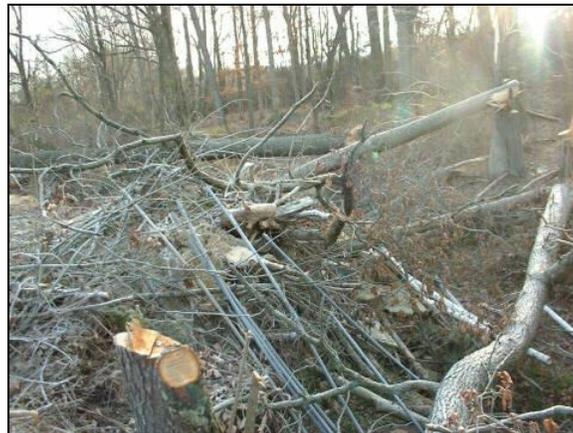
**Site Description:** Trees and construction debris were noted in the stream above the Doubletree Estates development at a permitted logging site.

**Approach:** Clean up trash in this area, leaving some woody debris as habitat for stream organisms.
