## **Appendix C: Concept Designs**

Brown and Caldwell

Project: Potomac Direct Watershed Assessment

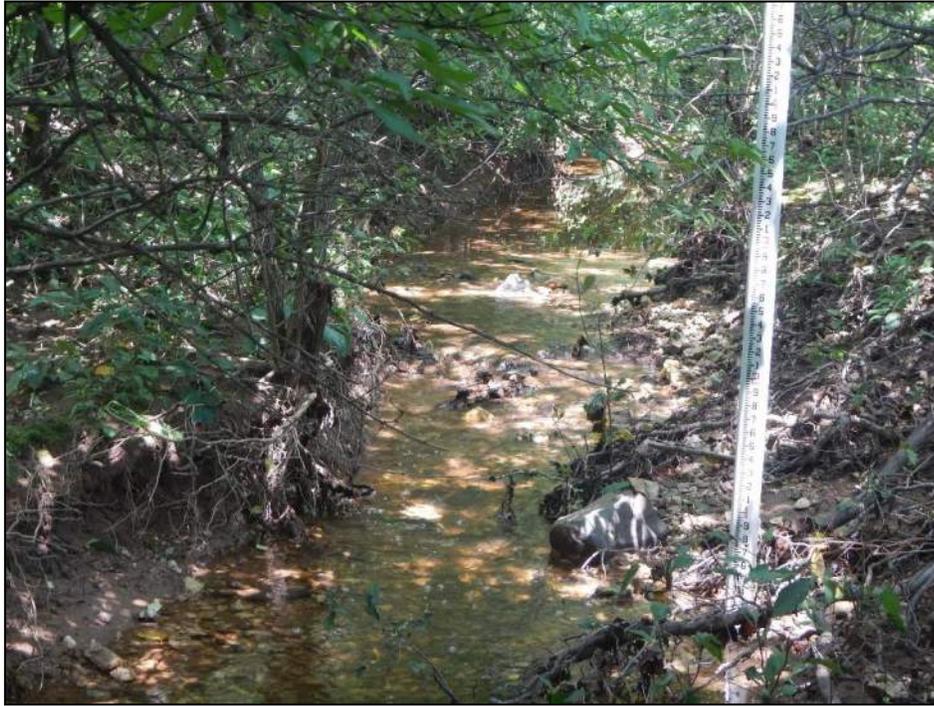
**Photo 1: Looking upstream at farthest upstream point of POTD-132-R-2009, with actively eroding banks, exposed root systems, and minimal vegetative cover.**

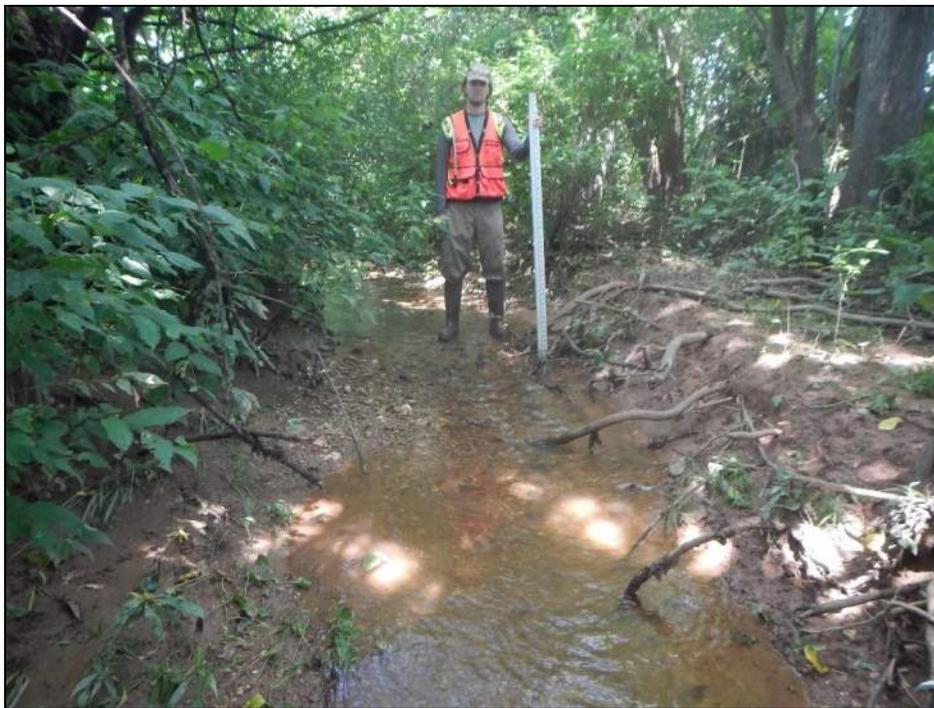
**Photo 2: Looking upstream near Ballenger Creek Pike at raw, actively eroding banks, minimal vegetative cover, and exposed roots.**

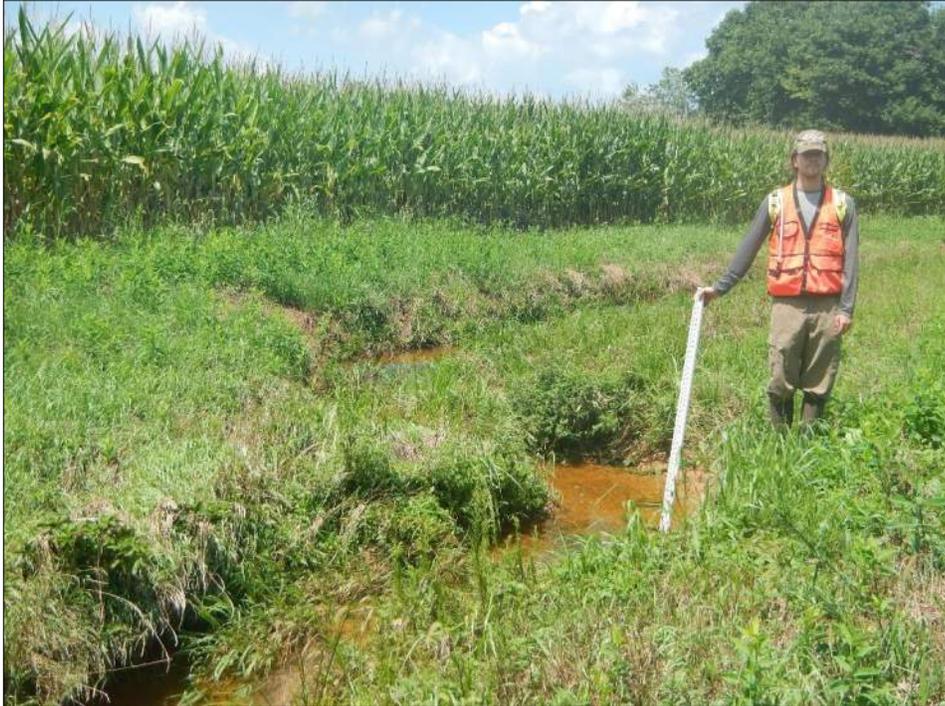
**Photo 3: Looking downstream at 2' tall, undercut, actively eroding banks with minimal connection to floodplain and a low-cut grass riparian corridor**

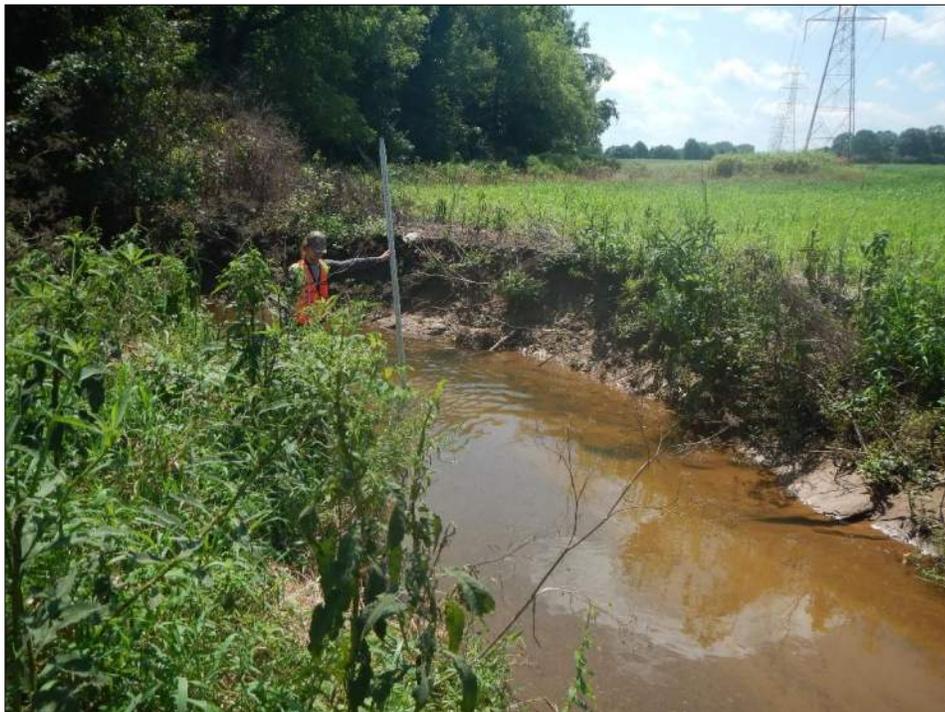
**Photo 4: Looking downstream at a 4' tall, vertical, actively eroding bank with a low-cut grass riparian corridor and no connection to floodplain**

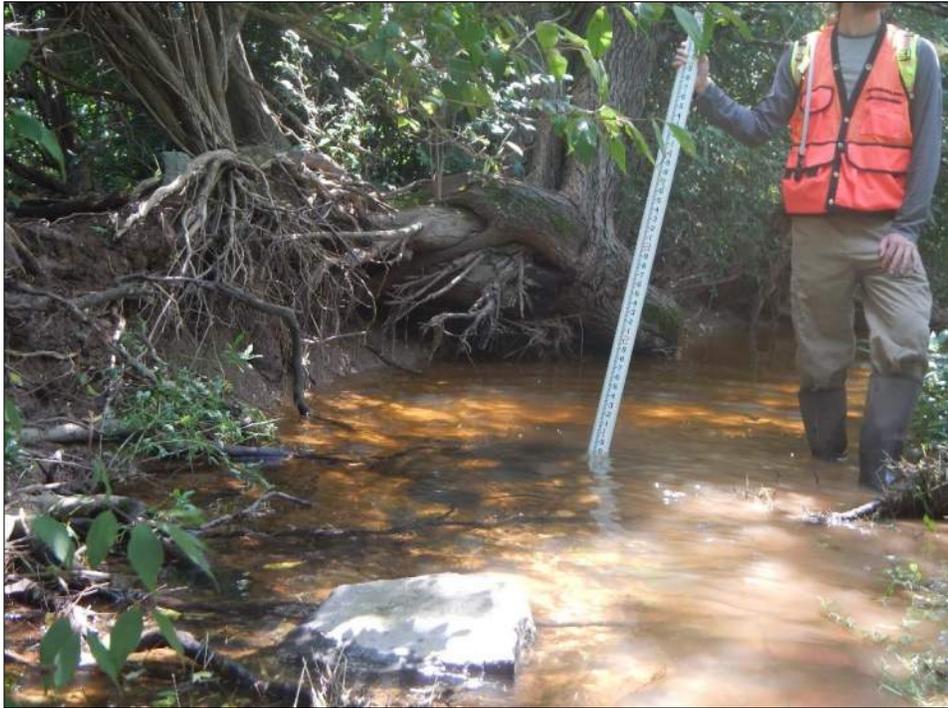
**Photo 5: Looking upstream at a 3' tall, incised, actively eroding bank with exposed roots and unstable trees**

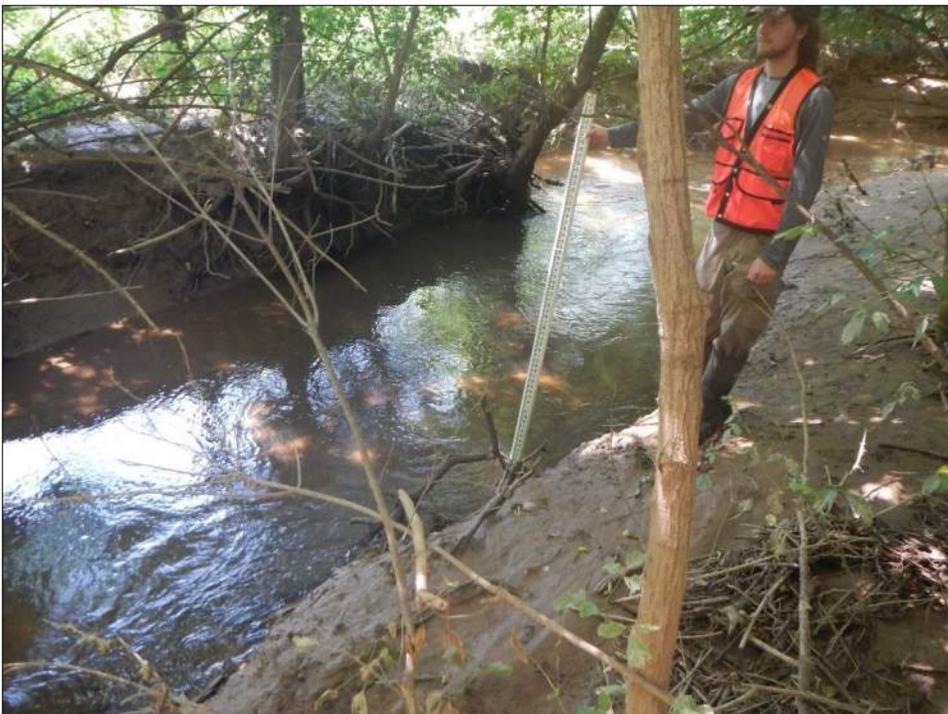
**Photo 6: Looking upstream at a 3' tall, vertical, raw, actively eroding bank with exposed roots and falling trees, and a raw, actively eroding point bar**

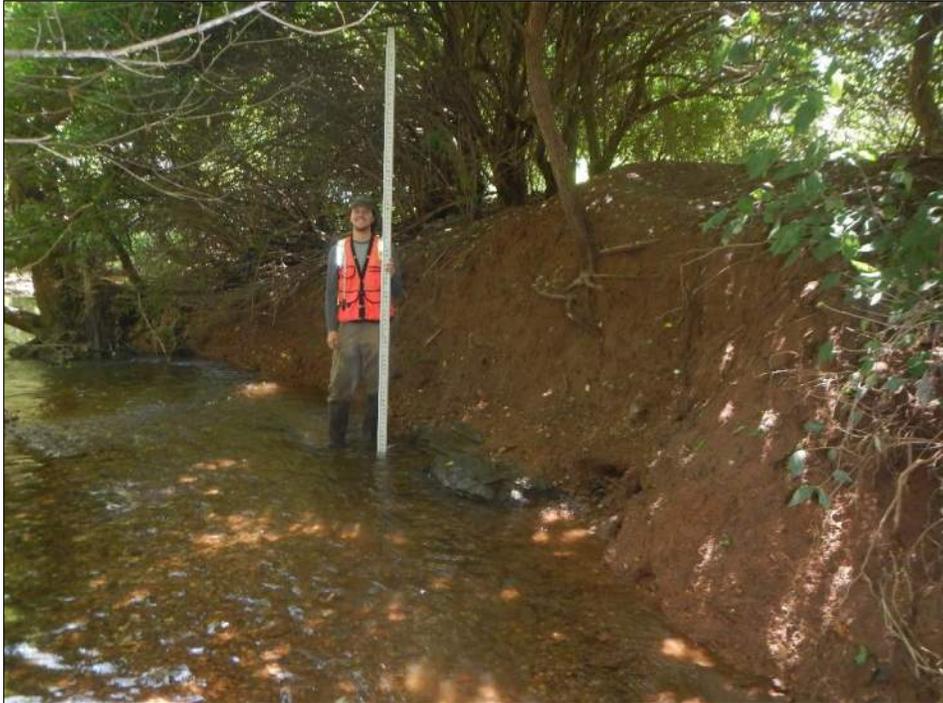
**Photo 7: Looking upstream at a 7' tall, raw, actively eroding bank with exposed roots and falling trees**

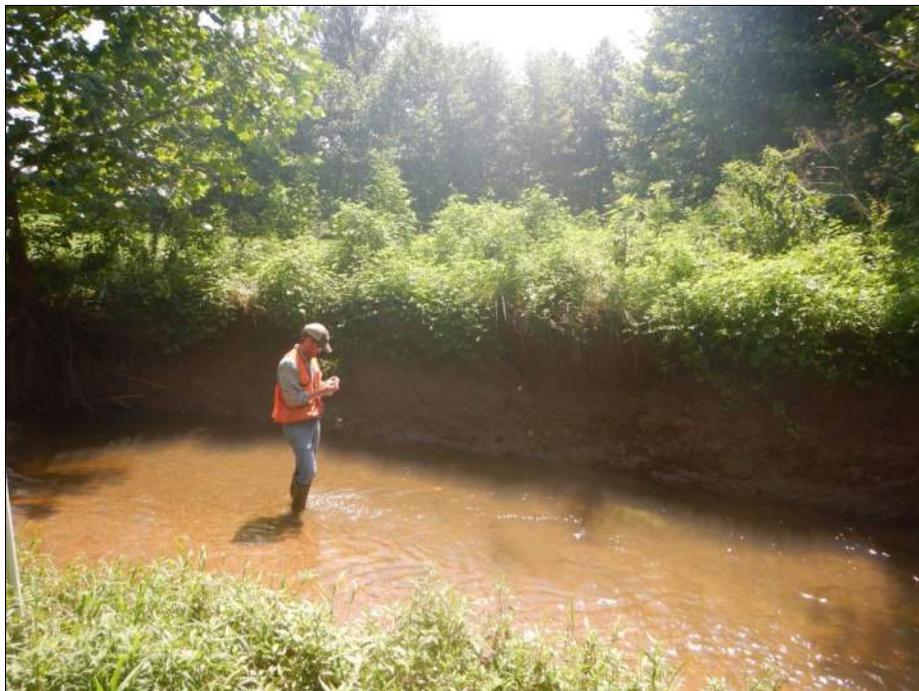
**Photo 6: Looking across stream at a 5' vertical, raw, actively eroding bank with minimal riparian vegetation and no connection to floodplain**

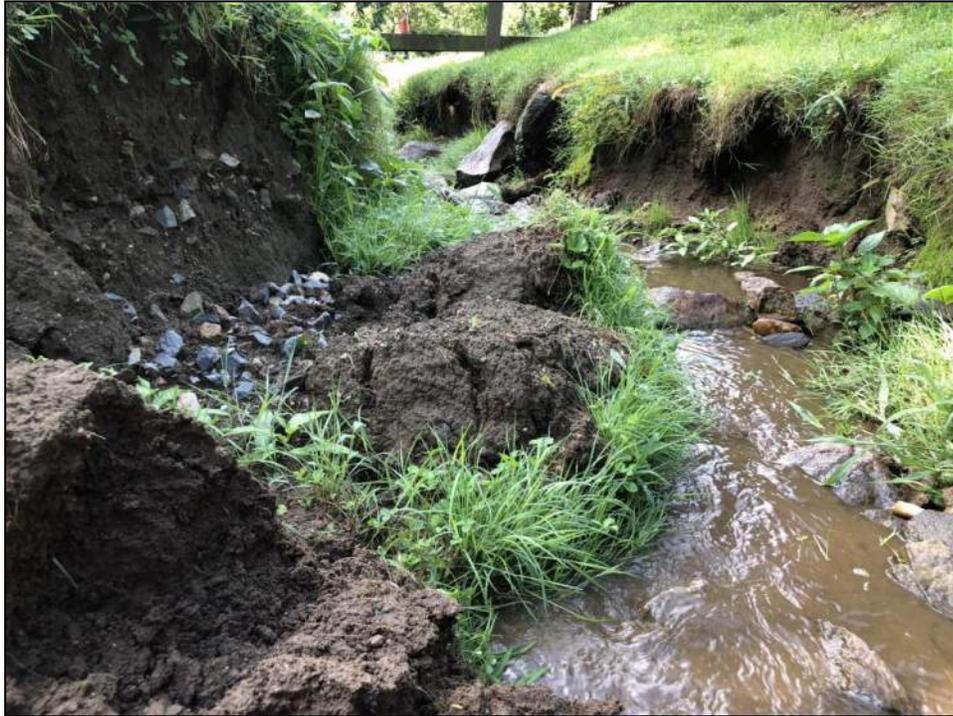
**Photo 1: Looking downstream at 3' tall vertical, raw, actively eroding banks with vegetation sloughing into stream**

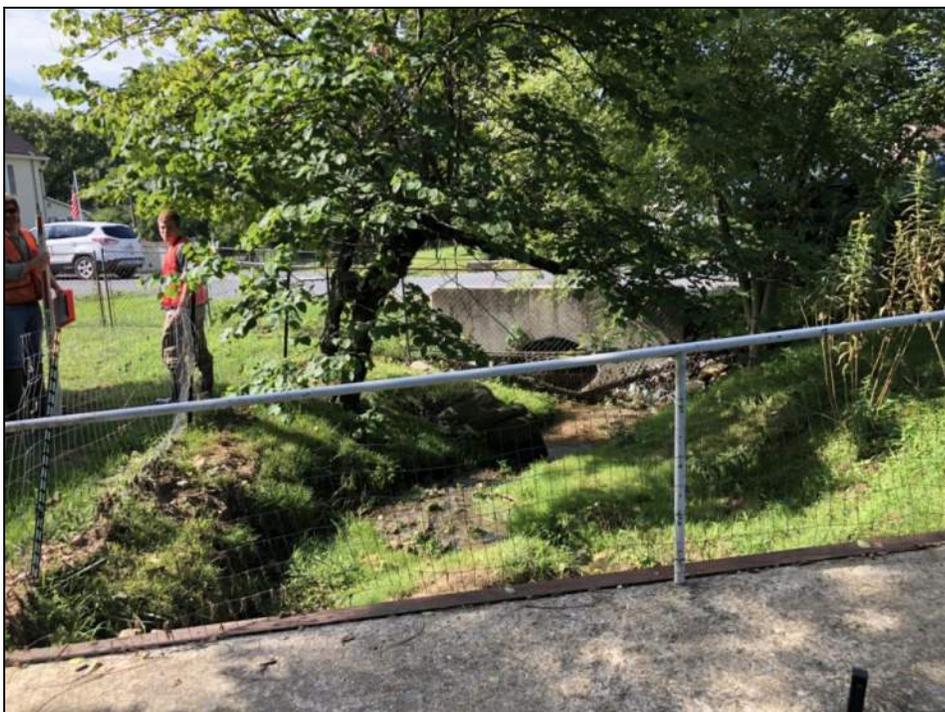
**Photo 2: Looking downstream at actively eroding and widening banks and a pedestrian bridge within the floodplain**

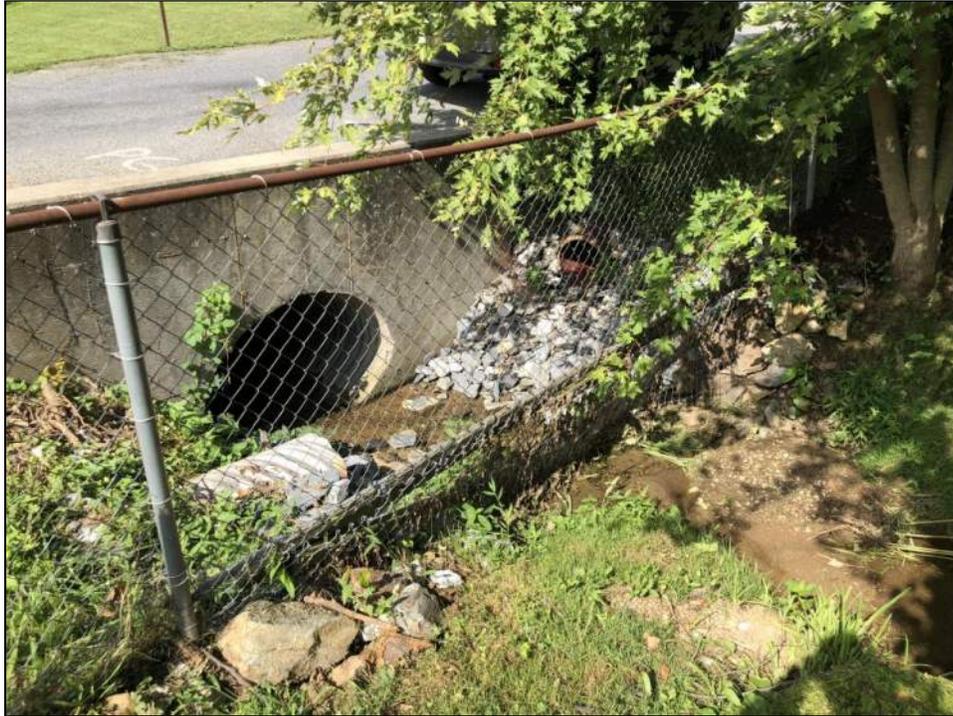
**Photo 3: Looking downstream at culvert opening blocked by chain-link fence, which accumulates organic matter and causes flooding and overtopping**

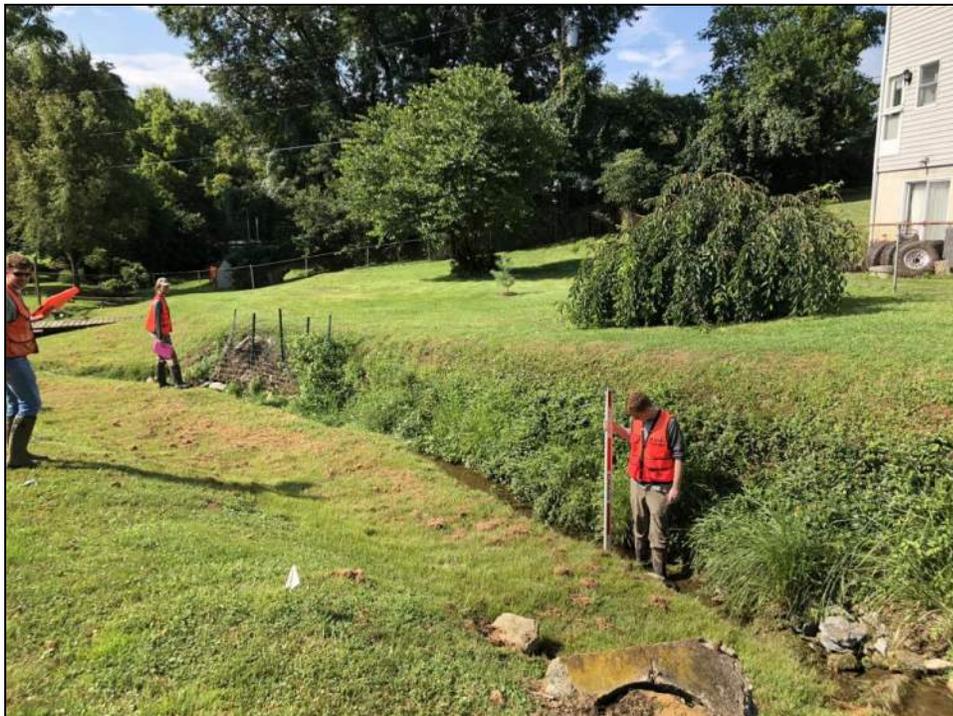
**Photo 4: Looking downstream at a 5' tall, vertical, actively eroding bank with a mowed grass riparian corridor**

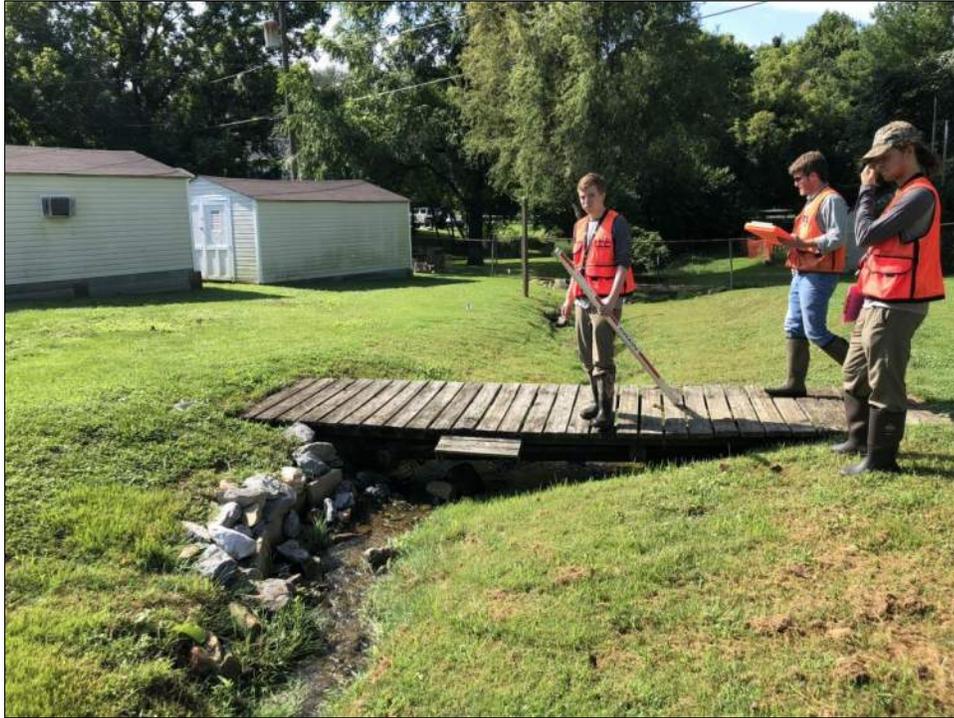
**Photo 5: Looking downstream at existing footbridge. Existing sheds are not currently impacted at baseflow but are within floodplain**

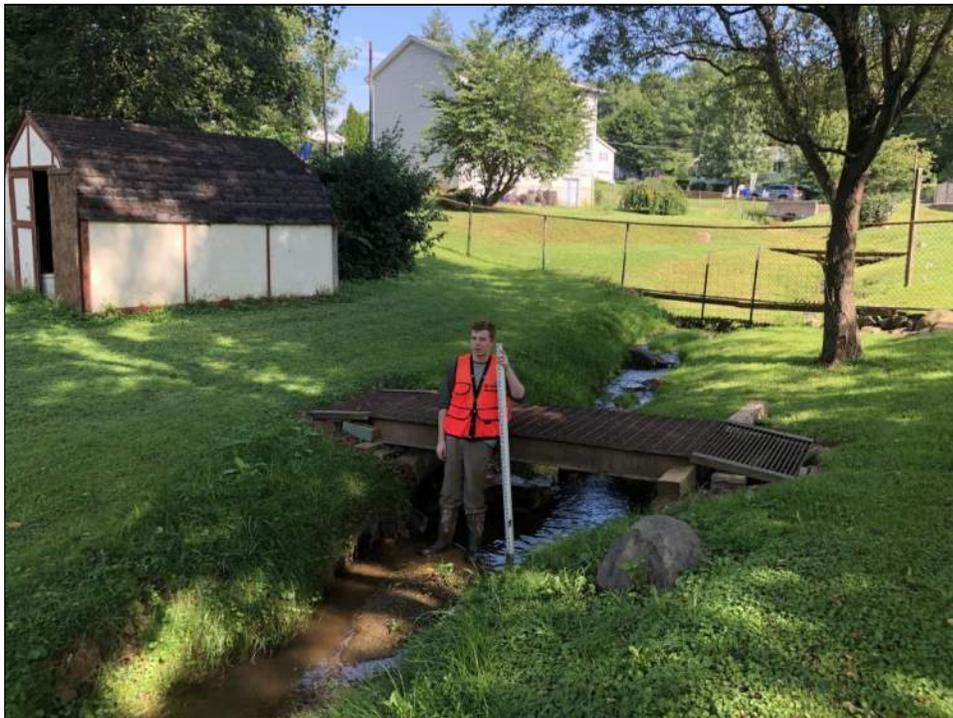
**Photo 6: Looking upstream at existing footbridge. Existing shed is not currently impacted at baseflow but is within floodplain**

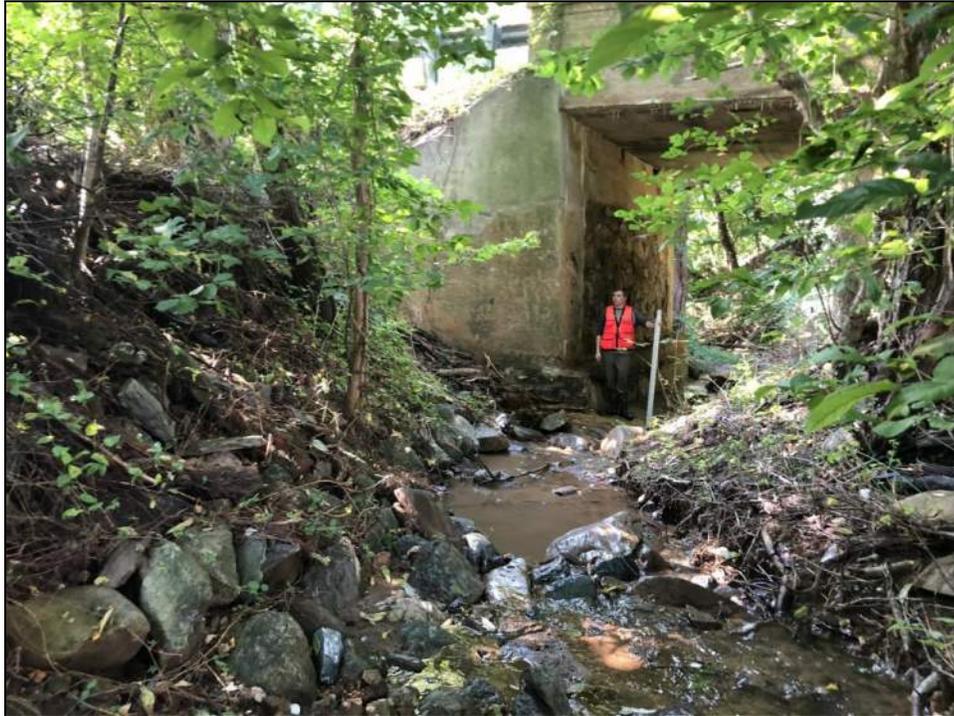
**Photo 7: Looking downstream at a raw, actively eroding banks with exposed roots and no connection to floodplain**

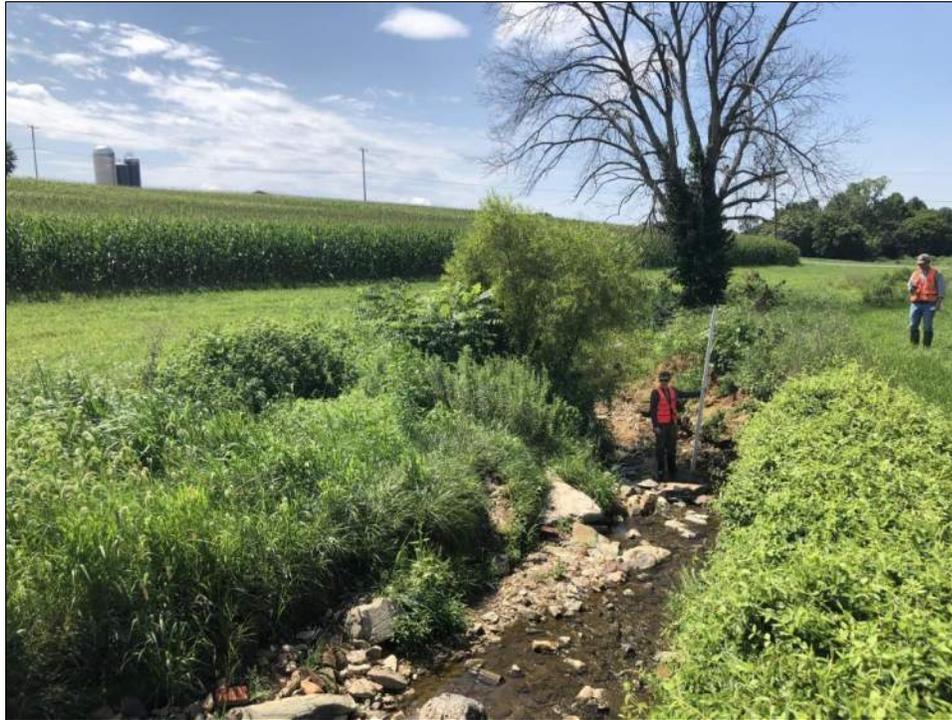
**Photo 1: Looking downstream at 4' tall vertical, actively eroding banks with vegetation sloughing into stream**

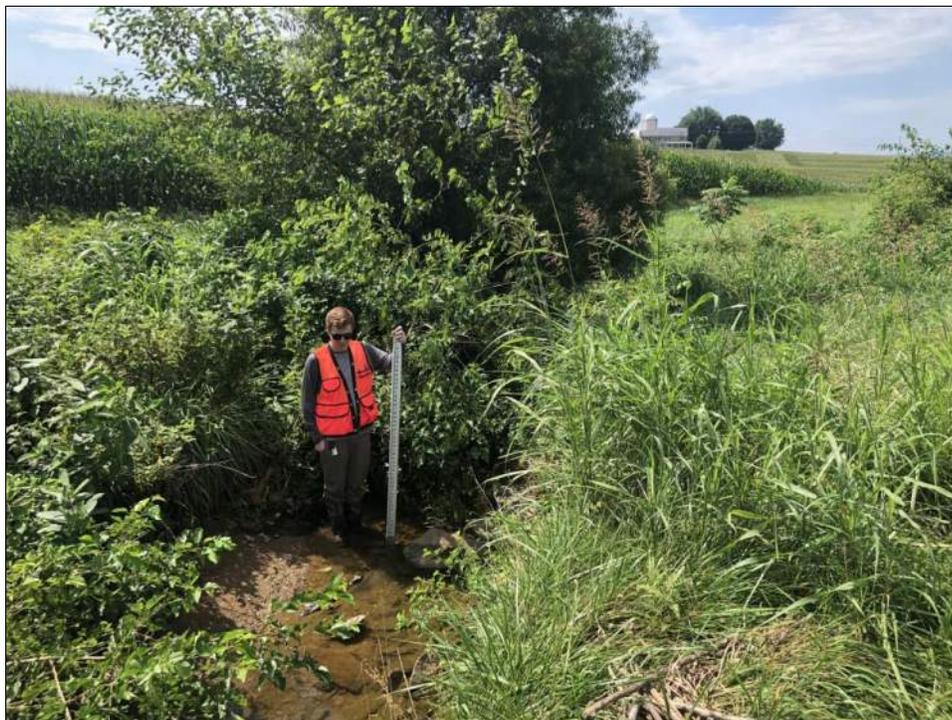
**Photo 2: Looking downstream at a tortuous meander with 4' tall, vertical, actively eroding banks with grassy riparian vegetation and no connection to floodplain**

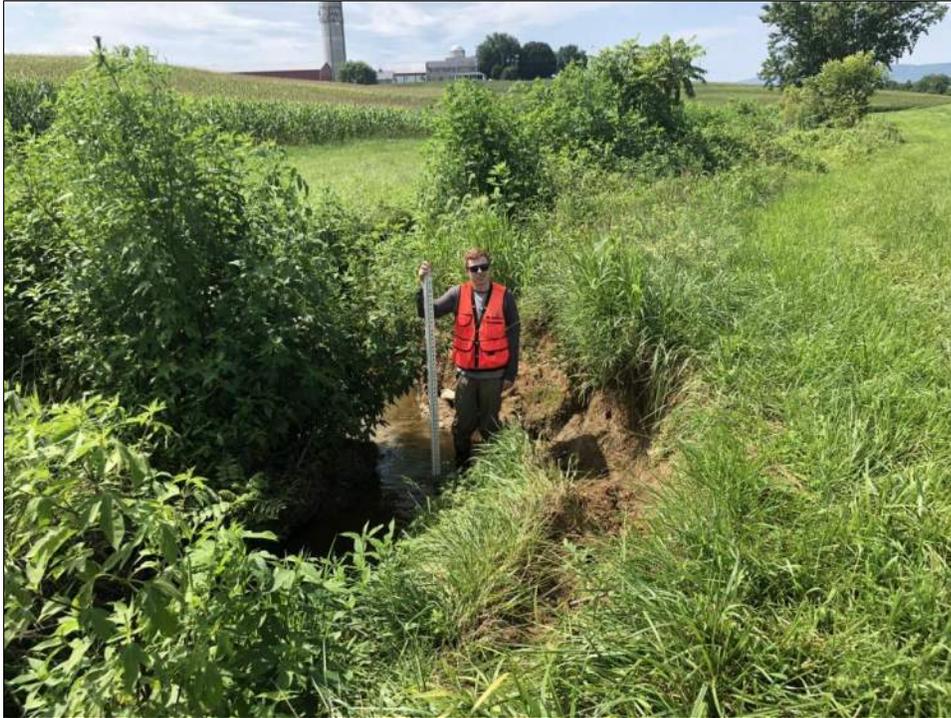
**Photo 3: Looking downstream at a 3' tall, incised, raw actively eroding bank with vegetation sloughing into stream and no connection to floodplain**

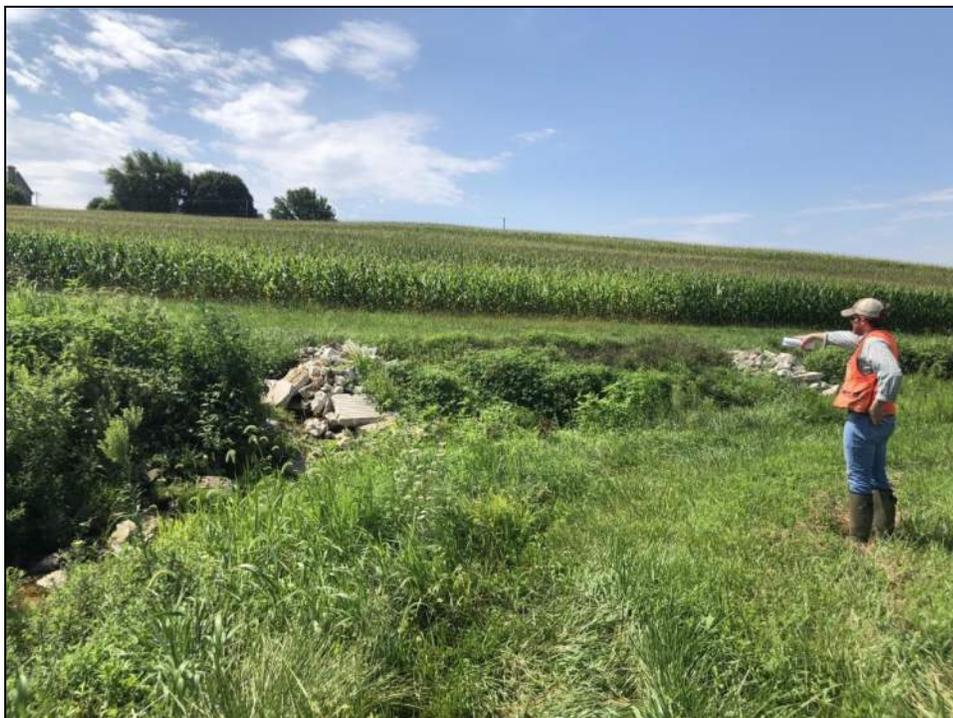
**Photo 4: Looking across stream at a 4' tall actively eroding banks with piled stone reinforcement placed by farmer in an attempt to slow erosion**

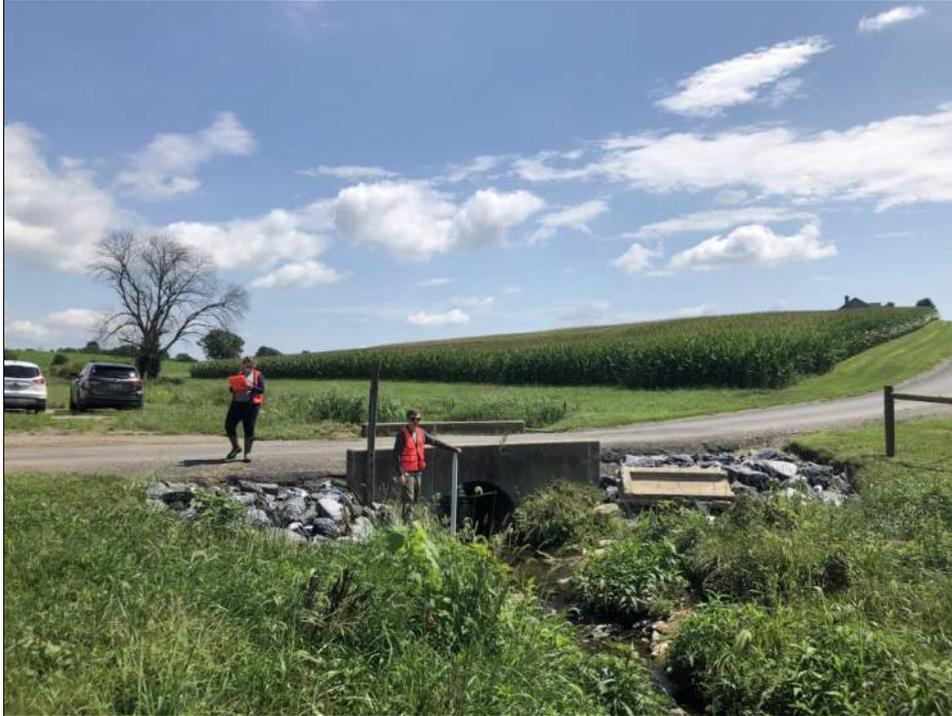
**Photo 5: Looking upstream at an under-sized culvert at a road-crossing, with signs of over-road flow and active erosion along downstream face of roadway**
