Safe Streets for All

Frederick County, MD

Rural Roads – High Injury Network Evaluation

February 14, 2025

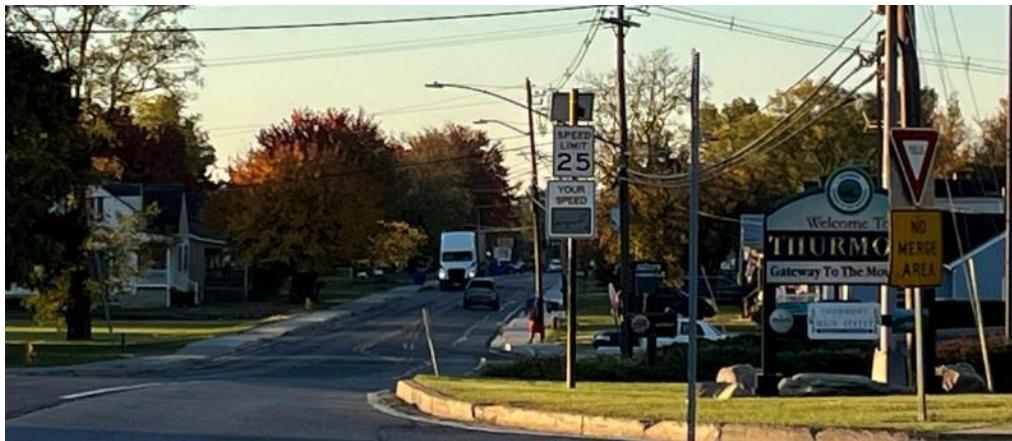
- Missing curve warning signage (W1-2) at the horizontal curves near Old Camp Airy Road and the near the geographical coordinates, 39.65077728629942, -77.4218309917171.
- Faded hatching yellow pavement marking lines near the intersections of MD 550 (N Church St) and the US 15 on/off ramps.
- There is an existing driver speed feedback sign (25 MPH) located near the intersection of MD 550 (N Church St) and the US 15 eastbound off ramp.

Figure 3: Existing digital 25 MPH speed limit sign near the intersections of MD 550 (N Church St) and US 15 EB off ramp

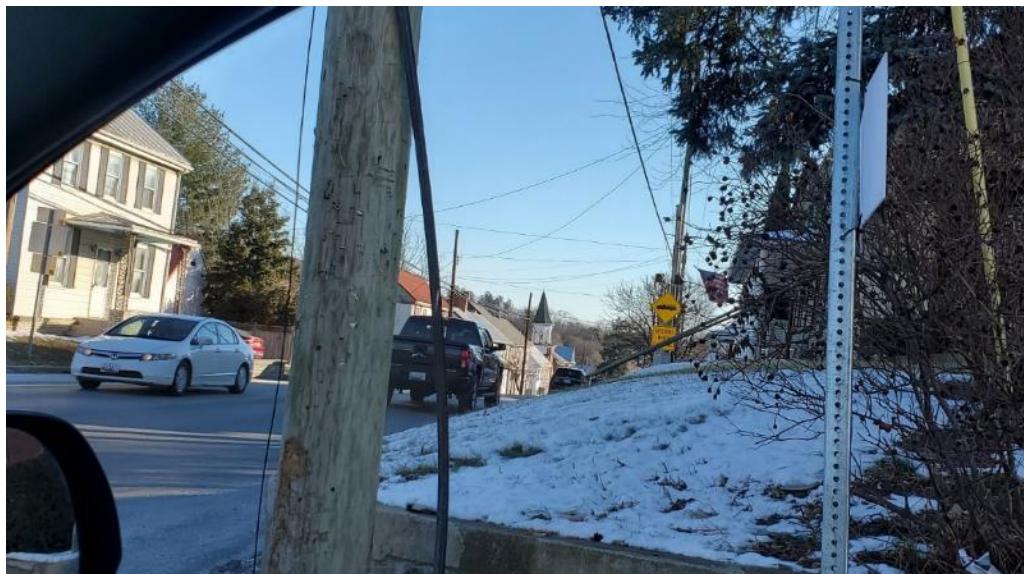
Figure 5: NB Mill Street at MD 26 – looking right (Note: utility pole, shrubbery and topography restricting available sight distance)

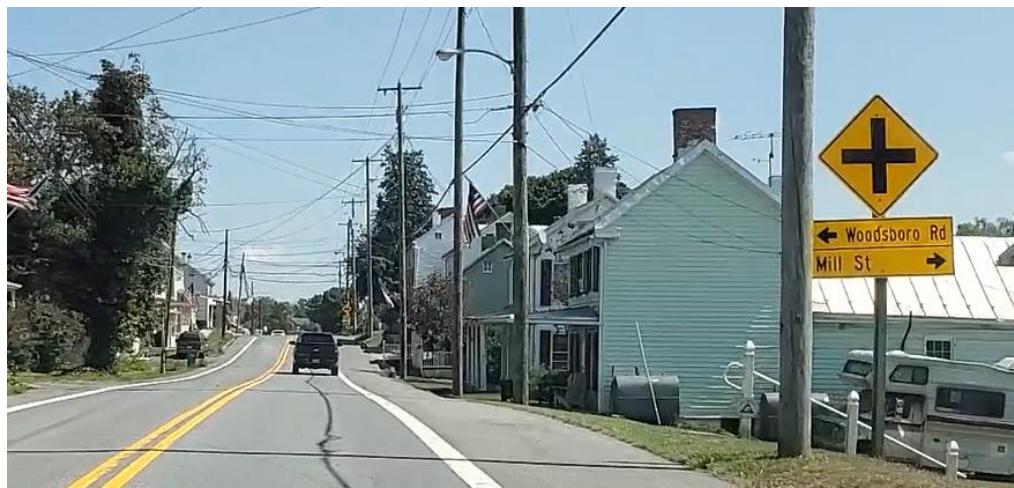
- Utility poles with leased street lighting consistently run along the southside of MD 26 / Liberty Road through Libertytown. There are many poles on the northside as well
- Existing signing along the corridor includes:
 - Eastbound MD 26/Liberty Road
 - A sidestreet/curve warning combination sign with supplemental street name plate is present for the South Street and Daysville Road intersections
 - Cross Road (W2-1) with supplemental street name plate is present for “Woodsboro Road / Mill St” as shown below

Figure 6: Eastbound MD 26/Liberty Road – Advanced cross road warning sign and street name plate

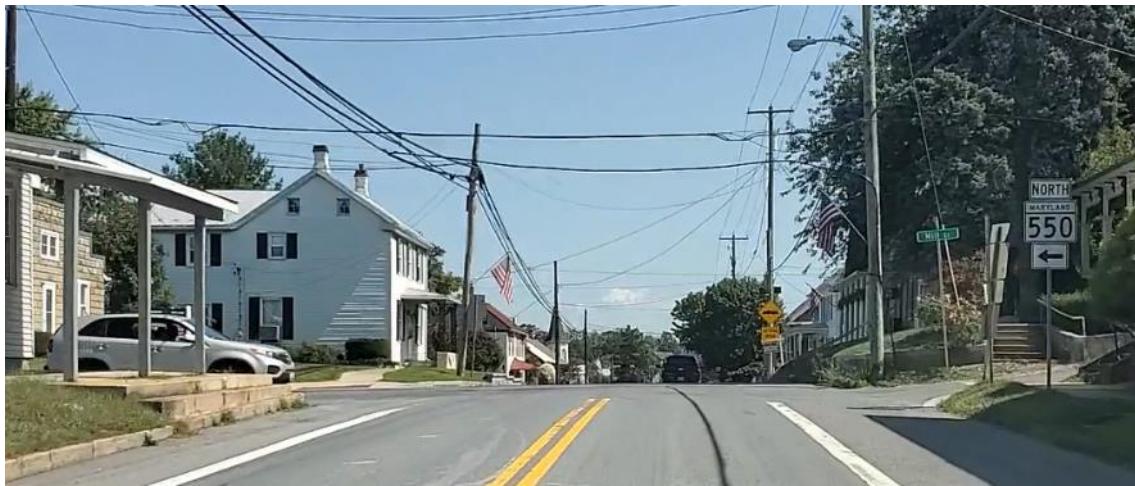
- Northbound Walnut St and southbound Church St include “Signal Ahead” warning signs.
- MD 26/Liberty Road at MD 550/Woodsboro Road/Mill Street:
 - Despite the advanced crossroad warning signs with supplemental name plate signs and route markers at the intersection, this intersection is easily overlooked by MD 26/Liberty Road motorists due its position at a vertical crest and the tightly spaced buildings both at and approaching the intersection.

- Southbound MD 550/Woodsboro Road motorists stopped at the stopline or just beyond must look “through” a residential porch to see oncoming eastbound MD 26 traffic, as shown in photo below.

Figure 7: Eastbound MD 26/Liberty Road at MD 550 intersection

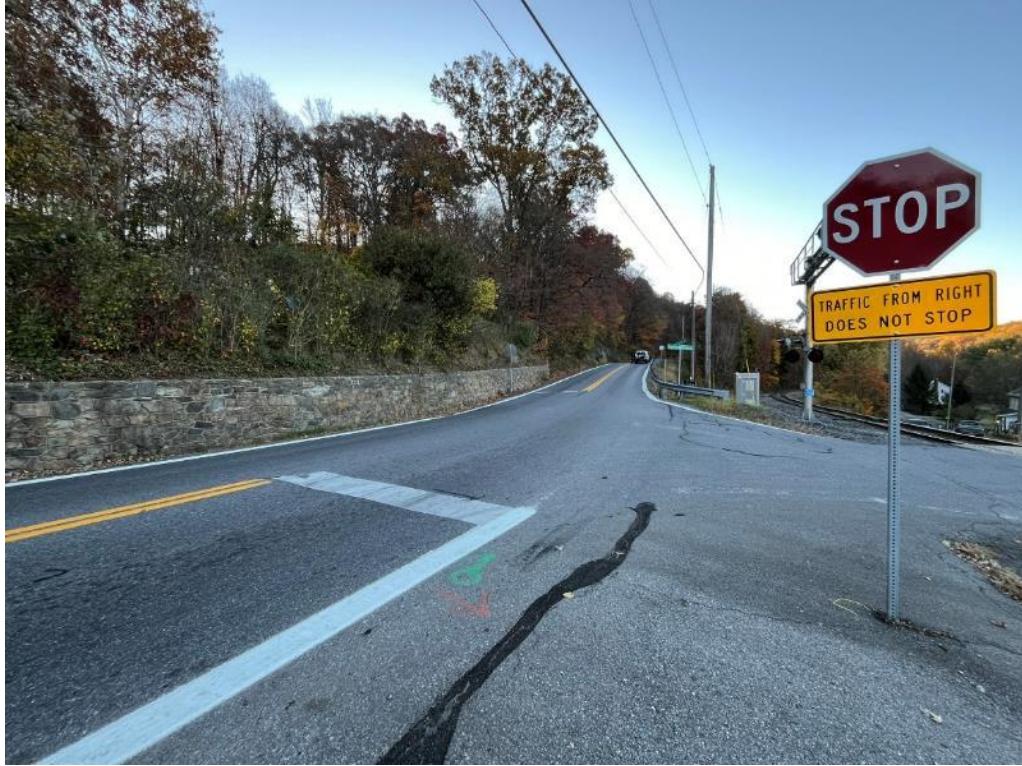
There are also existing flashing beacons, stop ahead and railroad crossing ahead warning signs in advance of the Sabillasville Road and Foxville Deerfield Road intersection.

Figure 9: Sabillasville Road and Foxville Road Intersection

- Refresh the existing stop line and edge line pavement markings at the intersection of Sabillasville Road and Foxville Deerfield Road.
- Install dotted centerline extension pavement markings at the intersection of Sabillasville Road and Foxville Deerfield Road.
- Refresh the existing stop line and edge line pavement markings at the intersections of Sabillasville Road and Harbaugh Valley Road.
- Replace the existing 30 inches by 12 inches W4-4a(1) signs (Traffic from Right/Left does not stop) at the intersection of Sabillasville Road and Foxville Deerfield Road, with larger signs (36 inches by 15 inches), to improve the visibility of the warning signs.

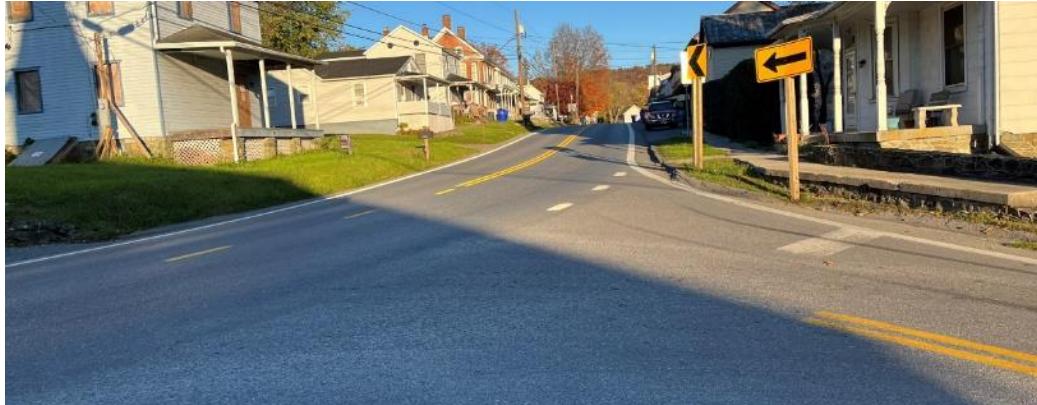
Figure 10: Poorly visible pavement markings (Sabillasville Road and Harbaugh Valley Road Intersection)

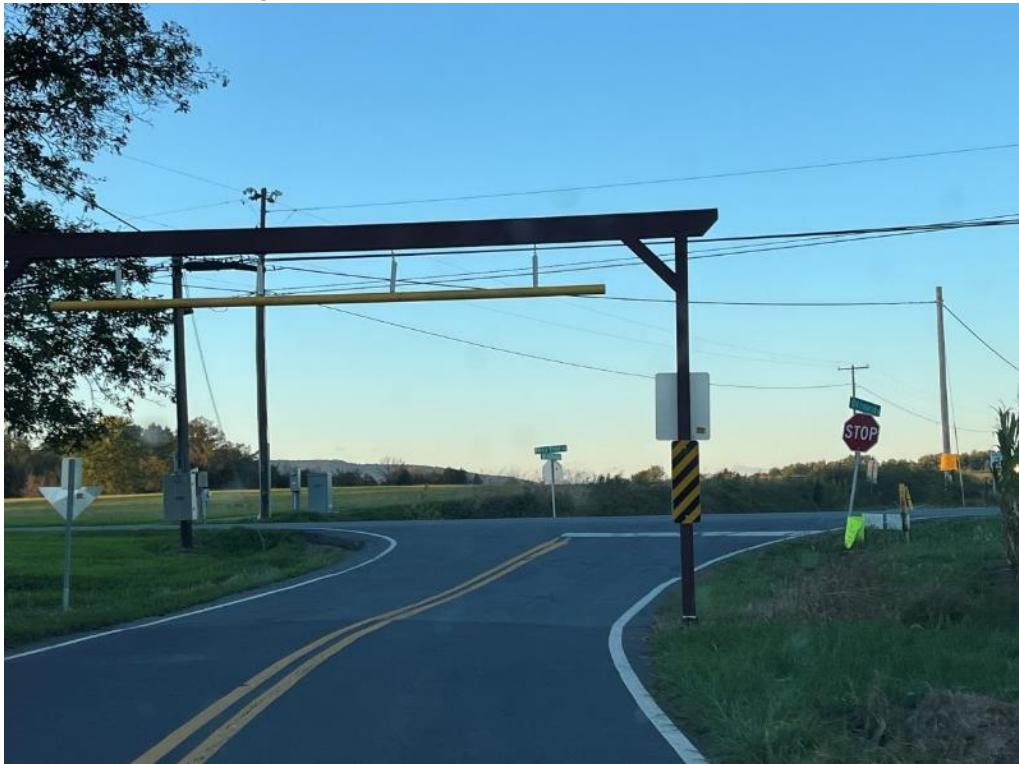
- Missing speed limit advisory plaques at curve warning signs.
- The intersection of Old Frederick Road and Rocky Ridge Road is very skewed in geometry.
- Numerous trees are present in the roadway clear zone near the address, 14726 Old Frederick Road, Rocky Ridge, MD 21778.

Figure 13: Intersection of Old Frederick Road and Rocky Ridge Road

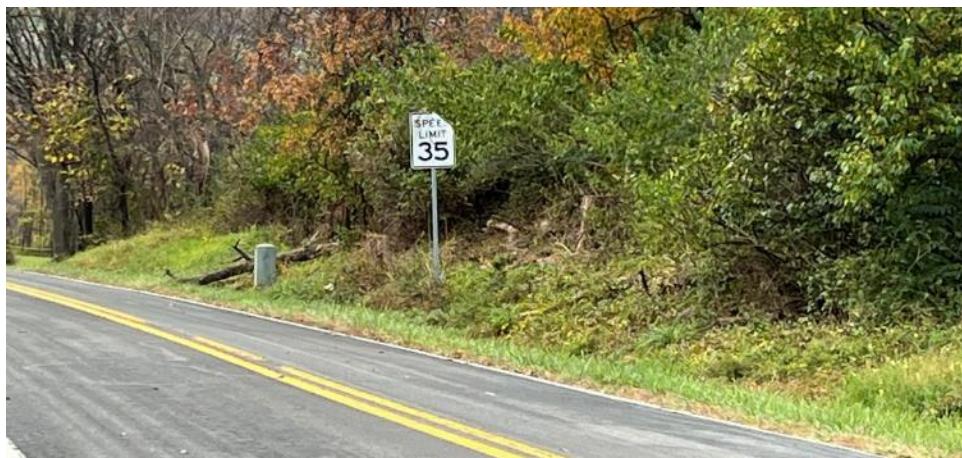
- Harp Hill Road has several horizontal and vertical curves.
- Many trees and shrubbery were within the roadway clear zone.
- Edge line and center line pavement markings look faded at some locations throughout the corridor.
- A damaged existing speed limit sign was located near 11425 Harp Hill Road, as shown below.

Figure 17: Damaged speed limit sign near 11425 Harp Hill Road

- Tree trimming to increase the roadway clear zone and reduce the frequency/severity of fixed object/tree shrubbery crashes.
- Install one direction curve warning signs to supplement the existing chevron signs along each of the horizontal curves near 11425 Harp Hill Road.
- Replace the damaged speed limit sign near 11425 Harp Hill Road.
- Request police enforcement of the speed limit near 11425 Harp Hill Road.
- Refresh faded edge line or centerline pavement markings along the entire corridor.

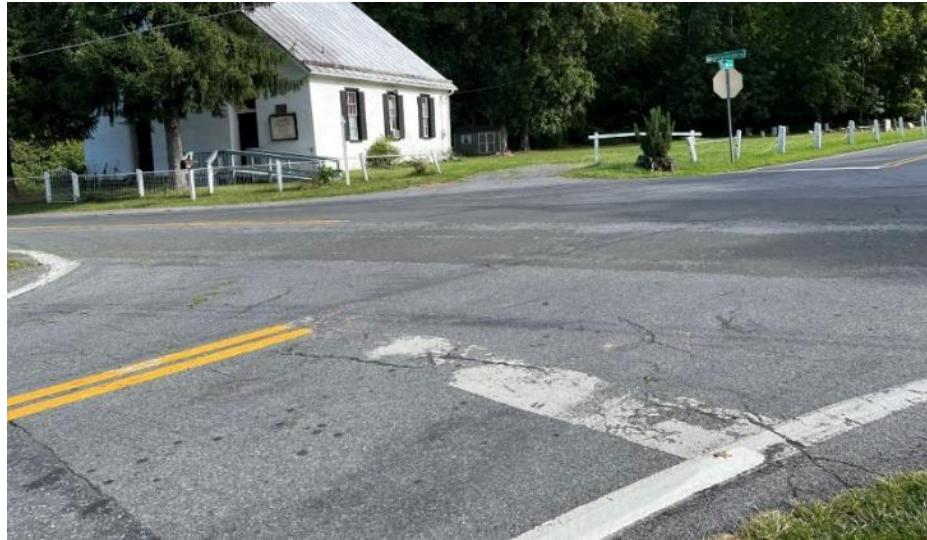
- The Mountaintdale Road and Bethel Road intersection is skewed in geometry.
- All existing regulatory and warning signs near the intersection of Mountaintdale Road and Bethel Road are in good condition. Existing warning signs at this intersection include stop sign ahead, curve ahead, advisory speed and intersection ahead warning signs.
- Northbound traffic at the intersection of Mountaintdale Road and Bethel Road typically drives about 20 feet past the stop bar before coming to a complete stop (Mountaintdale Road is assumed to run in an east-west direction).
- Significantly faded stop bar for the southbound movement at the intersection of Mountaintdale Road and Bethel Road (see **Figure 21** below).
- Obscured speed limit sign near the Mountaintdale Road and Bethel Road intersection (see **Figure 22** below).

Figure 21: Faded Markings at Mountaintdale Road and Bethel Road Intersection

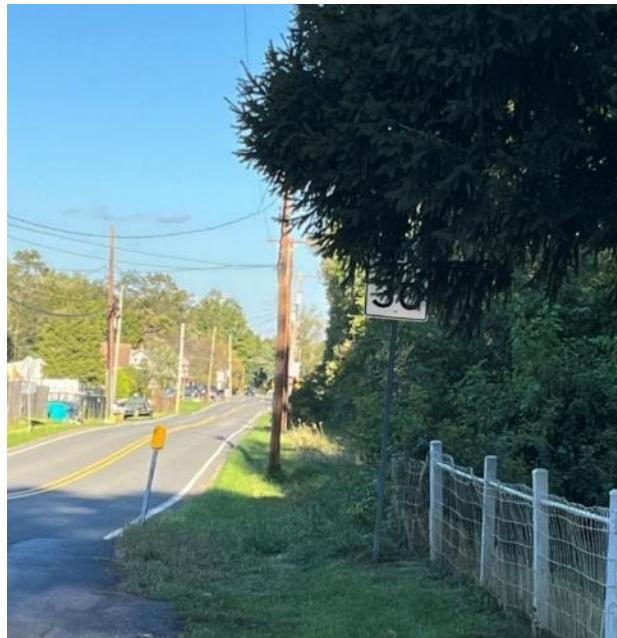
Figure 22: Poorly visible speed limit sign near Mountaintdale Road at Bethel Road Intersection.

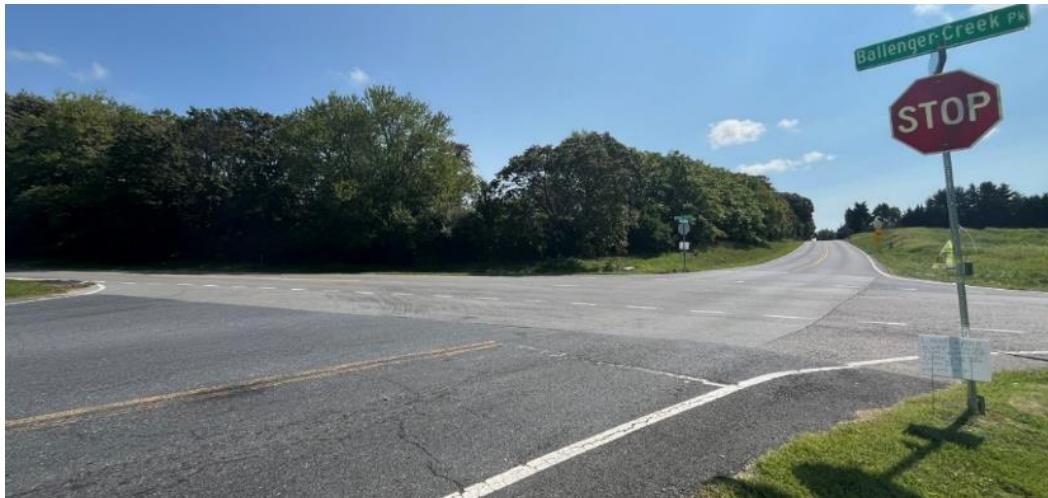
- The stop line for westbound Mountville Road at Ballenger Creek is faded (see Figure 24 below).
- Edge line extension pavement markings are faded making it difficult for approaching motorists to know how far they can pull up to the intersection (see **Figure 24** below).

Figure 24: Faded pavement marking/stop bar at Mountville Road and Ballenger Creek Pike

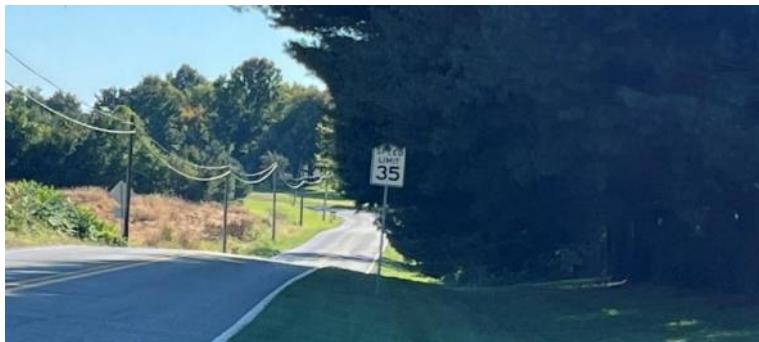
- The speed limit sign near the intersection of Mountville Road and Ballenger Creek Pike is obstructed as shown in **Figure 25** below.

Figure 25: Obstructed speed limit sign along westbound Ballenger Creek near Mountville Road

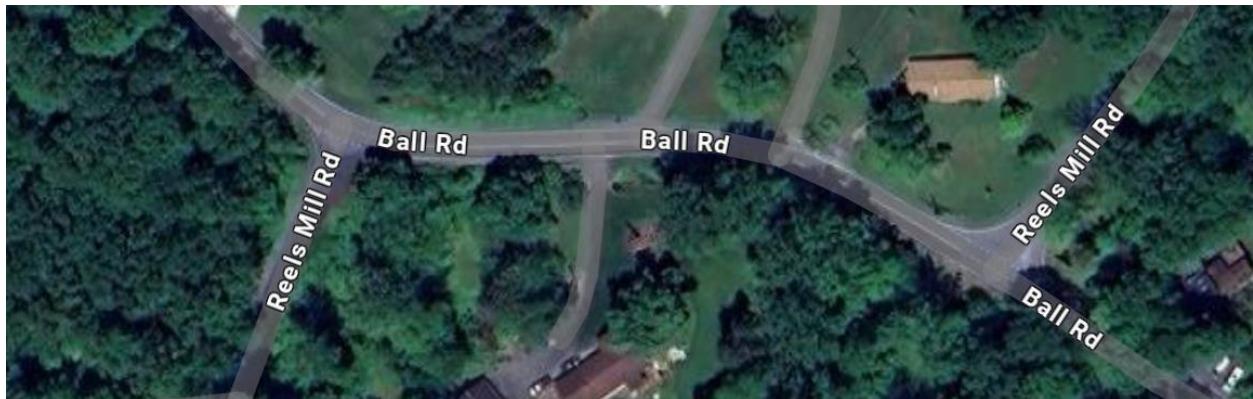
- Reels Mill Road forms two intersections with Ball Road. The Reels Mill Road north and south legs are separated by approximately 550-ft.

Figure 27: Reels Mill Road forms two off-set intersections with Ball Road. (Source: Google Maps)

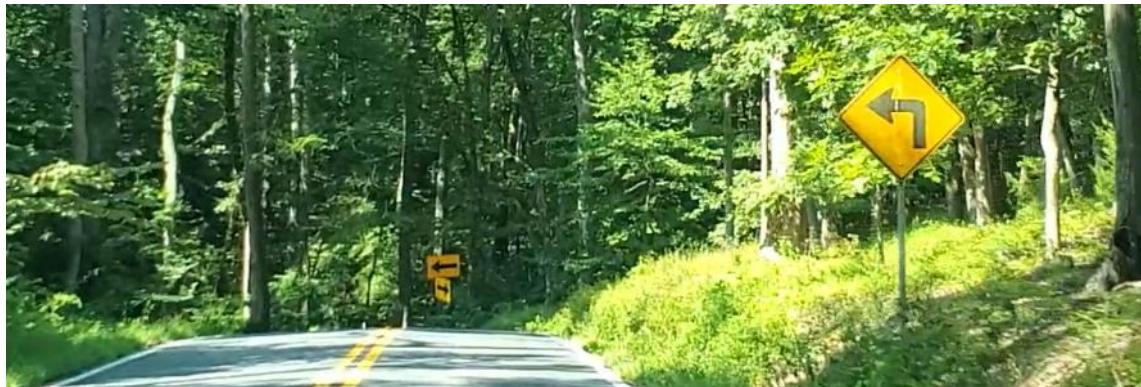
- While there are no advanced sidestreet warning signs on Gas House Pike approaching Dance Hall Road, the intersection does include centerline skips and an edgeline extension. The “Dance Hall Road” street name sign is bent.
- The southbound Dance Hall Road “stop ahead” warning sign is obstructed by vegetation. Further, most Dance Hall Road signs are in fair condition though many are dirty or obstructed by vegetation, as shown below.

Figure 29: Southbound Dance Hall Road approaching sharp turn – Note: Turn (W1-1) sign is faded and dirty

- Install edgeline rumble stripes along Dance Hall Road as well as rumble strips on the approaches to the sharp curve.
- Install RPMs, which were identified in the RPM “hot spot” analyses as well.
- Trim trees and vegetation back from edge of road to the maximum extent possible based on right-of-way.
- Consider curve just north of Gas House Pike for high-surface friction treatment
- Install experimental elongated pavement marking signs (W1-1), which would likely require experimentation approval from FHWA, on northbound & southbound Dance Hall Road approaching the horizontal curve north of Gas House Pike, such as curve (W1-2) warning sign example from Kansas below:
