HISTORIC PRESERVATION COMMISSION FREDERICK COUNTY, MARYLAND

CASE NO. CR 21-02 NOMINATION TO COUNTY REGISTER STAFF REPORT

Property: Beatty Cramer House
9010 Liberty Road, Frederick

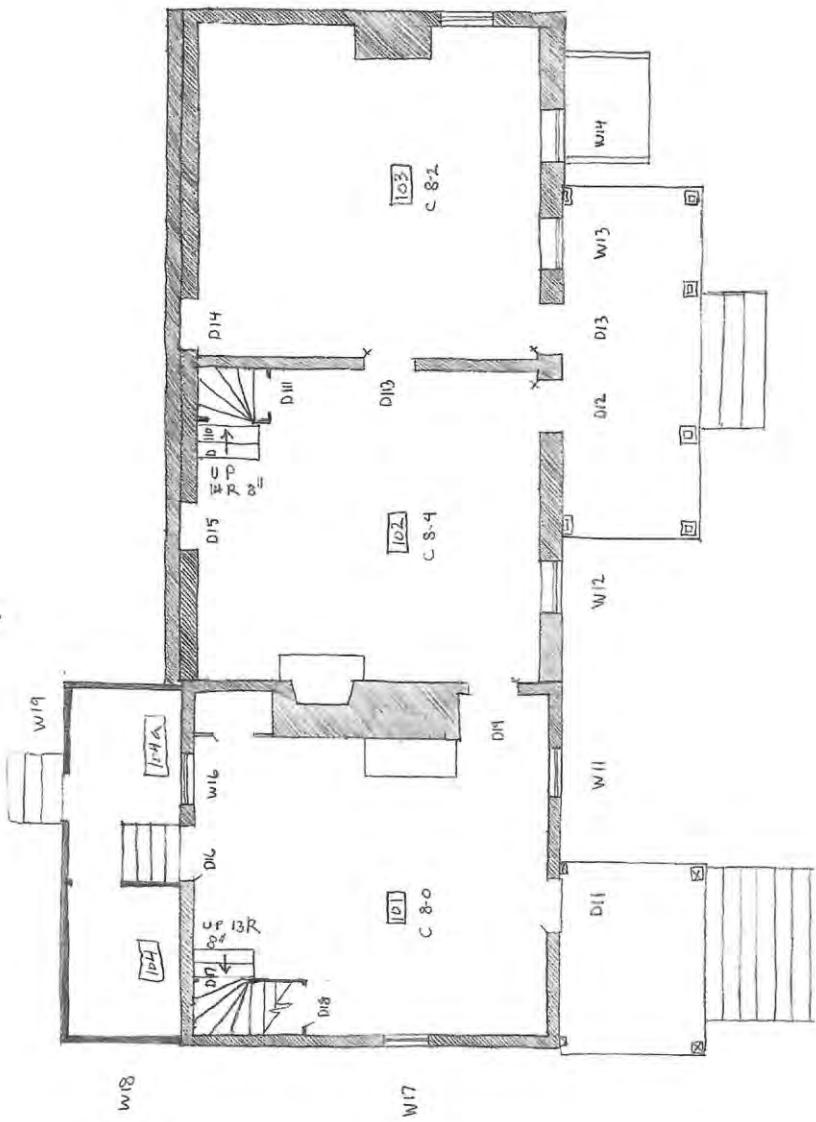
FIRST FLOOR PLAN

87.50 H. CRAMER HOUSE

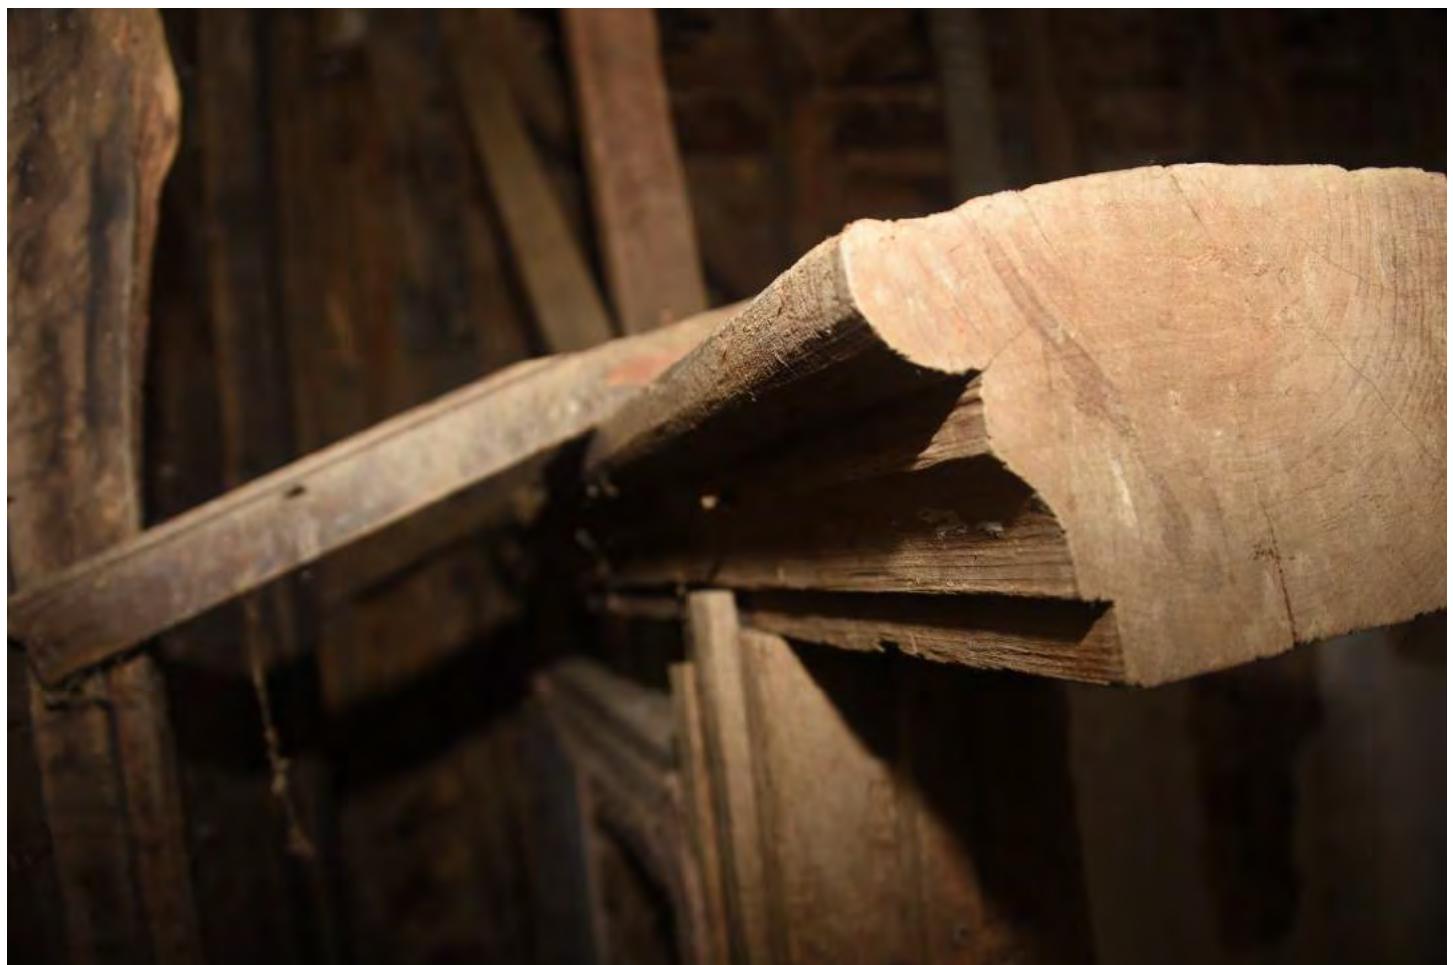
MD_FrederickCounty_Beatty-Cramer_0004.tif
North elevation, cornice moulding on top plate, covered by later curtain wall.

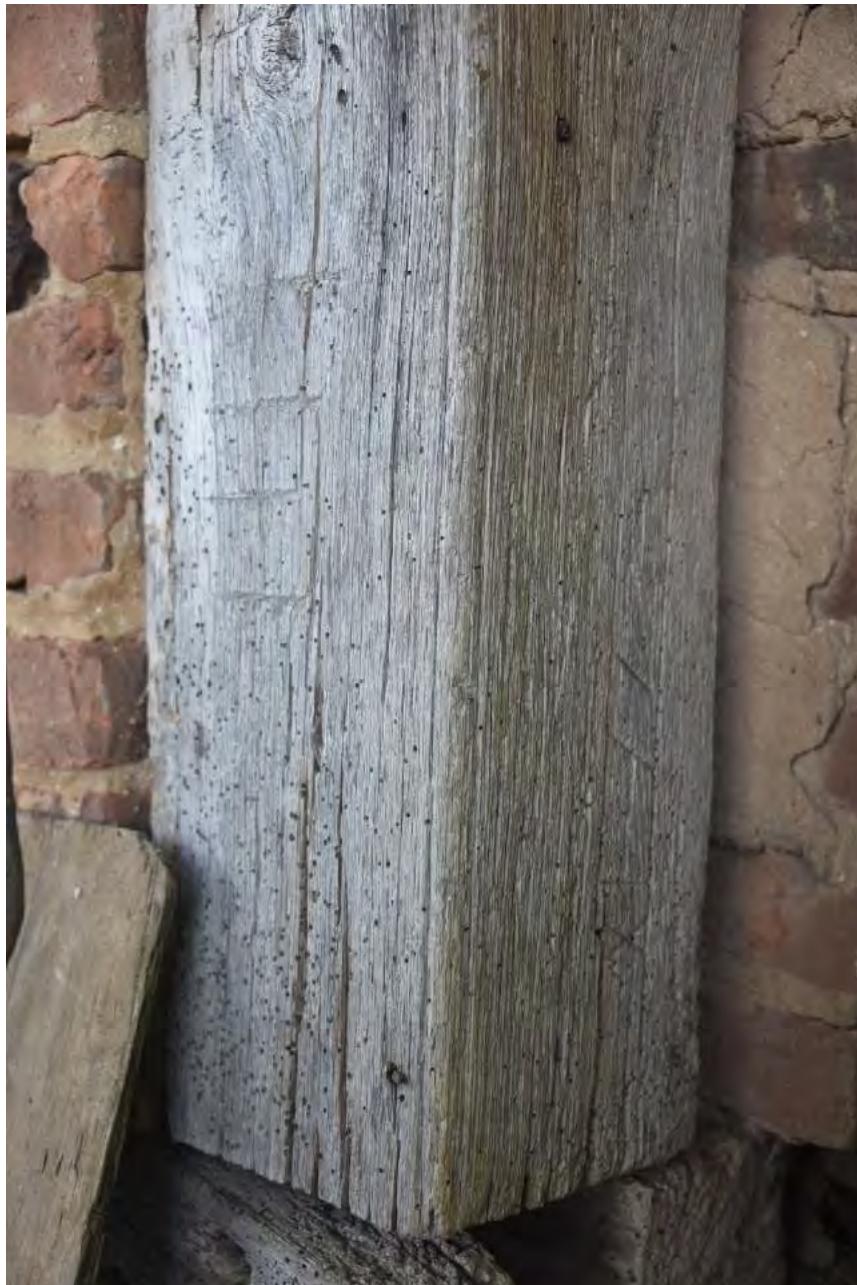
MD_FrederickCounty_Beatty-Cramer_0005.tif
Northeast corner post with corner bead and marriage marks

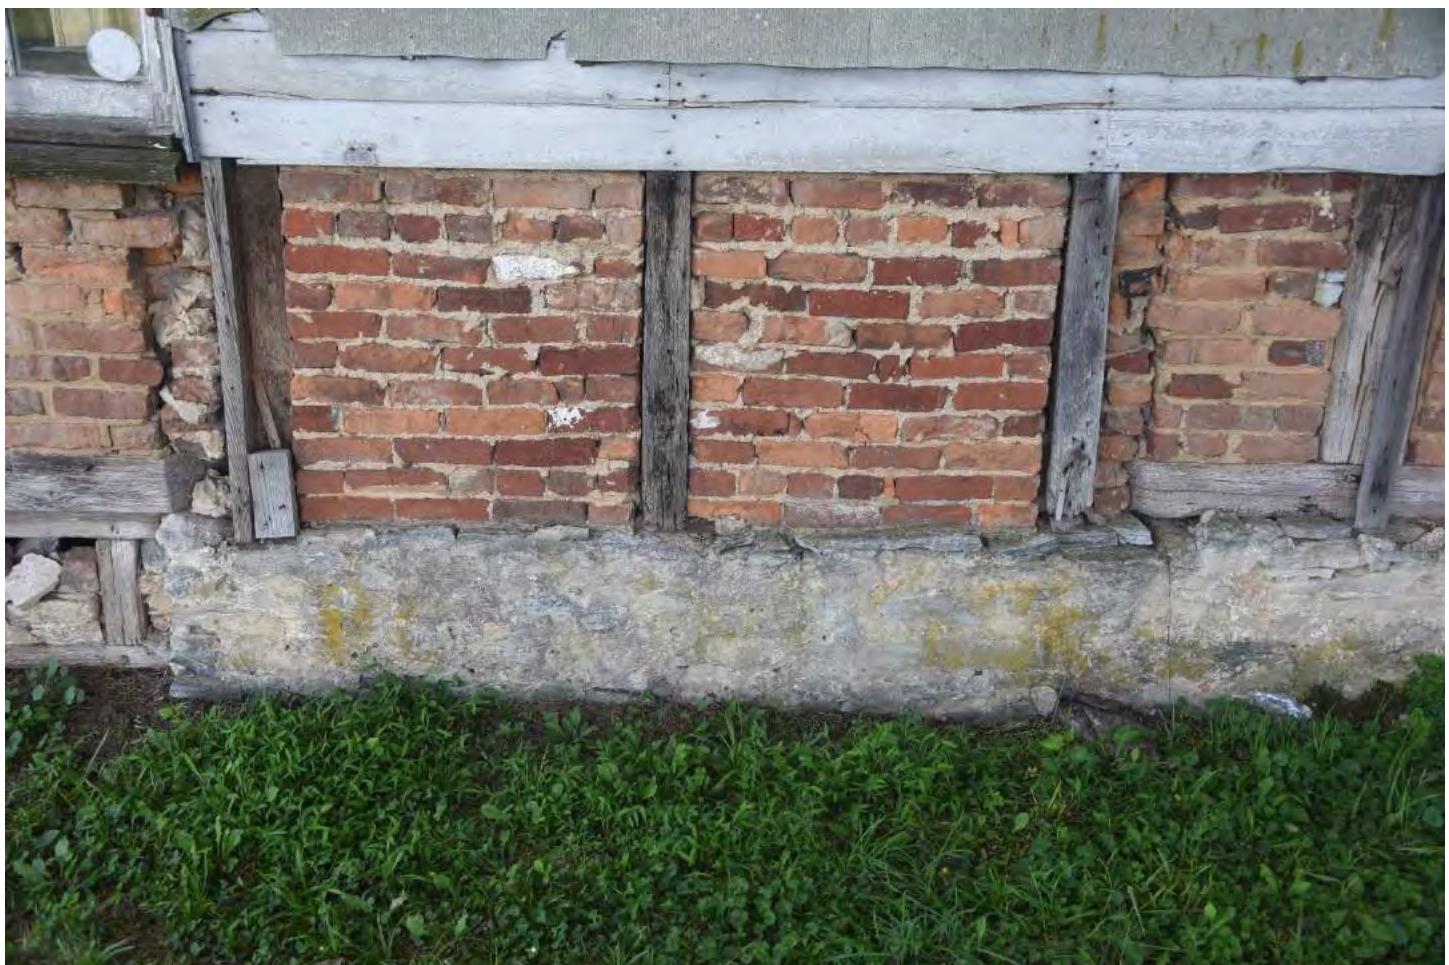
MD_FrederickCounty_Beatty-Cramer_0007.tif
East elevation, detail of foundation showing evidence of earlier fireplace.

Stone is corbelled on the interior of the east foundation wall to support a hearth and a nineteenth-century chimney above. A stone projects from the exterior side of the east foundation wall in the

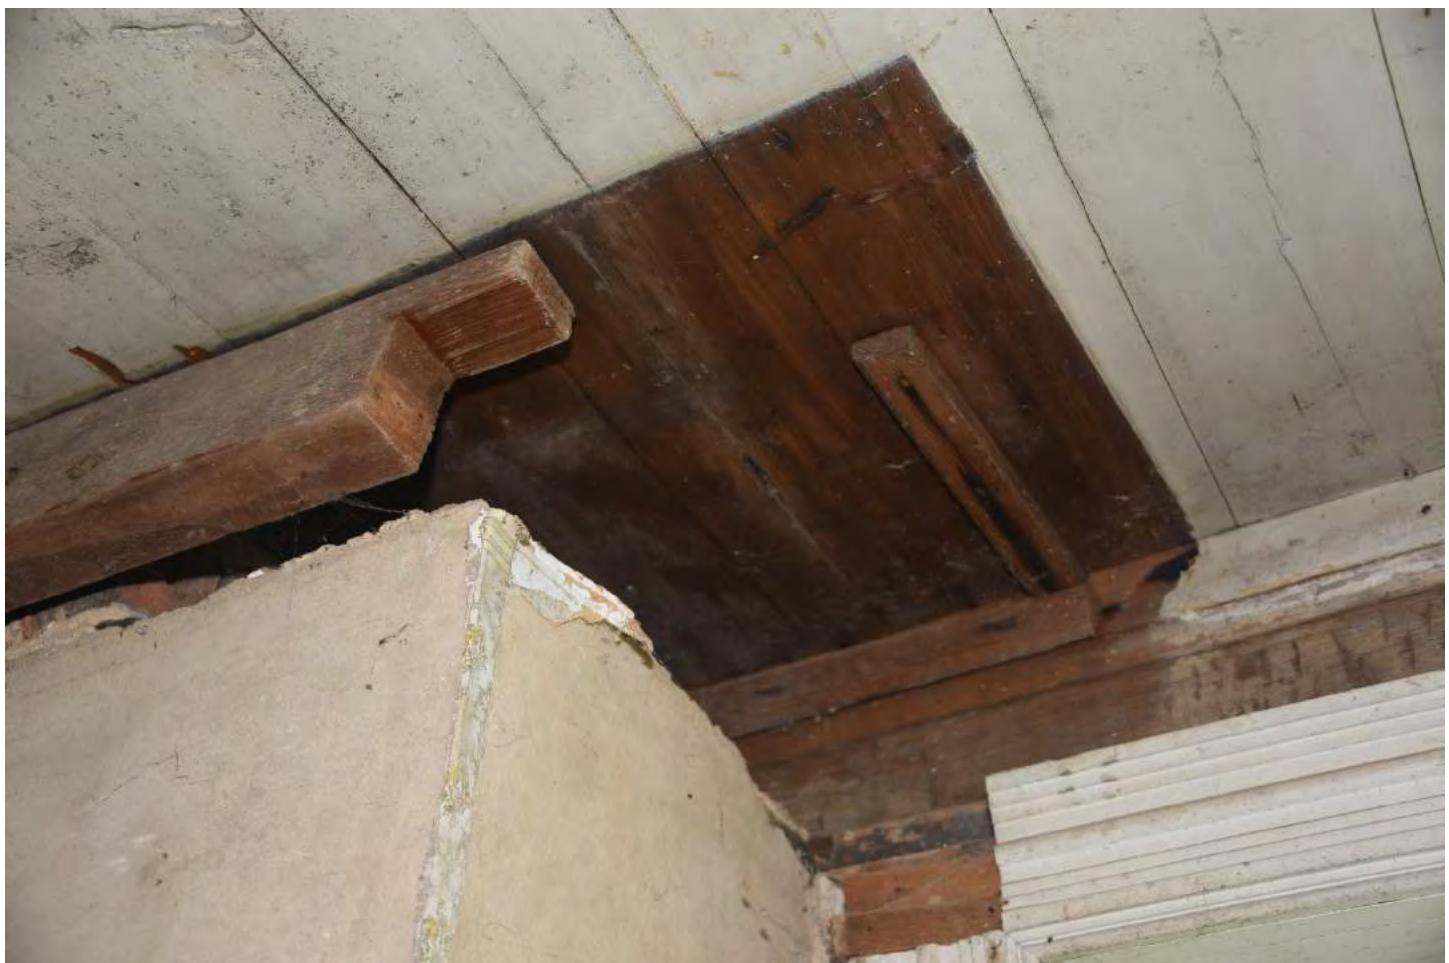
MD_FrederickCounty_Beatty-Cramer_0011.tif
East room, ghost of original cabinetry at chimney.

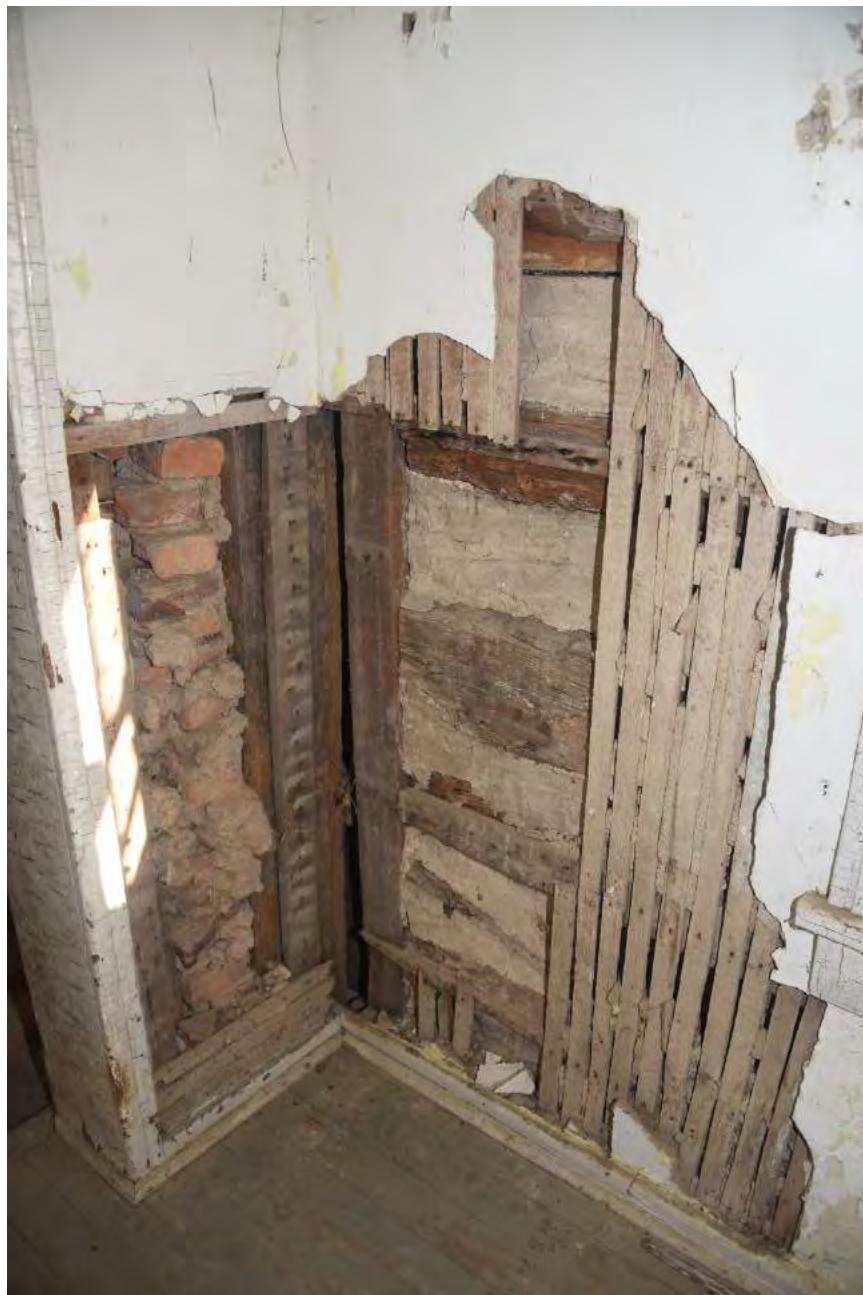
MD_FrederickCounty_Beatty-Cramer_0021.tif
West room, southeast corner showing log wall with corner post.

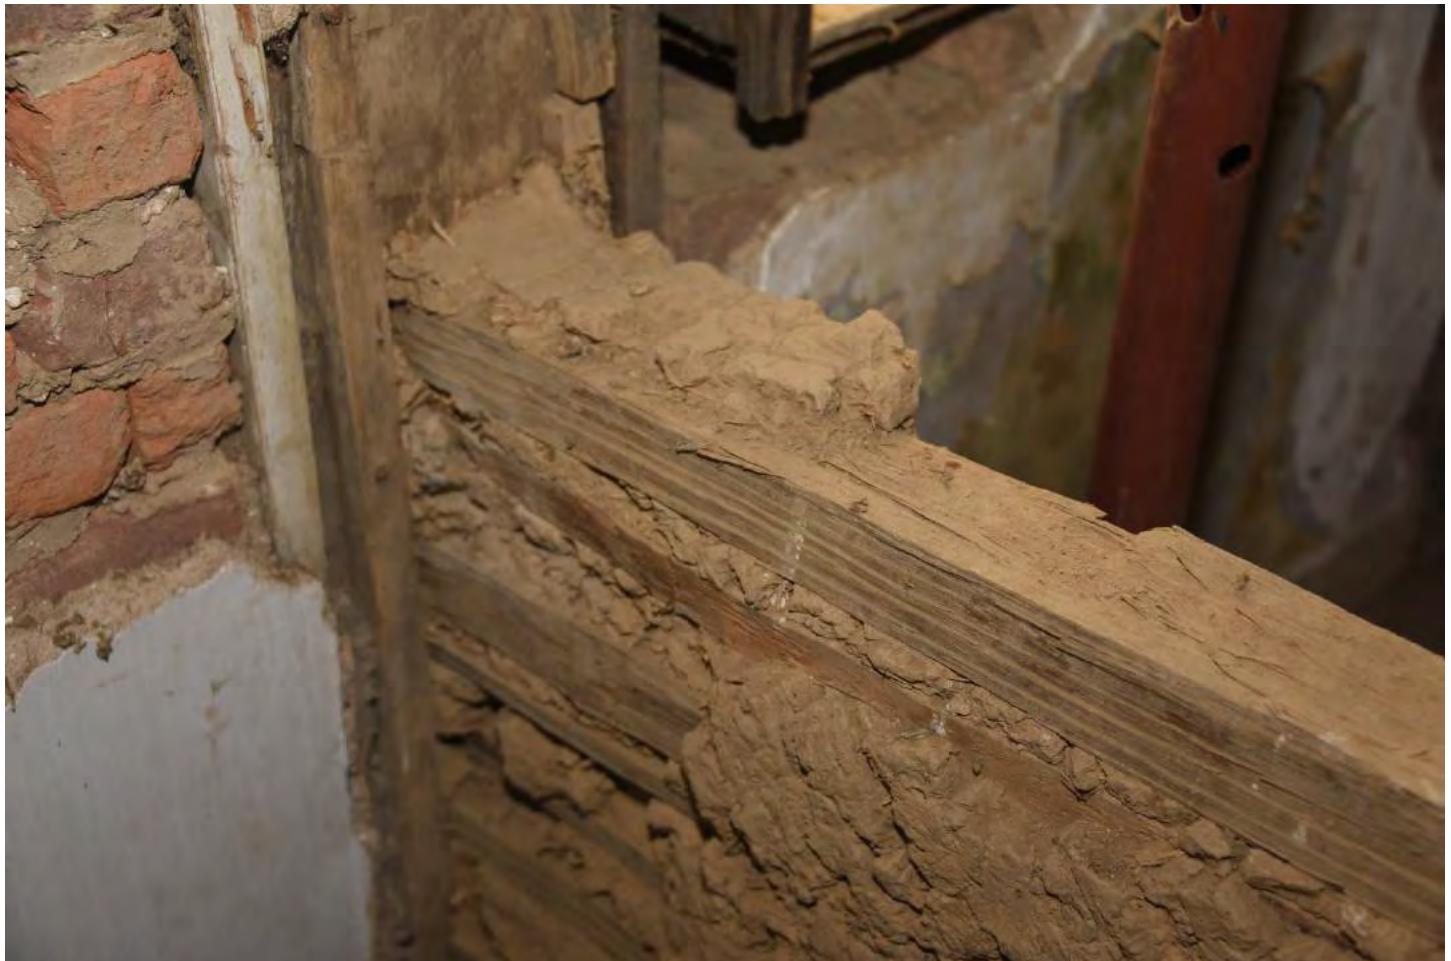
MD_FrederickCounty_Beatty-Cramer_0025.tif
East chamber, southwest corner Dutch biscuit detail.

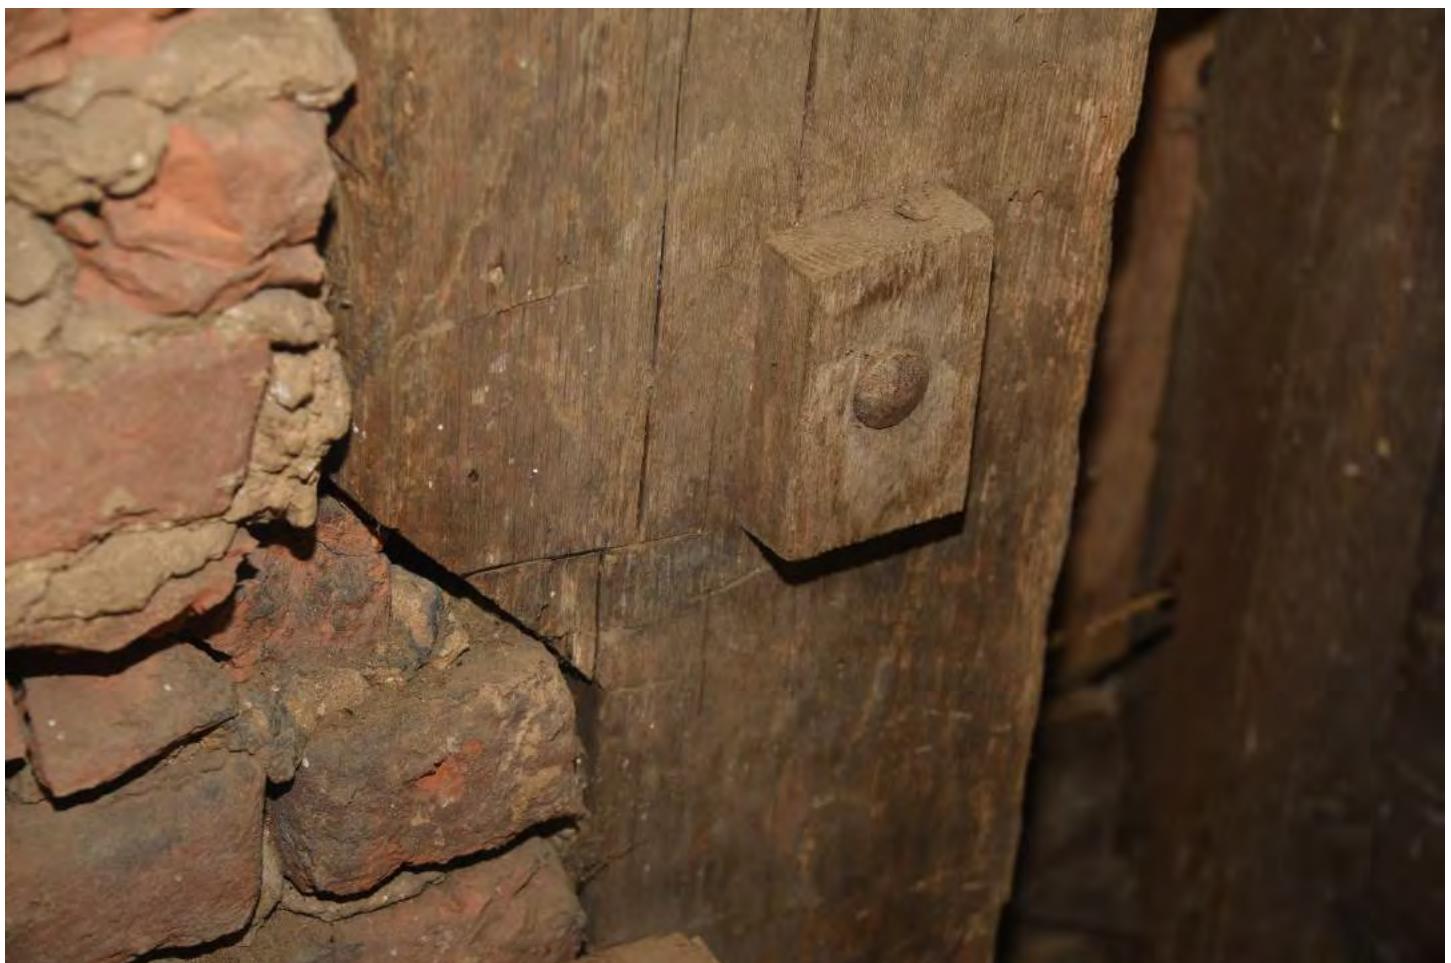
MD_FrederickCounty_Beatty-Cramer_0027.tif
Center chamber, northwest corner post with jowl

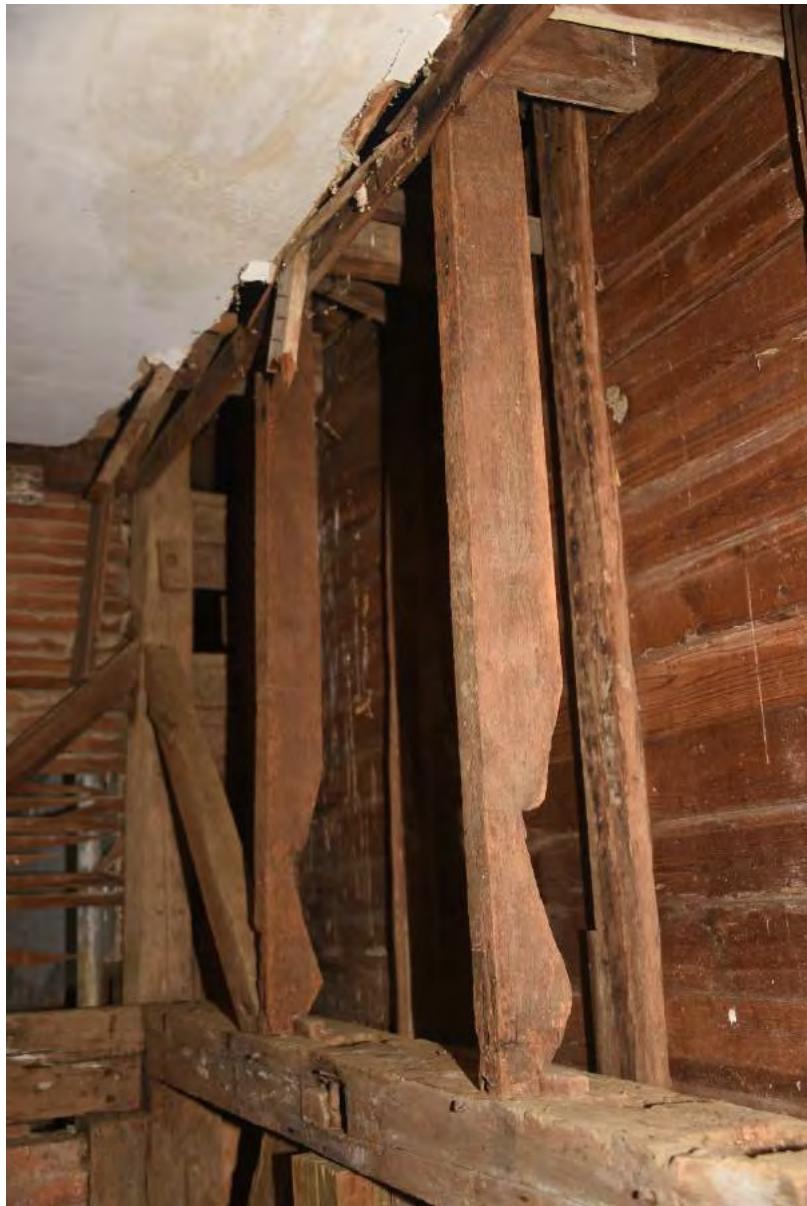
MD_FrederickCounty_Beatty-Cramer_0028.tif
Center chamber, north wall with rafters reused as studs.

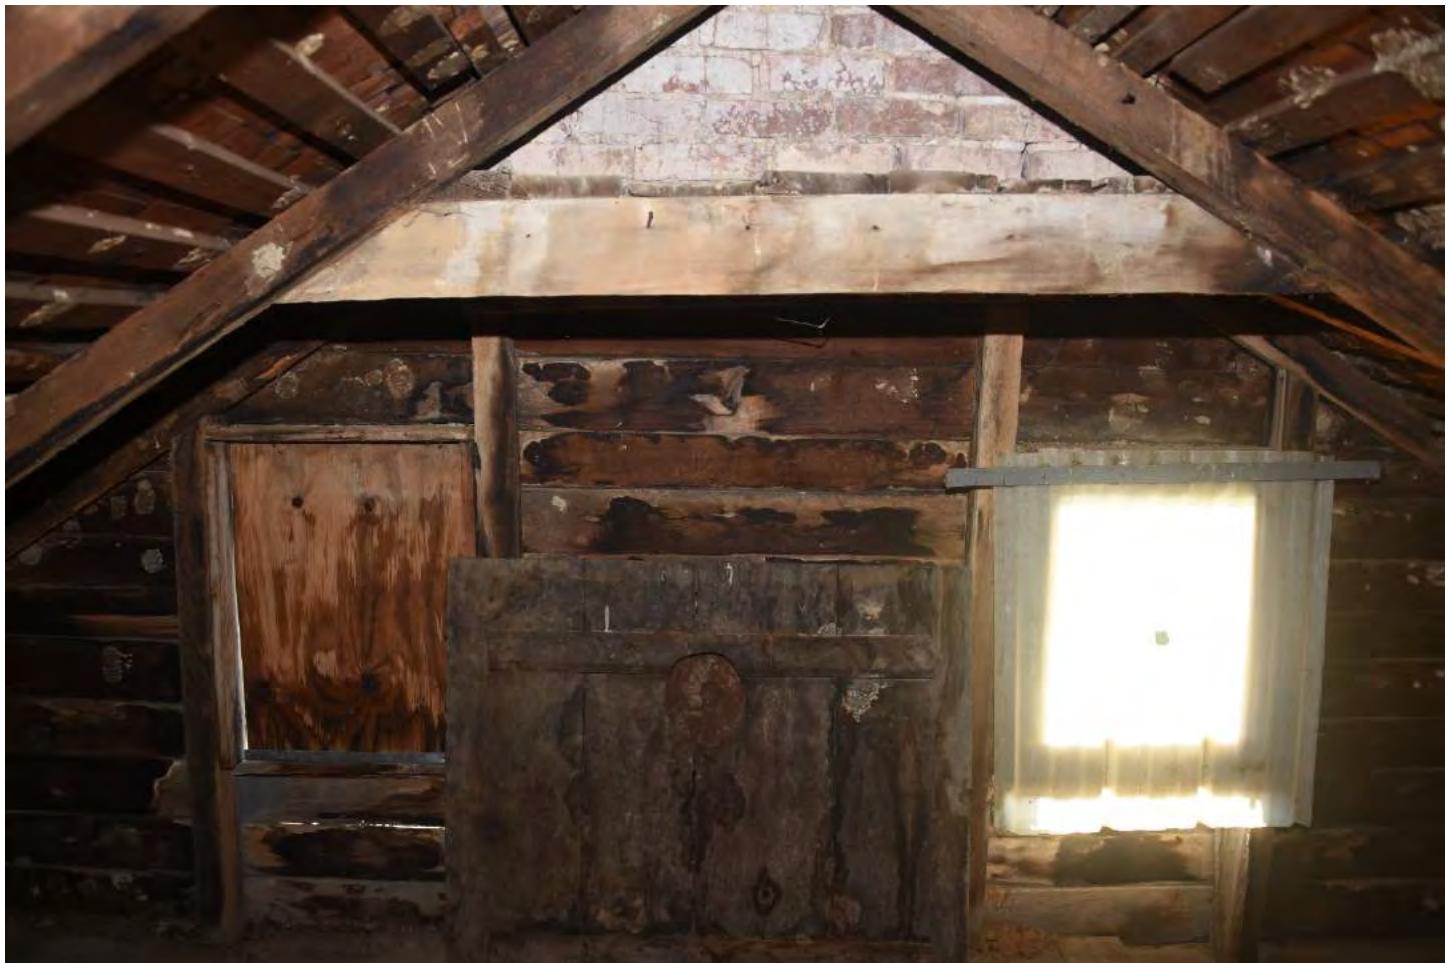
MD_FrederickCounty_Beatty-Cramer_0032.tif
Attic, west elevation showing false chimney.

There are three chimneys in the attic. The one inside the west wall is a false chimney built on a shelf nailed to the rafters. The middle chimney, about 5'-7" wide rises straight from the attic floor to the roofline. Due to its condition in 1996 it was removed down to the roof line. Inside the east wall the chimney widens from 2'-9" in width at the floor line to 3'-11" at the roof line. Other salvaged material is present in the attic. In the mid-part of the attic there are floorboards with pit saw marks and, at the east end, the bottom of the floorboards display red paint and either black paint or smoke stain. A corner post in the walls at the winder stair is beaded and covered

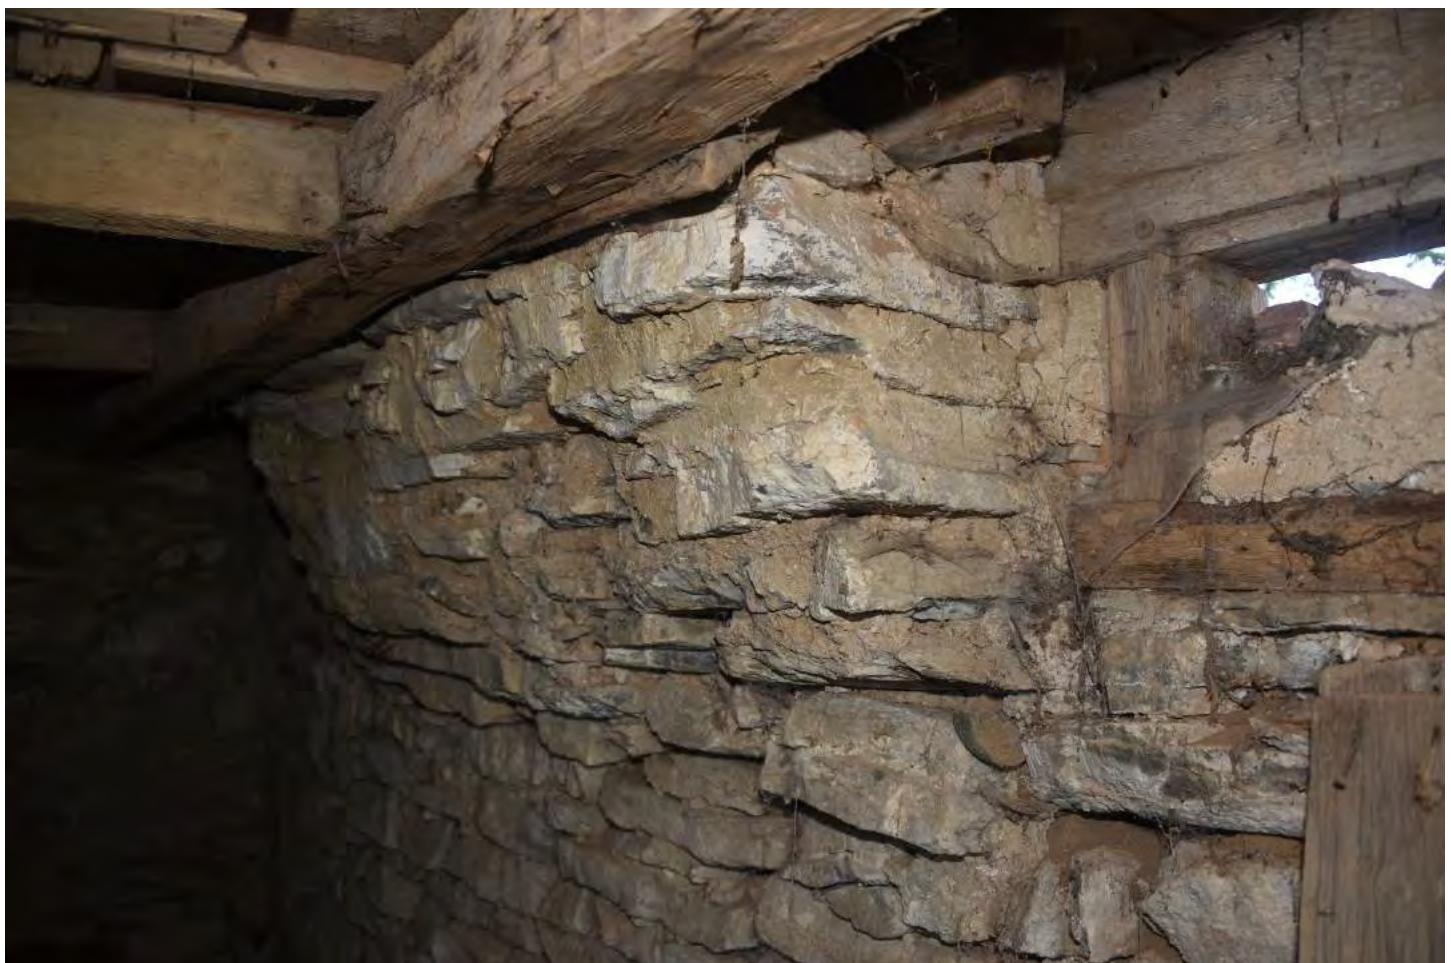
MD_FrederickCounty_Beatty-Cramer_0034.tif
East basement, east wall corbel for fireplace.

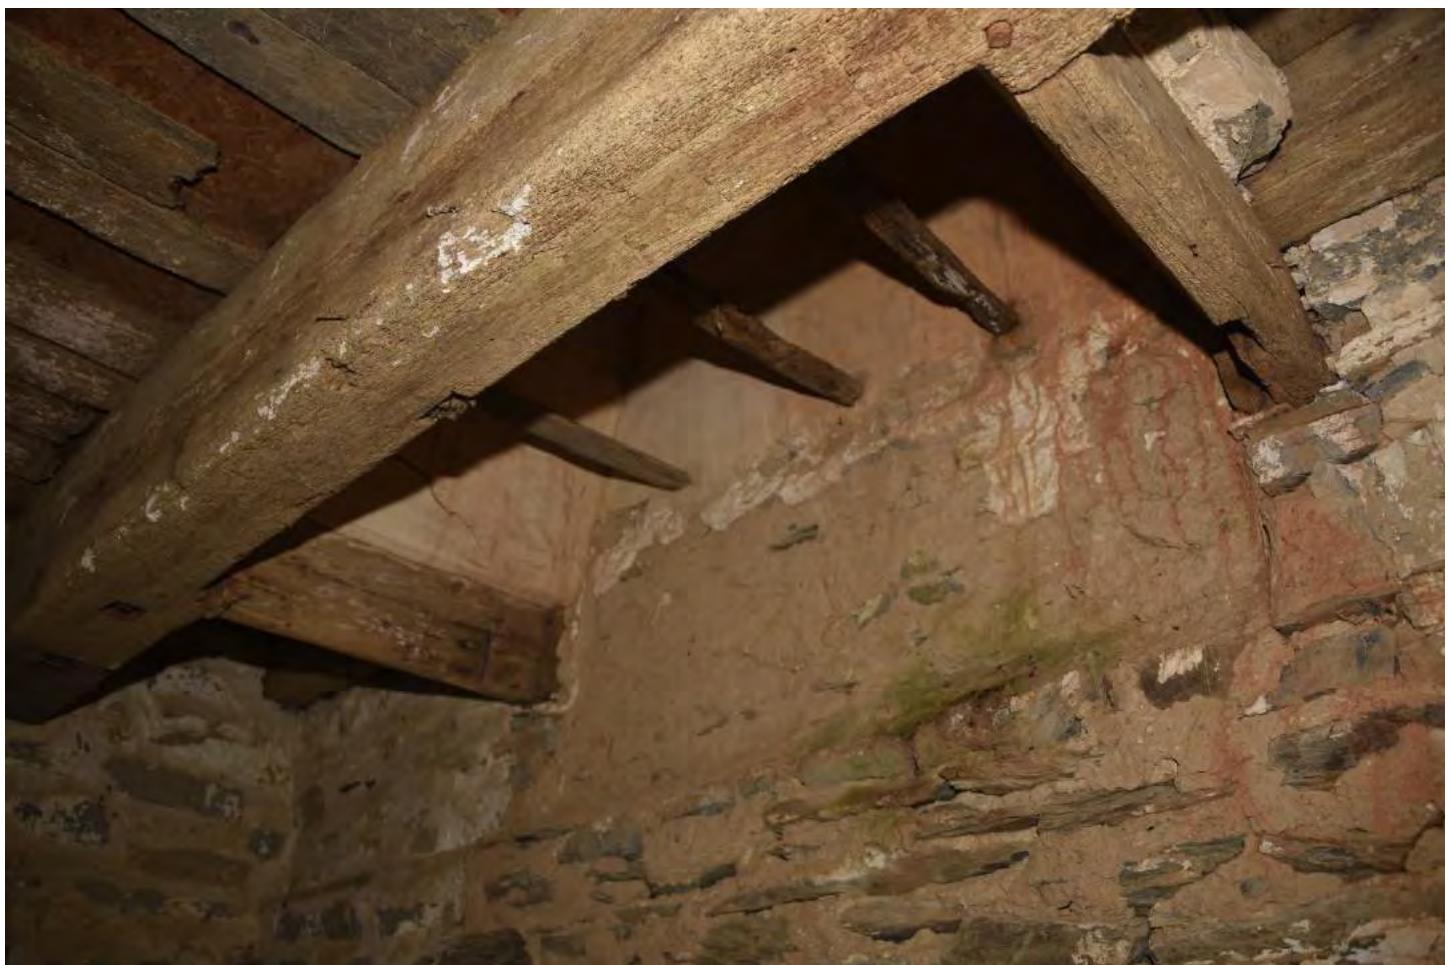
MD_FrederickCounty_Beatty-Cramer_0039.tif
Springhouse, lower story, fireplace hood on east.

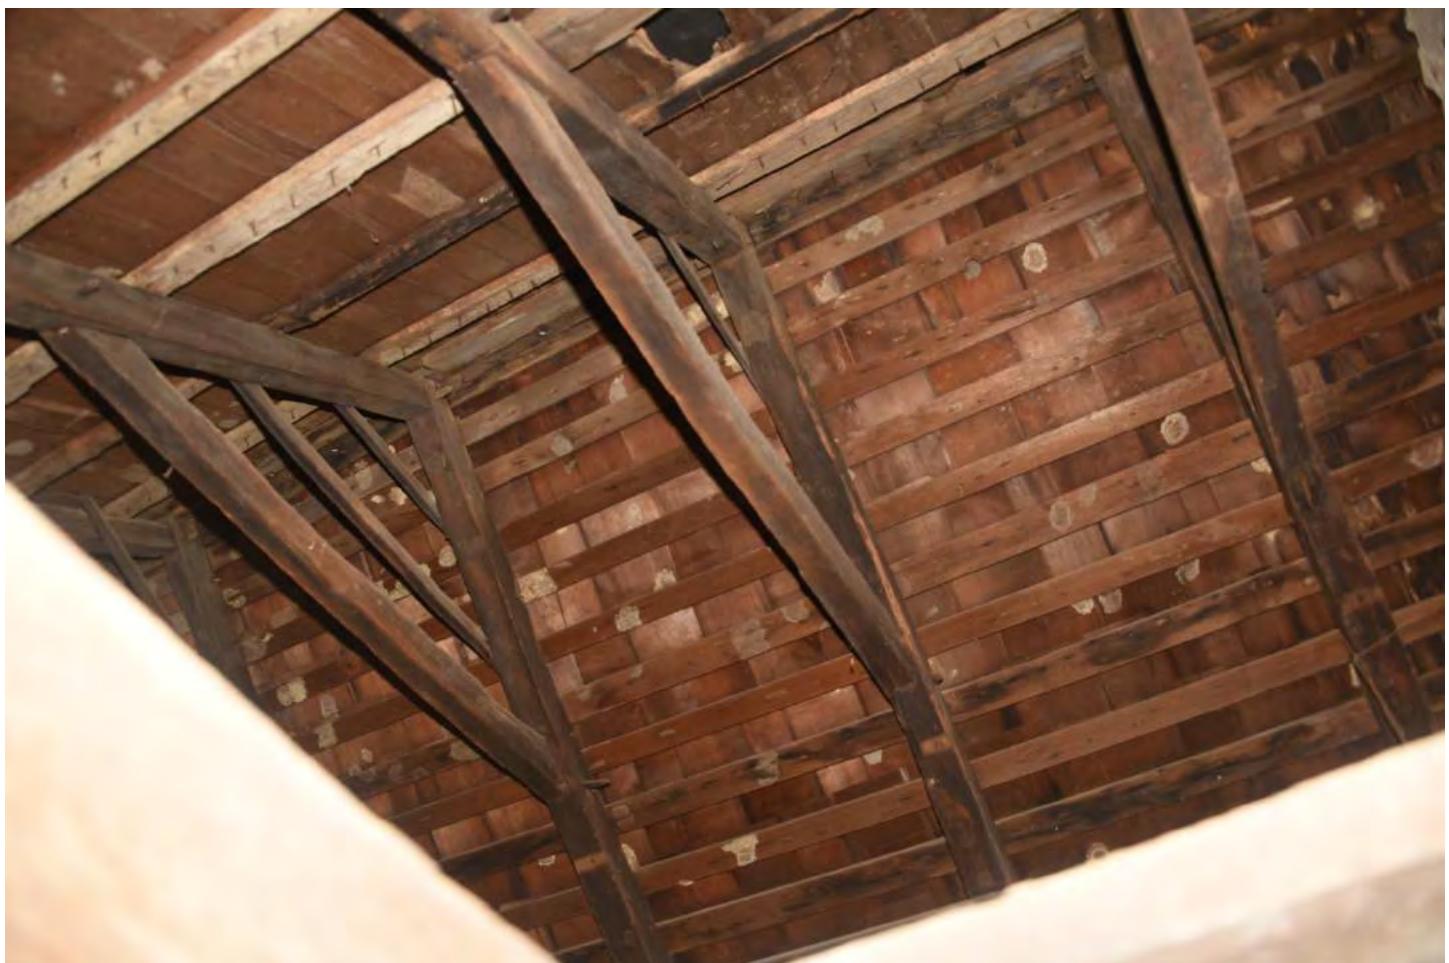
MD_FrederickCounty_Beatty-Cramer_0041.tif
Springhouse, roof frame.

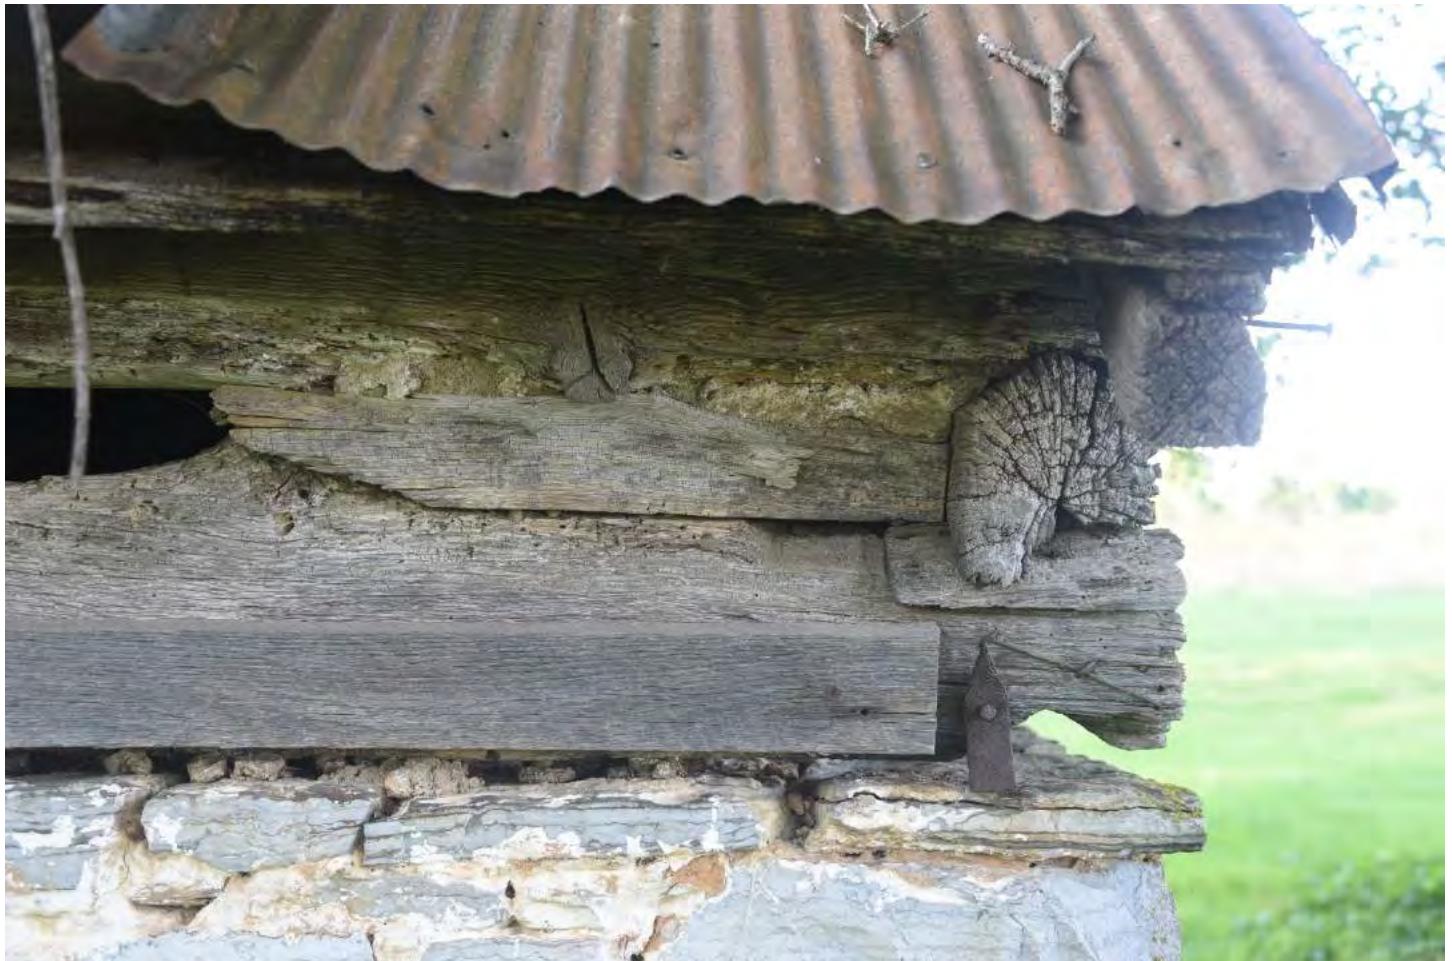
MD_FrederickCounty_Beatty-Cramer_0043.tif
Smokehouse, south elevation, east corner of original log structure.
