AN ASSESSMENT OF STORMWATER MANAGEMENT RETROFIT AND STREAM RESTORATION OPPORTUNITIES IN BENNETT CREEK WATERSHED, FREDERICK COUNTY, MARYLAND

Prepared for:
Frederick County
Division of Public Works
Frederick, Maryland

Prepared by:
Tetra Tech, Inc.

April 2009

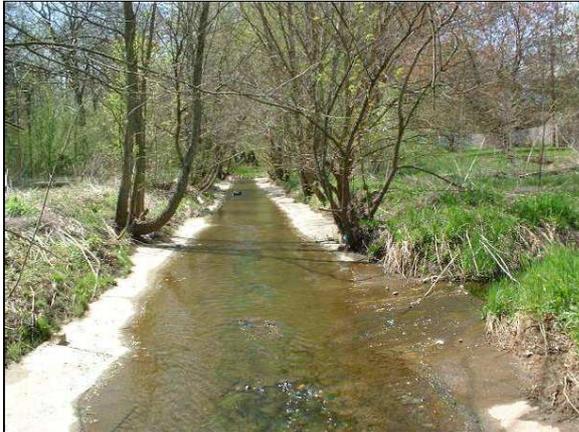
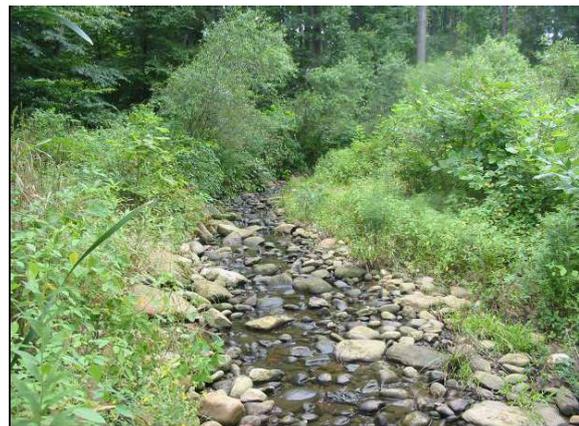
Figure 3.9. Stream Restoration (upper left: concrete lined urban channel; lower right: restored stream) (Sources: M. Perot, Versar; unknown)

Maintenance: Maintenance of natural stream channel design projects includes periodic inspection and monitoring to ensure that conditions remain within the expected range of variability. Post-construction plantings need to be monitored to ensure that they become well-established. In addition, periodic channel adjustments may be necessary after large flow events, especially while post-construction plantings become established (Perot et al. 2006).

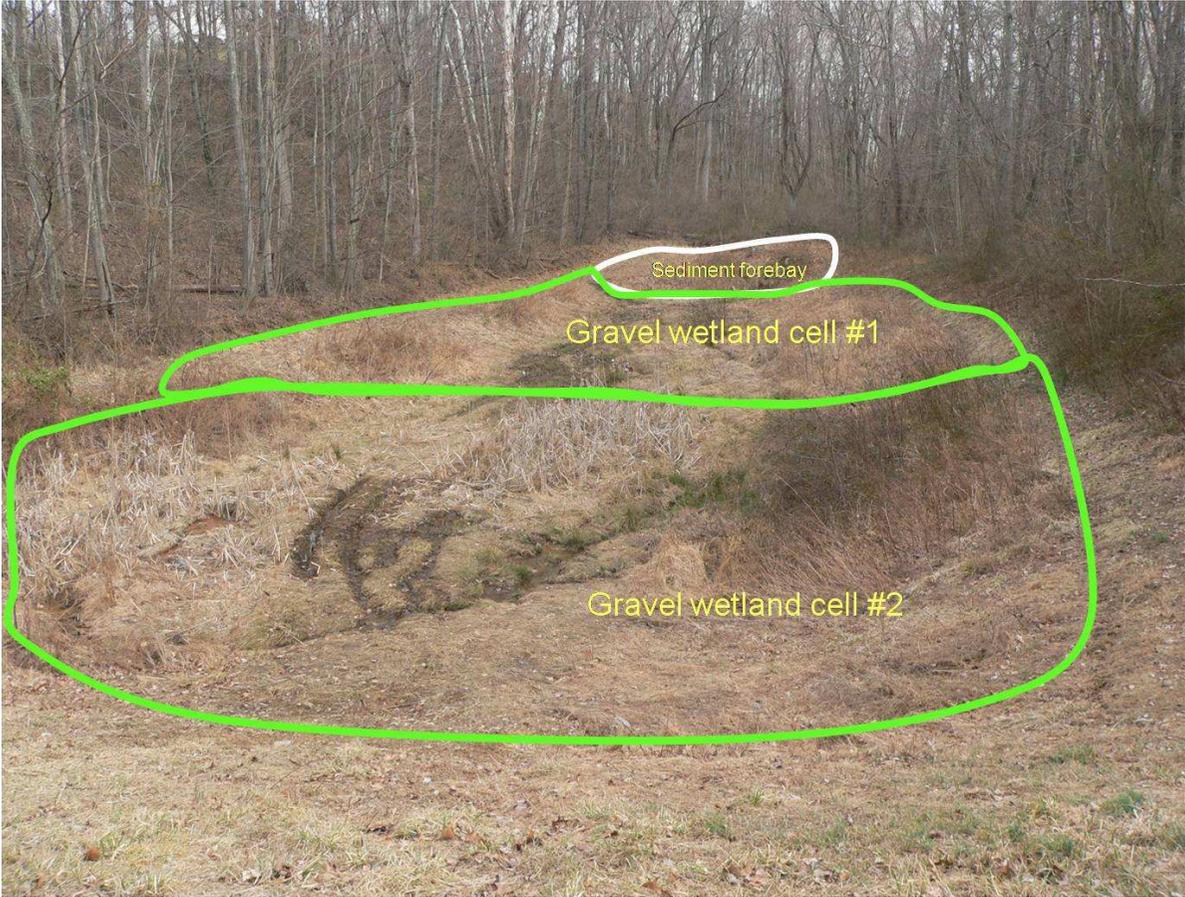
Option 2: The dimensions of the proposed restoration approaches in these diagrams are approximate.

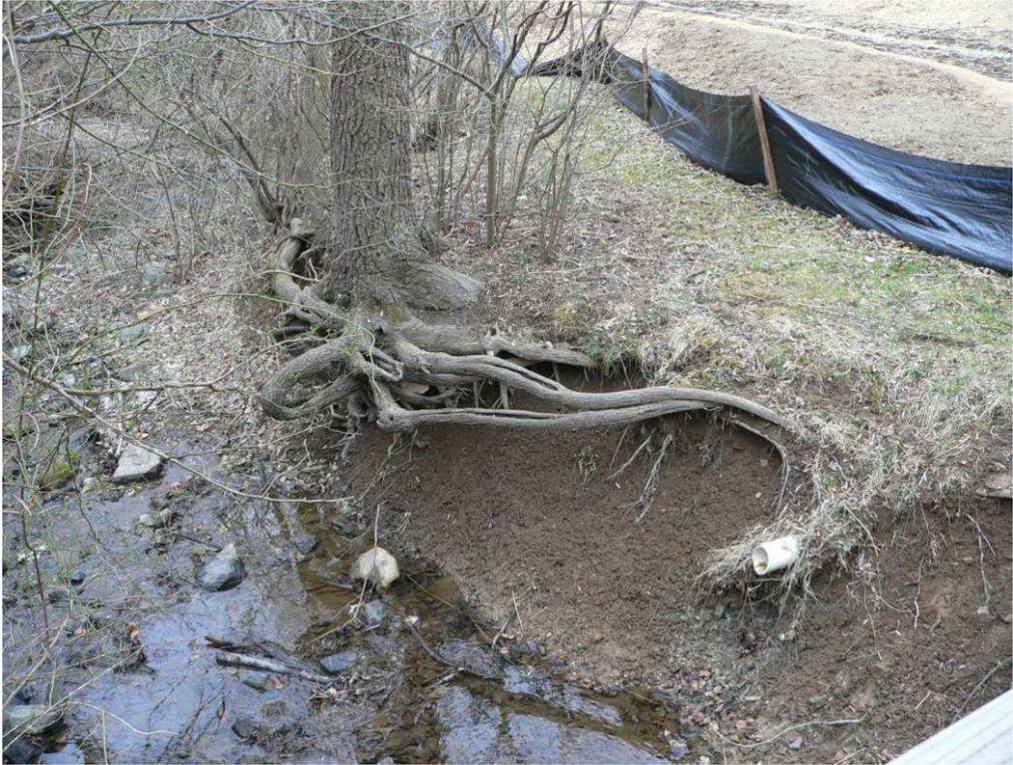
Photos of the existing stormwater structure:

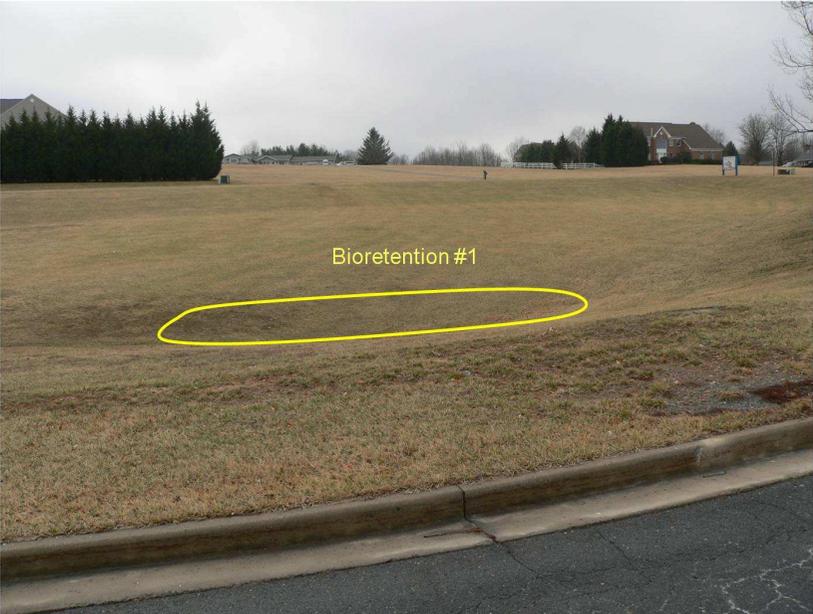
Locations of some of the proposed restoration approaches (dimensions are approximate):

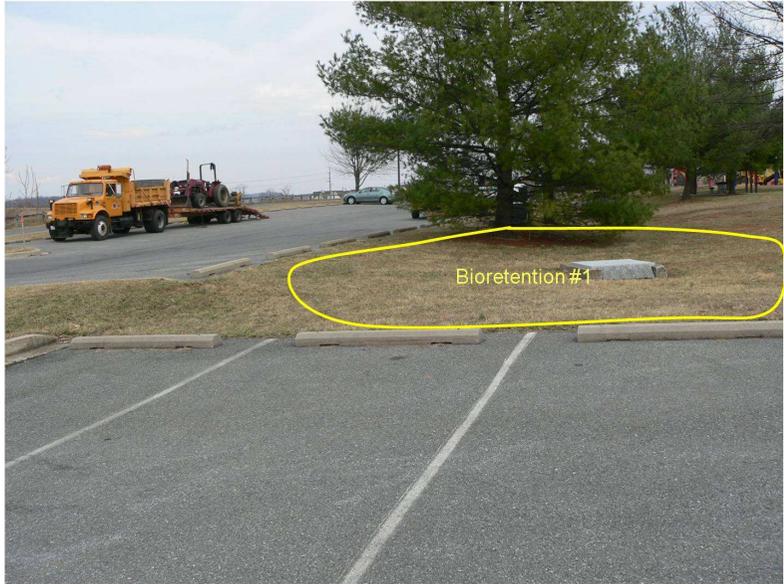
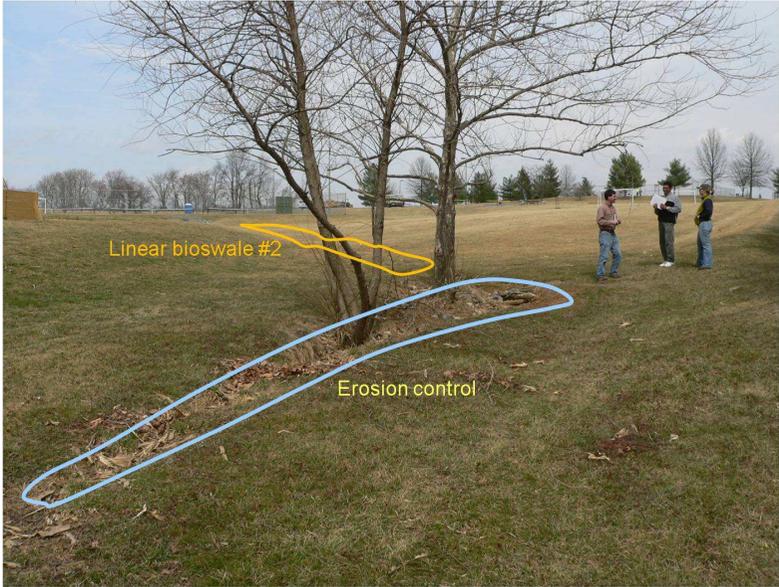
Locations of some of the proposed restoration approaches (dimensions are approximate):

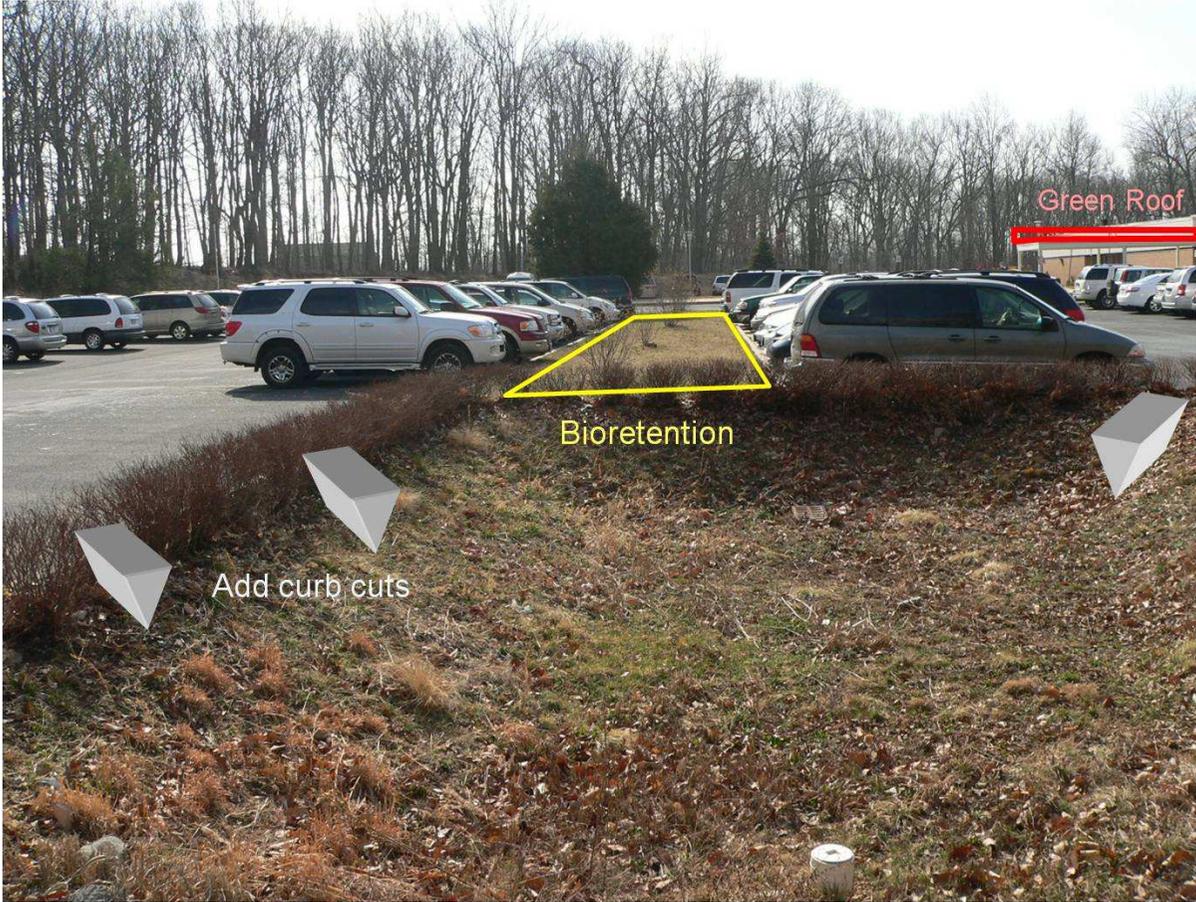
Locations of some of the proposed restoration approaches (dimensions are approximate):

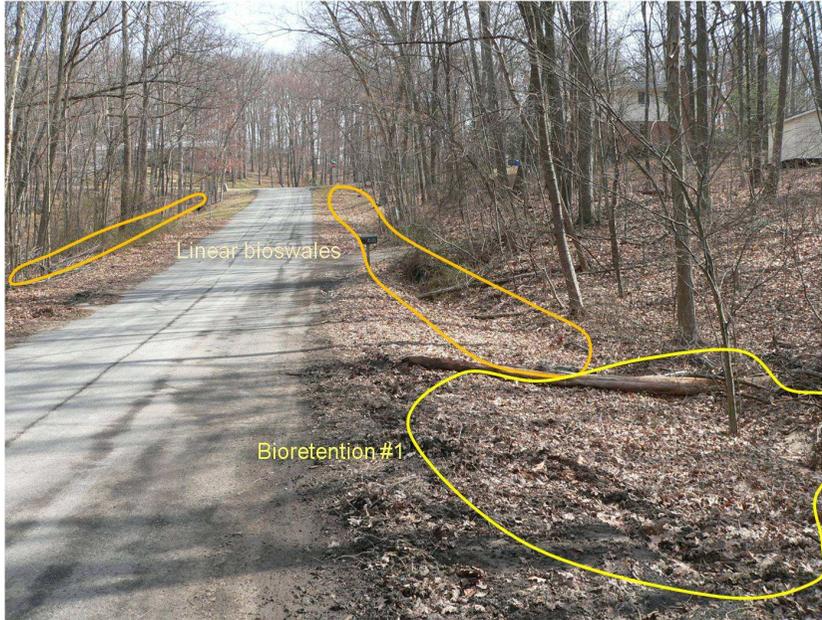
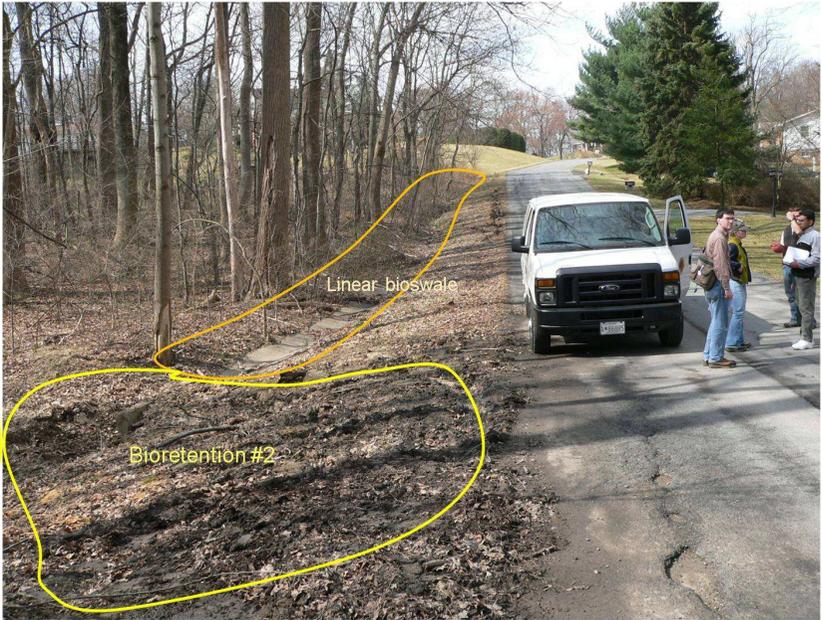
Locations of some of the proposed restoration approaches (dimensions are approximate):

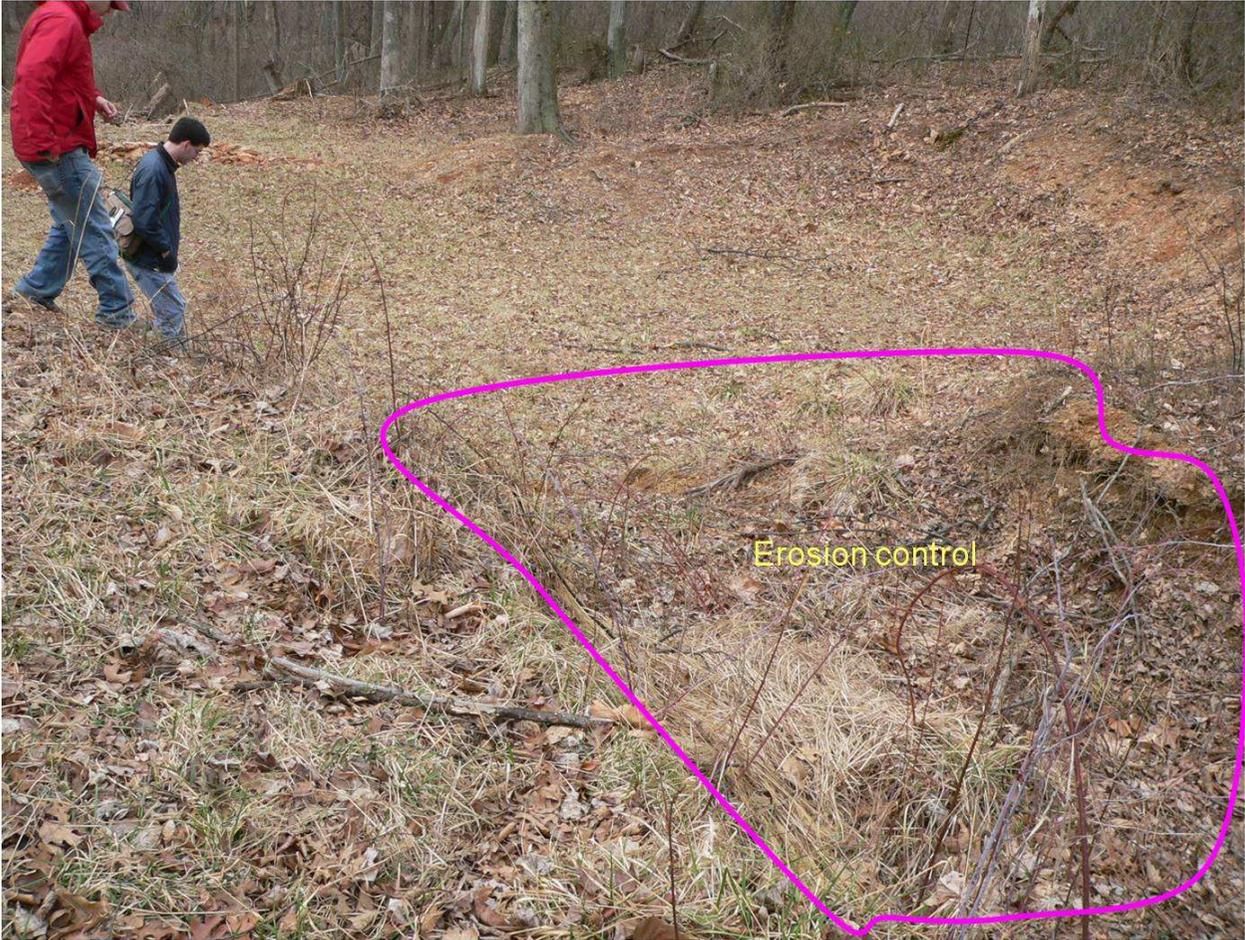
Locations of some of the proposed restoration approaches (dimensions are approximate):
