**AN ASSESSMENT OF  
STREAM RESTORATION AND  
STORMWATER MANAGEMENT  
RETROFIT OPPORTUNITIES IN  
LOWER BUSH CREEK WATERSHED,  
FREDERICK COUNTY,  
MARYLAND**

**Frederick County  
Division of Public Works  
118 North Market Street  
Frederick, Maryland 21701-5422**

**Versar, Inc.  
9200 Rumsey Road  
Columbia, Maryland 21045**

**August 2003**

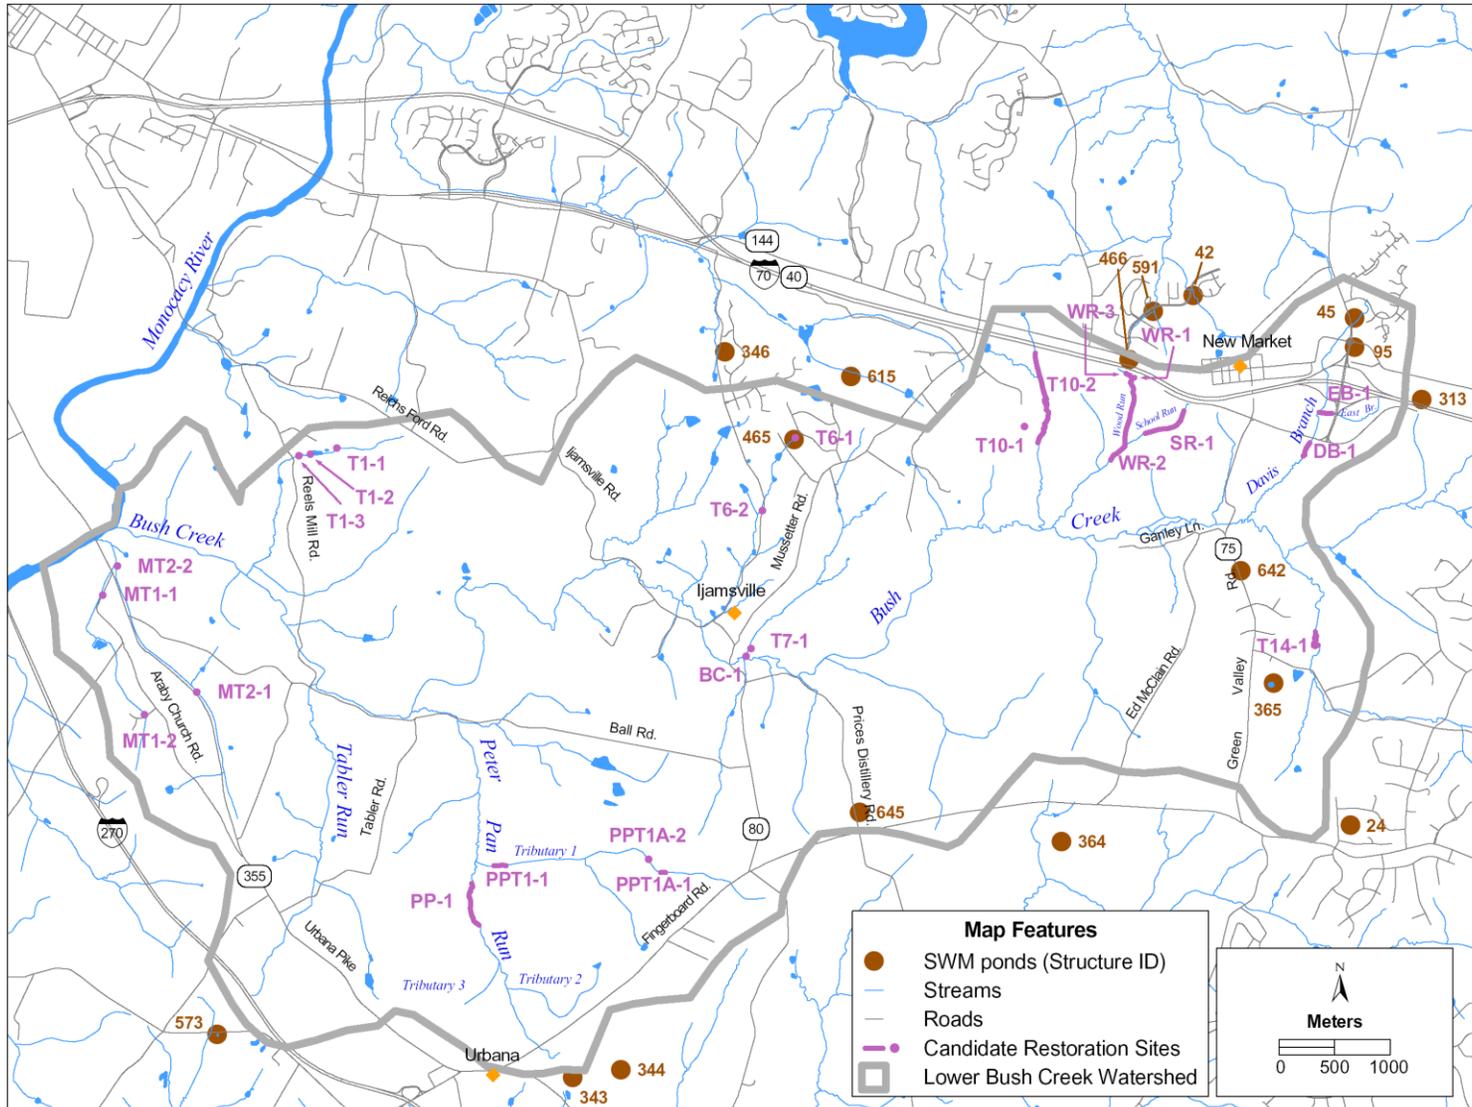
Figure 4-1. Candidate stream restoration and SWM retrofit sites identified during reconnaissance surveys in Lower Bush Creek Watershed, Frederick County, MD. Existing SWM facilities are also shown.

Twenty-four candidate restoration sites were identified in the field surveys. A map of all site locations, including those identified as localized point problems or longer problem reaches, was constructed using field GPS coordinates (Figure 4-1). Based upon the analysis described above, numerical ratings were used to rank each site according to its opportunity to improve watershed conditions (Table 4-1). As shown in Table 4-1, six sites presented opportunities for both stream restoration and SWM controls; 17 sites were candidates for stream restoration; and one site presented an opportunity for SWM maintenance. Although these rankings are based on a number of important factors, we anticipate that the County will ultimately choose a suite of final sites based on integrating these results with other information, including data not currently available. In addition, some of these projects may be implemented by other organizations.
