Safe Streets for All

Frederick County, MD

Rural Roads – High Injury Network Evaluation

February 14, 2025

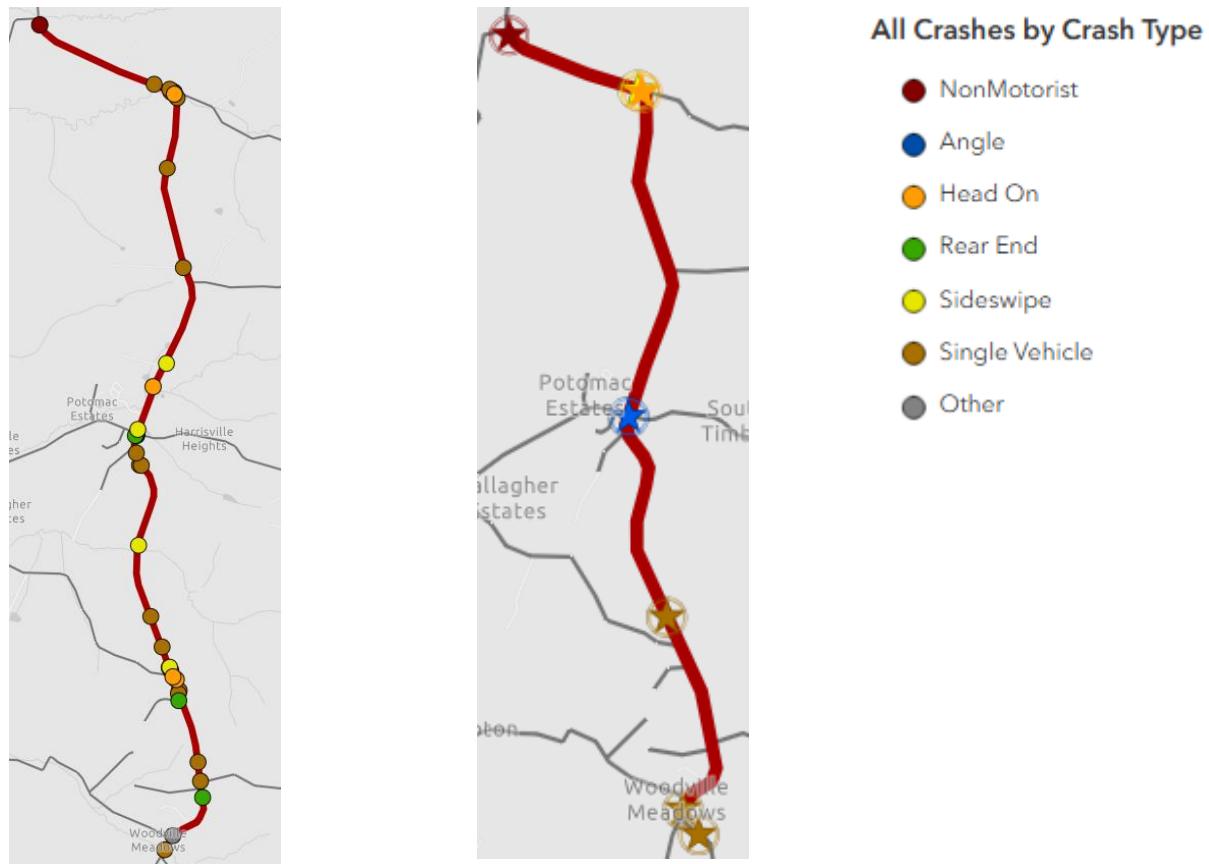
Figure 1: Woodville Road – All Crashes (left) and KSI only (right)

Single Vehicle Crash Trend: There were 19 (51%) single vehicle crashes reported with 11 of the single vehicle crashes reported under dark or low light conditions.

- Talbot Run Road vicinity – 6 crashes, all resulted in hitting stationary objects and 3 occurred on wet/icy roadway conditions.
- Glissans Mill Road – 4 crashes, two resulted in hitting fixed objects and two vehicles traveled off the road

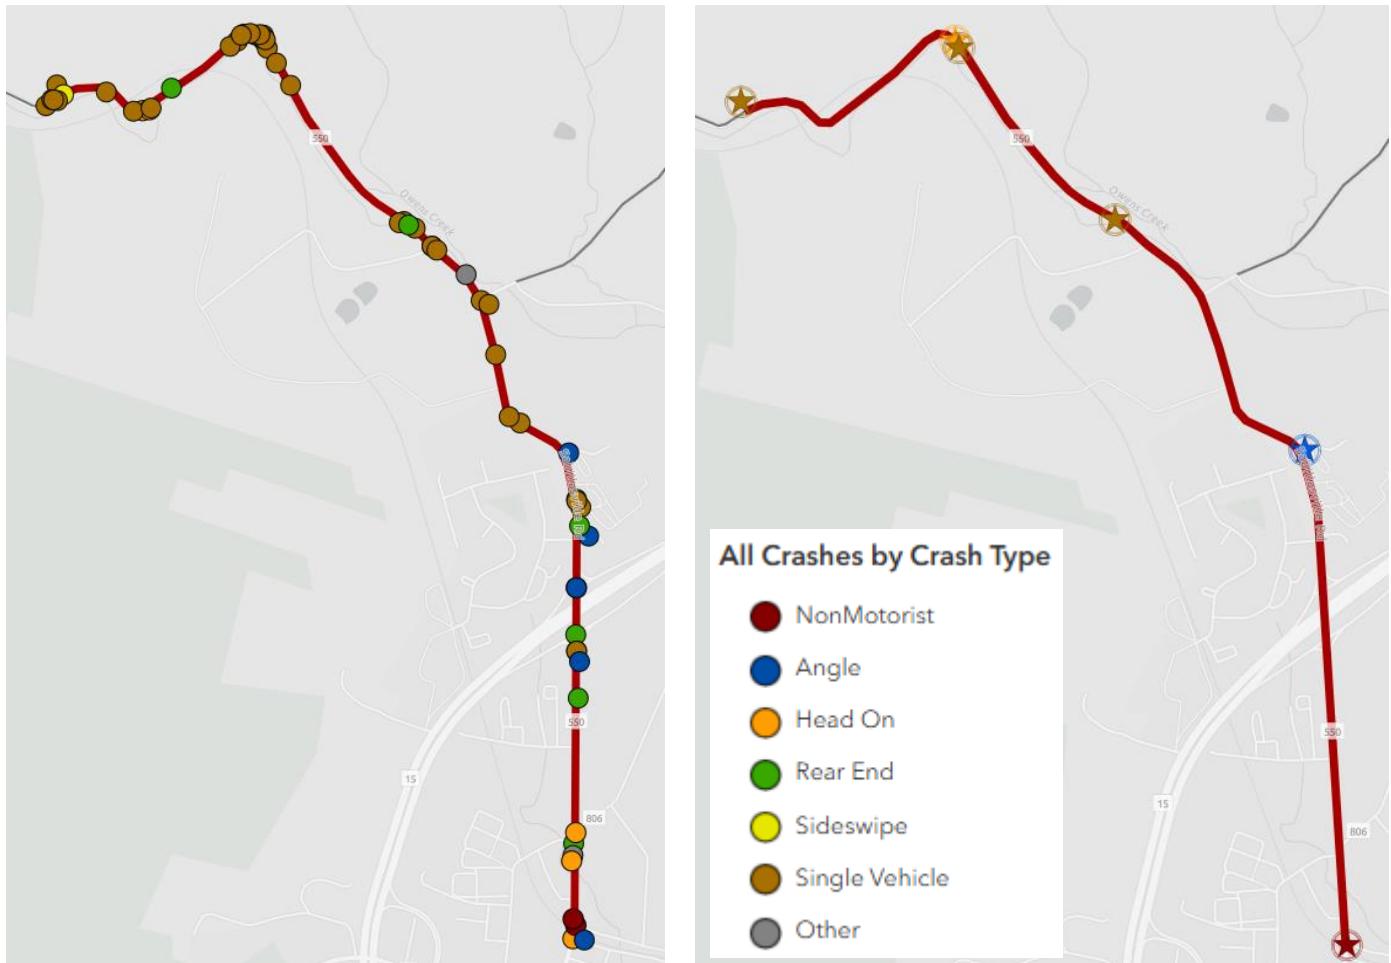
Figure 2: MD 550 / Church Street – All Crashes (left) and KSI Only (right)

- Missing curve warning signage (W1-2) at the horizontal curves near Old Camp Airy Road and the near the geographical coordinates, 39.65077728629942, -77.4218309917171.
- Faded hatching yellow pavement marking lines near the intersections of MD 550 (N Church St) and the US 15 on/off ramps.
- There is an existing driver speed feedback sign (25 MPH) located near the intersection of MD 550 (N Church St) and the US 15 eastbound off ramp.

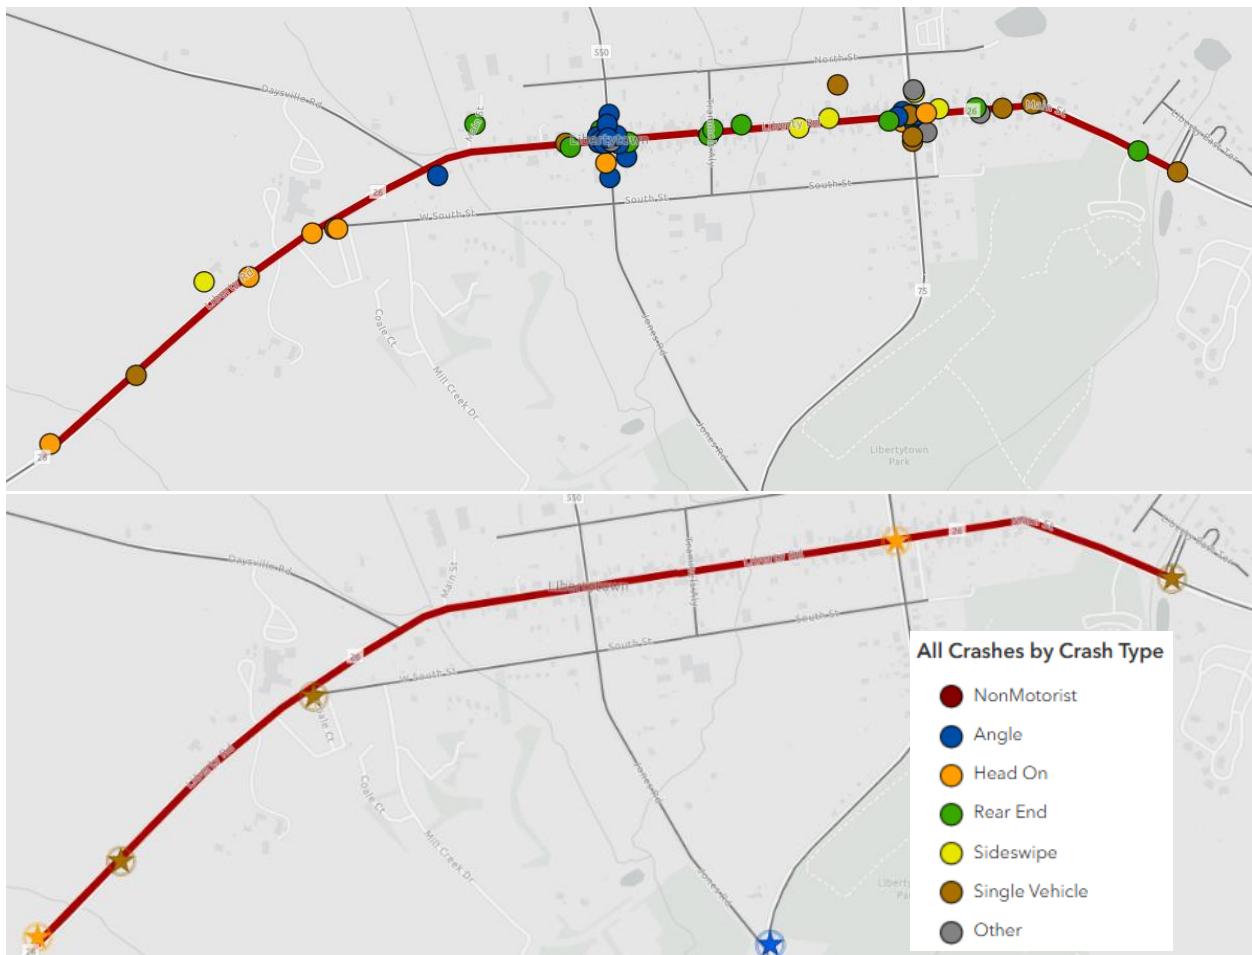
Figure 4: MD 26/Liberty Road – All crashes (above) and KSI only (below)

Single Vehicle Crash Trend: There were 11 (17%) single vehicle crashes reported with 6 of the single vehicle crashes reported under dark or low light conditions.

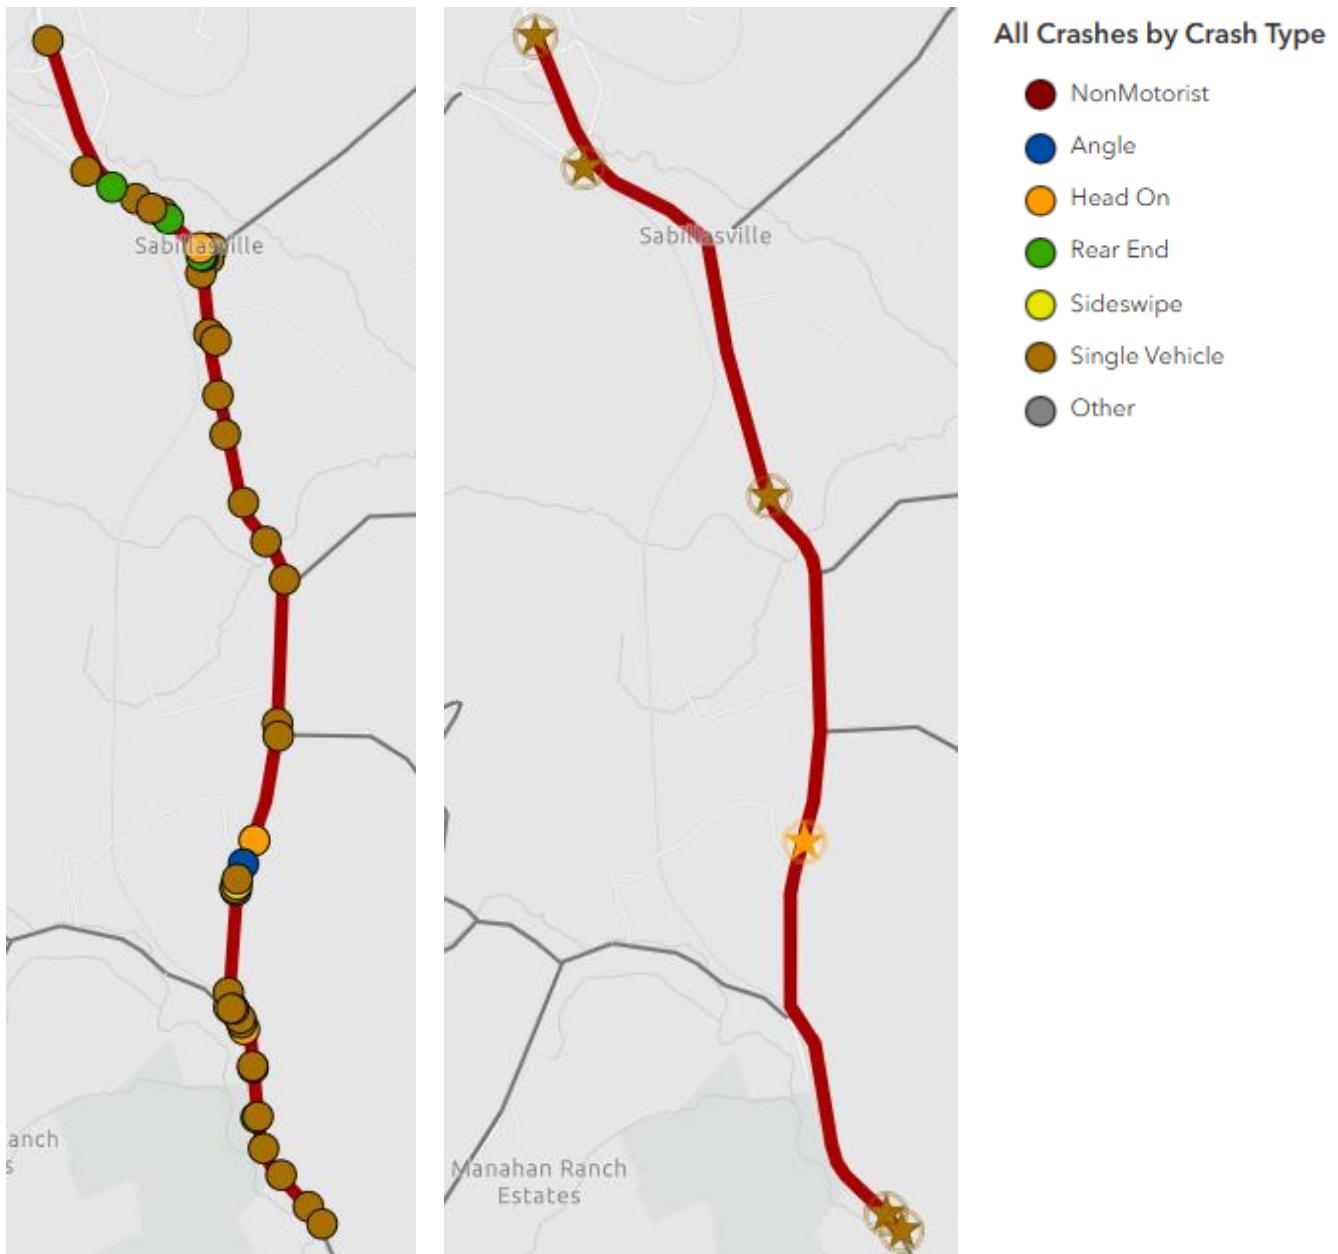
Figure 8: MD 550 / Sabillasville Road – all crashes (left) and KSI only (right)

Single Vehicle Crash Trend: There were 34 (77 %) single vehicle crashes reported of which 16 (36 %) occurred under dark or low light conditions. While single vehicle crashes occurred throughout the corridor, clusters of single vehicle crashes occurred near the horizontal curve at Foxville-Deerfield Road.

- Refresh the existing stop line and edge line pavement markings at the intersection of Sabillasville Road and Foxville Deerfield Road.
- Install dotted centerline extension pavement markings at the intersection of Sabillasville Road and Foxville Deerfield Road.
- Refresh the existing stop line and edge line pavement markings at the intersections of Sabillasville Road and Harbaugh Valley Road.
- Replace the existing 30 inches by 12 inches W4-4a(1) signs (Traffic from Right/Left does not stop) at the intersection of Sabillasville Road and Foxville Deerfield Road, with larger signs (36 inches by 15 inches), to improve the visibility of the warning signs.

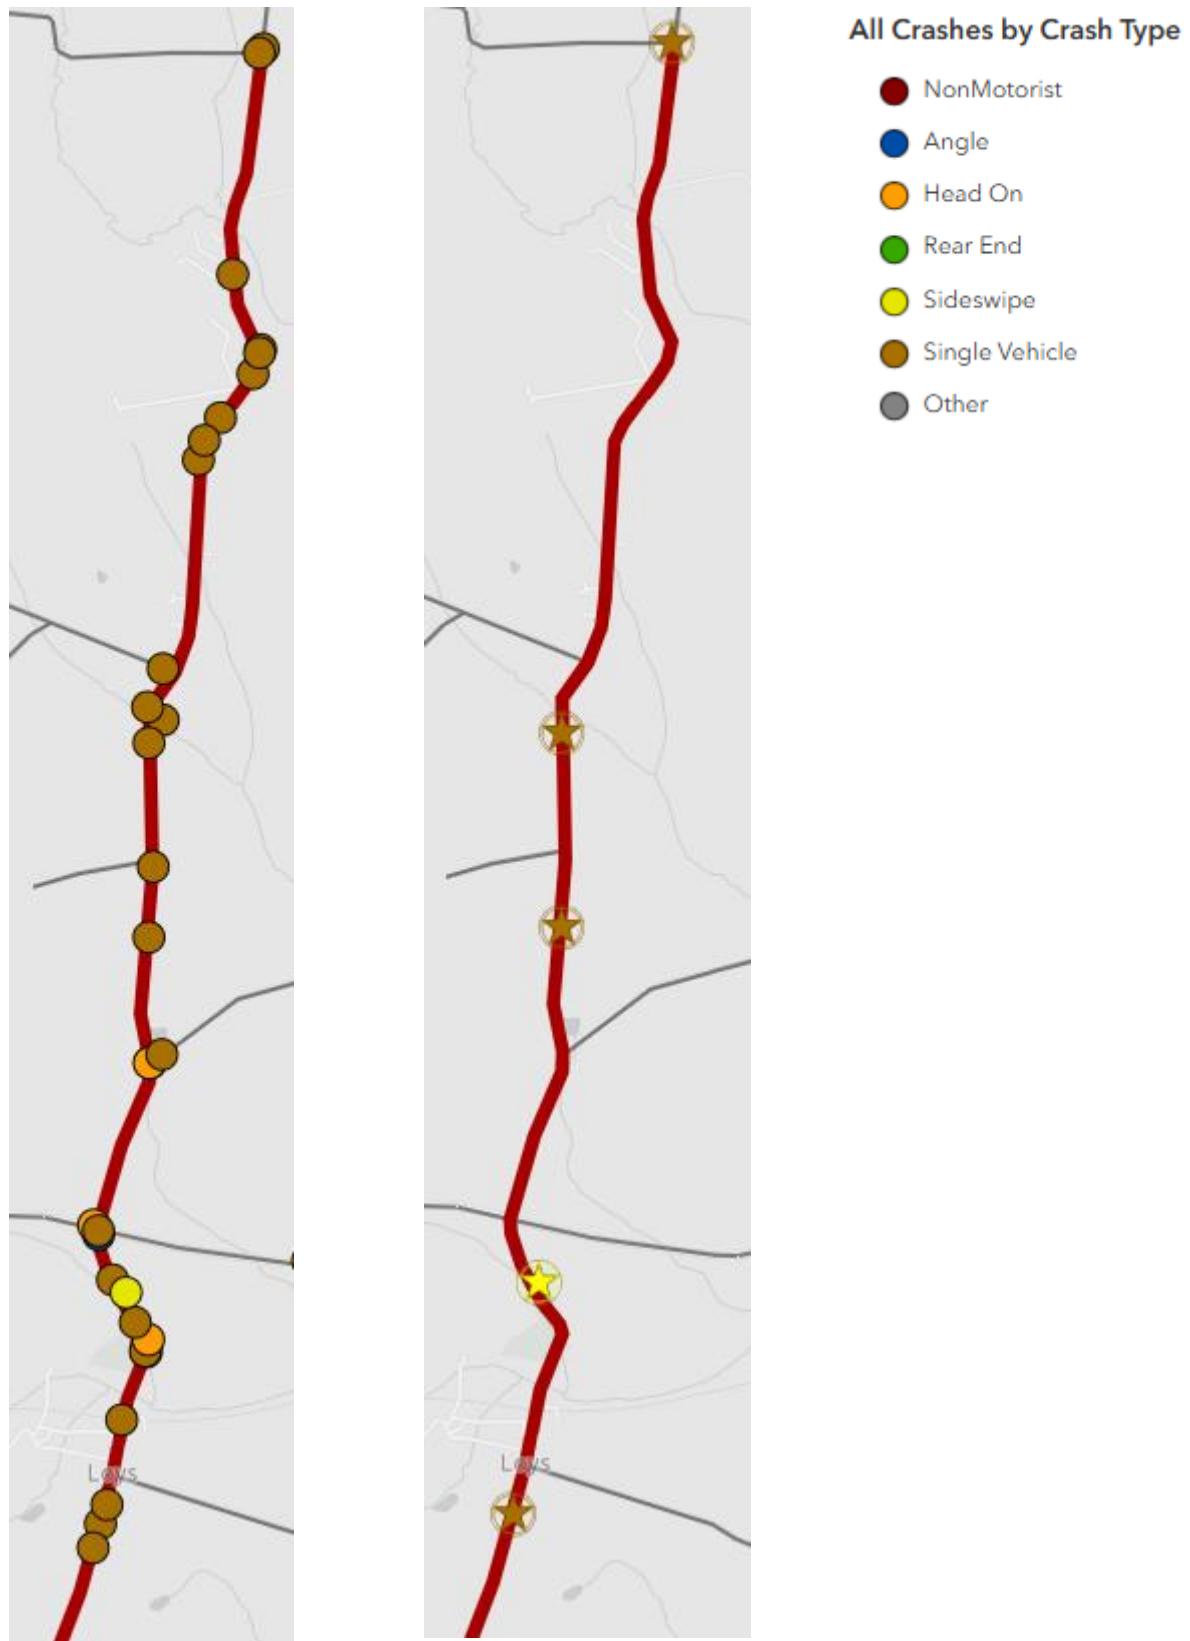
Figure 12: Old Frederick Road – all crashes (left) & KSI Only (right)

Single Vehicle Crash Trend: There were 27 (82%) single vehicle crashes reported, including 9 under dark conditions. The majority (21) of single vehicle collisions involved striking fixed objects. Locations with the highest number of collisions are as follows:

- Mud College Road – 8 crashes, 5 involved hitting fixed objects
- Rocky Ridge Road – 4 crashes, all occurred during daylight and resulted in hitting fixed objects
- Old Mill Road – 4 crashes, 3 involved hitting fixed objects

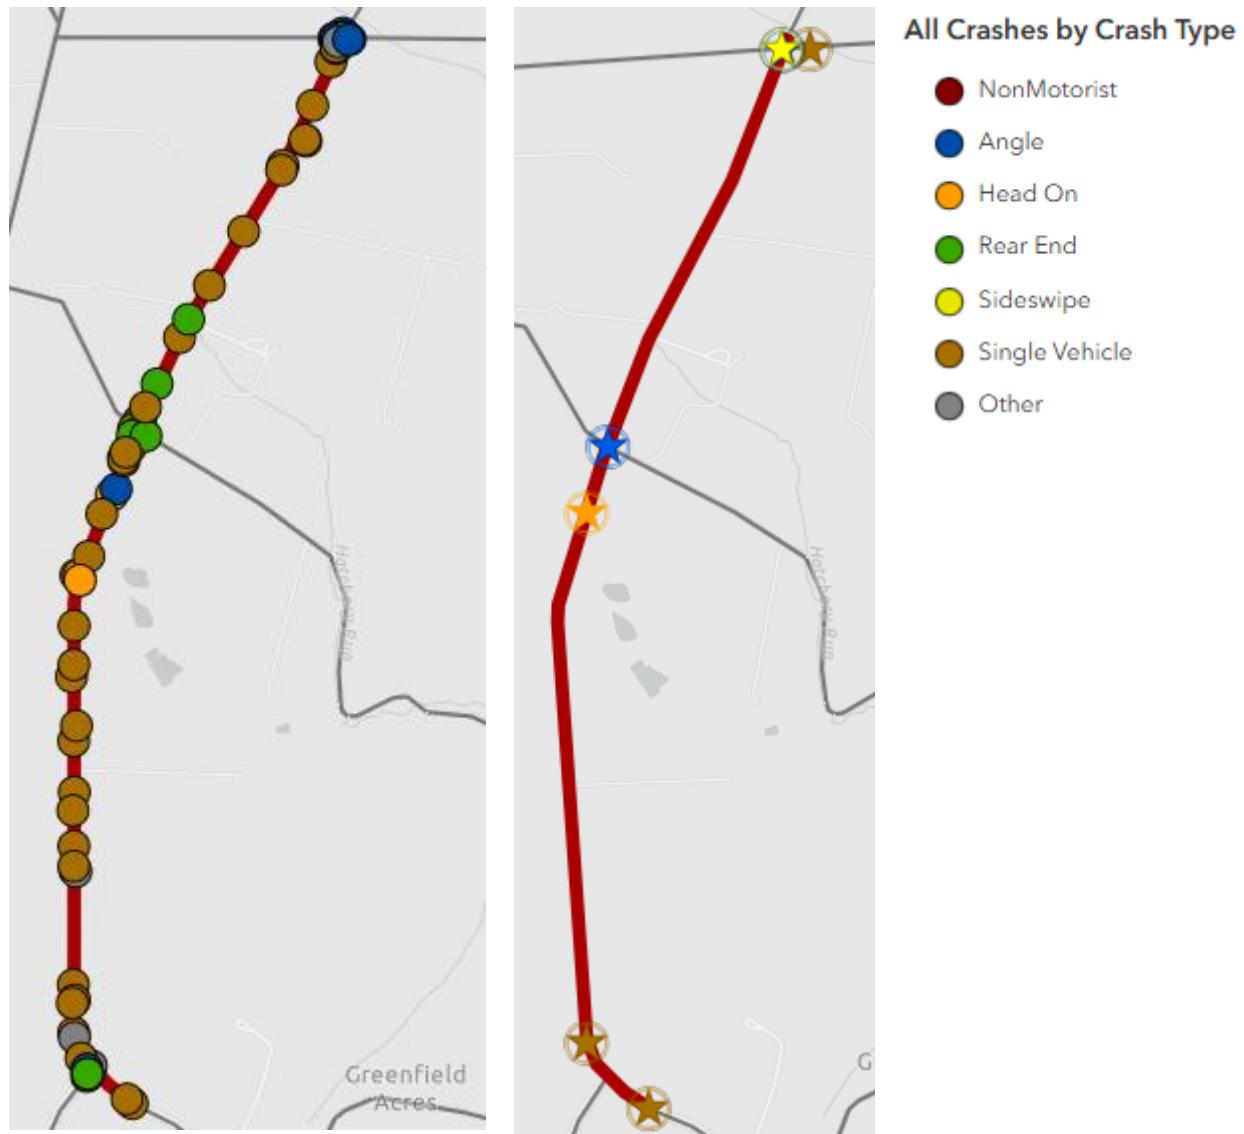
Figure 14: MD 85/Buckeystown Pike – All Crashes (left) and KSI only (right)

Single Vehicle Crash Trend: There were 36 single vehicle crashes reported, including one fatal crash, with 17 (47%) reported under dark conditions. The majority occurred under clear or cloudy weather conditions.

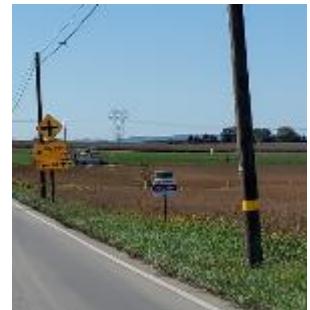
- Most of the corridor is level and straight with the few curves well signed. There are two, short, southbound MD 85/Buckeystown Pike striped passing areas, though most of the corridor includes double yellow centerline markings.
- This section of MD 85/Buckeystown Pike consists of two 12-ft travel lanes and 2.5-ft shoulders.
- There were no bicycle facilities along the corridor.
- Utility poles line are present on both sides of MD 85/Buckeystown Pike for much of the corridor. Many of the utility poles include reflective tape (see image at right).
- The Lily Pons Road stop sign includes reflective striping on the sign post.

- Install 10-in wide edgelines along corridor to highlight the edge of road and encourage reasonable speeds through the roadway section.
- Install reflective tape around each utility pole for added nighttime edge of road visibility
- Add retroreflective strip to sign posts, especially the sidestreet “stop” signs on EB Oland Road, on EB & WB Greenfield Road, and on NB MD 28 / Dickerson Road
- Replace existing “stop” signs on Lily Pons Road and Oland Road with oversized (48” x 48”) stop signs

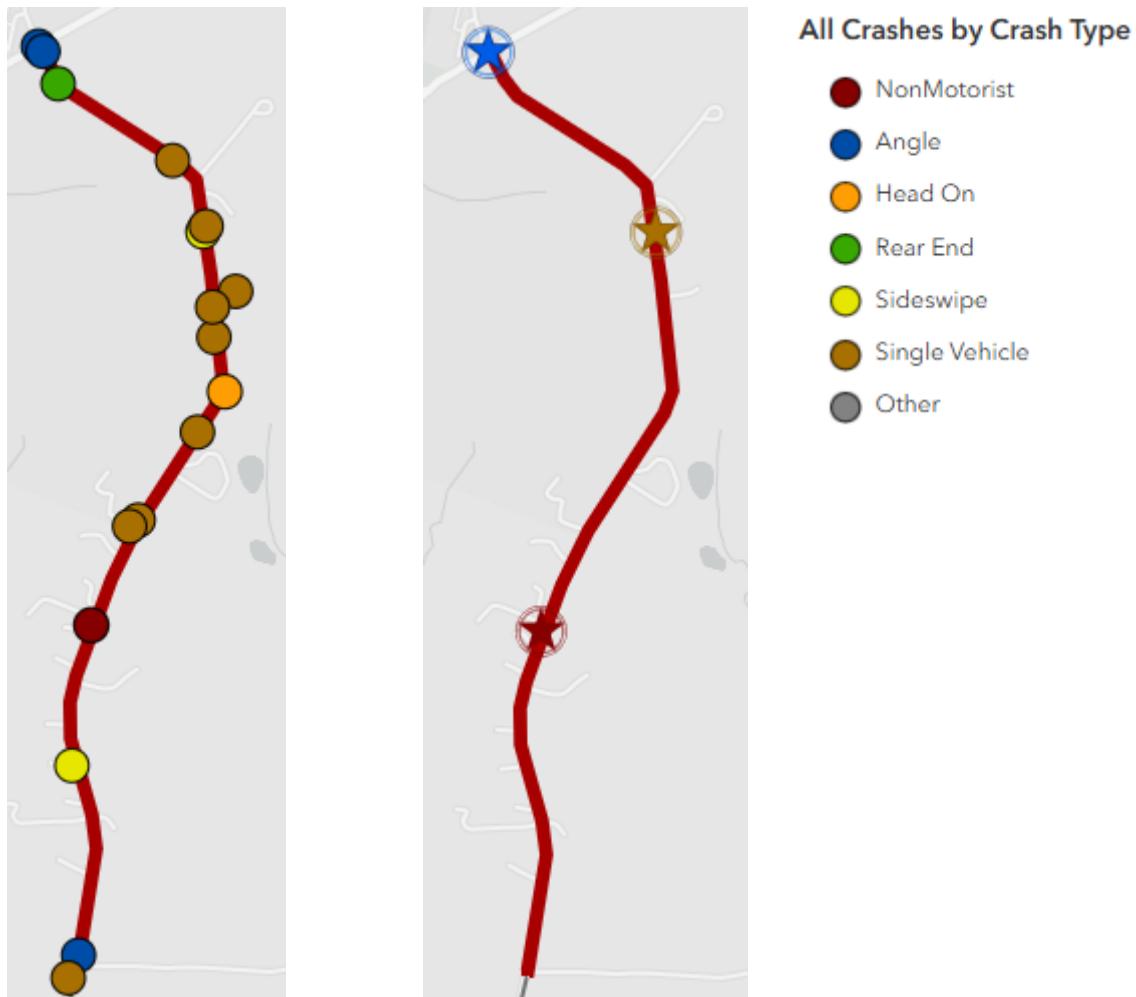
Figure 19: Big Woods Road – All Crashes (left) and KSI only (right)

Single Vehicle Crash Trend: There were 12 (57%) single vehicle crashes and 5 were reported under dark light conditions.

As shown in **Figure 19**, these collisions occurred primarily between the northern most curves and on the straightaway south of the southern curve.

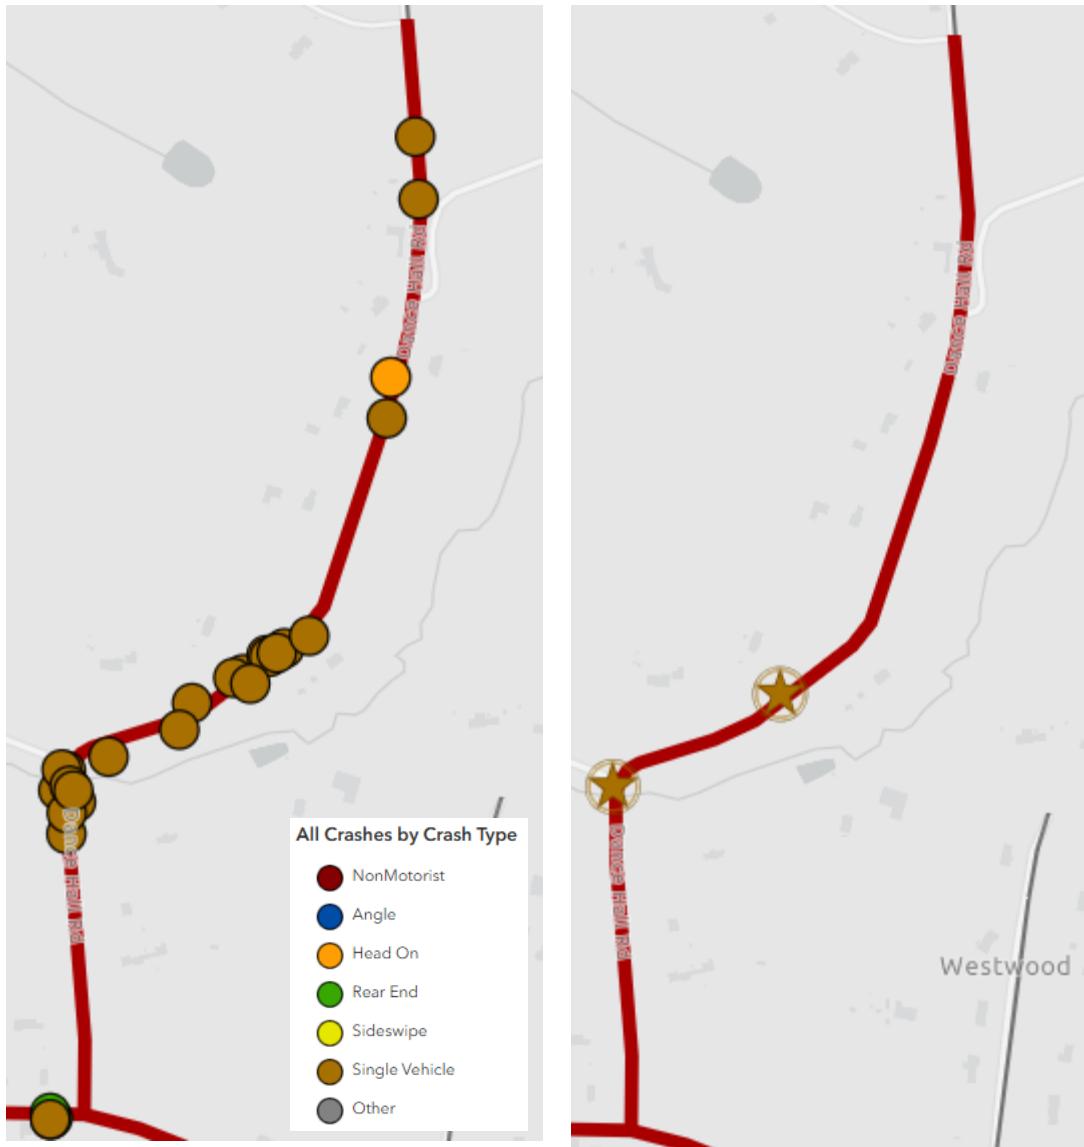
Figure 28: Dance Hall Road -- All crashes (left) and KSI only (below)

As shown in Error! Reference source not found., the single vehicle collisions occurred throughout the study corridor, though clustering around the sharp curve just north of Gas House Pike.

- Install edgeline rumble stripes along Dance Hall Road as well as rumble strips on the approaches to the sharp curve.
- Install RPMs, which were identified in the RPM “hot spot” analyses as well.
- Trim trees and vegetation back from edge of road to the maximum extent possible based on right-of-way.
- Consider curve just north of Gas House Pike for high-surface friction treatment
- Install experimental elongated pavement marking signs (W1-1), which would likely require experimentation approval from FHWA, on northbound & southbound Dance Hall Road approaching the horizontal curve north of Gas House Pike, such as curve (W1-2) warning sign example from Kansas below:
