FREDERICK COUNTY HISTORIC PRESERVATION COMMISSION STAFF REPORT

Request: Certified Local Government Evaluation of National Register eligibility of the Beatty Cramer House

Address: 9010 Liberty Road, Frederick

Historic name: Beatty-Cramer House

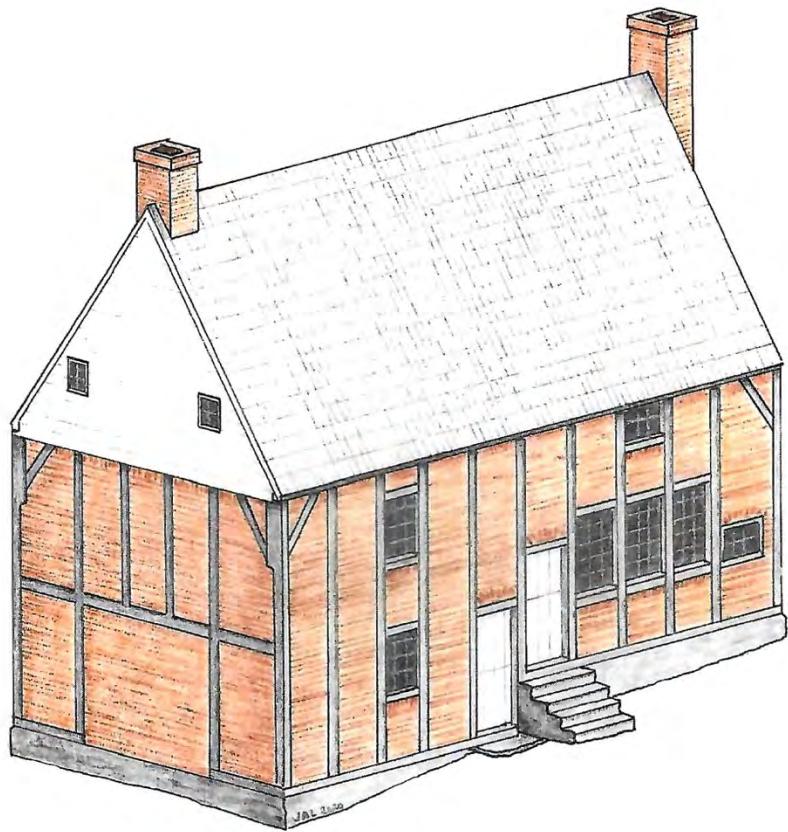
**Beatty Cramer Original (Period I) House
Conjectural Drawing (not to scale).**

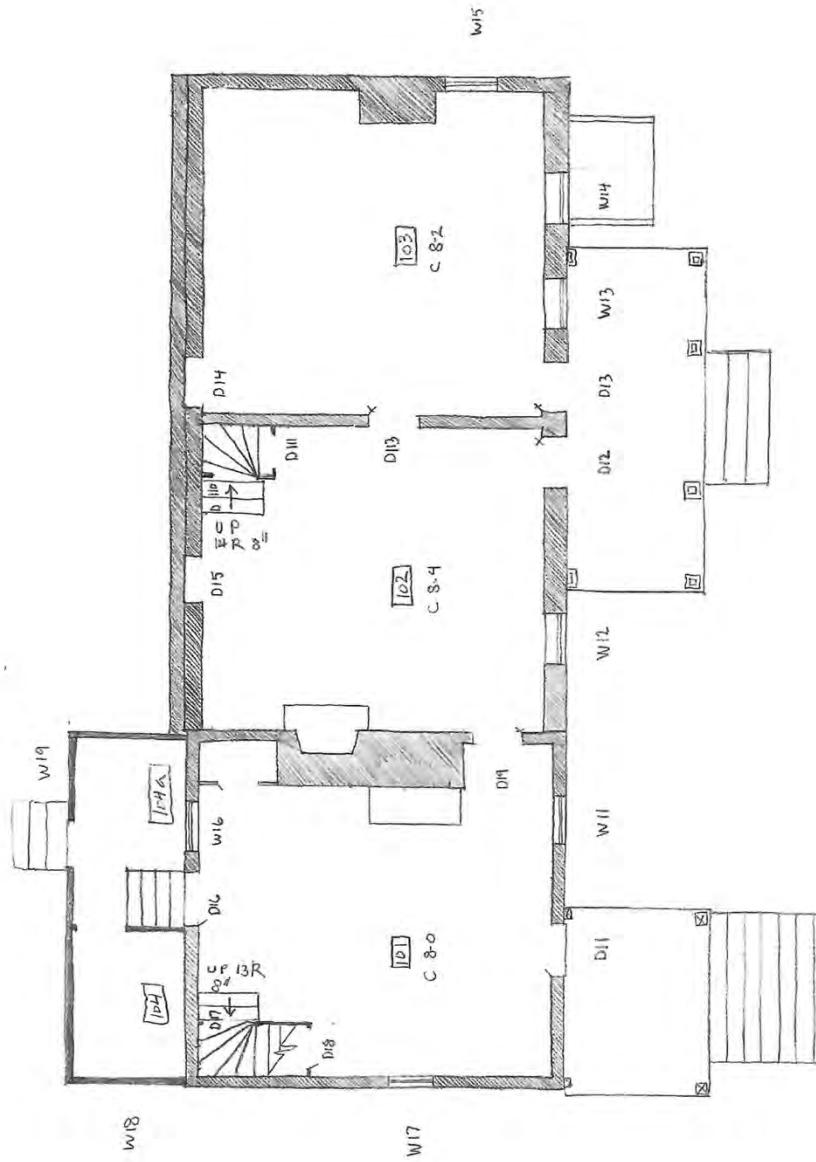
87.50 H. CRAMER HOUSE

FIRST FLOOR PLAN

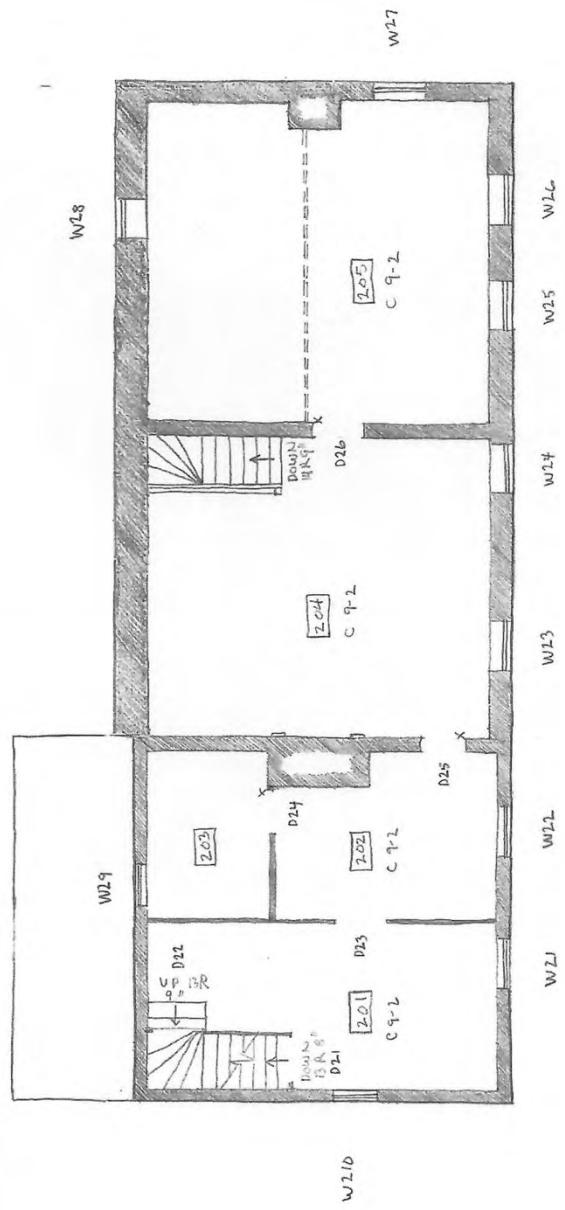
87.50 H. CRAMER, HOUSE

SECOND FLOOR PLAN

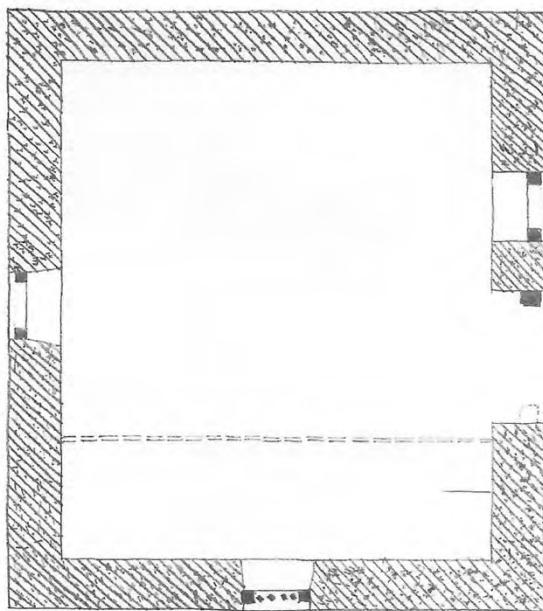
18'-4"

SPRING HOUSE

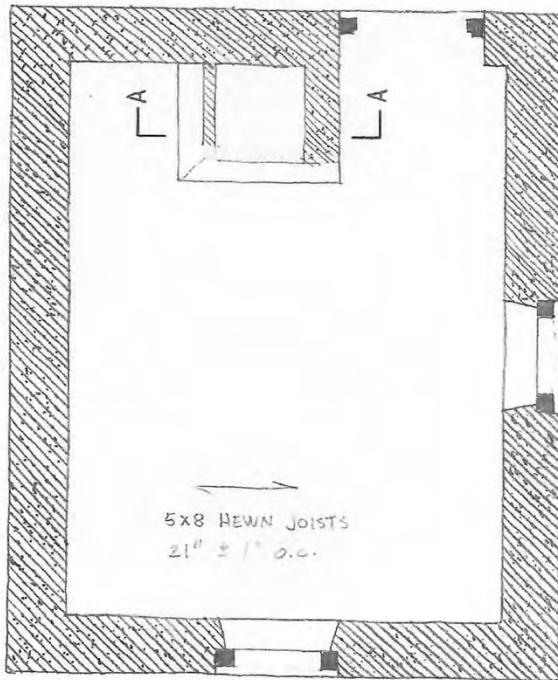
CHAIR RAIL $1\frac{1}{4}'' \times 1\frac{1}{2}''$ TOP 32" AFF
WITH $\frac{1}{4}''$ BEAD TOP AND BOTTOM EDGES
BASEBOARD $1\frac{1}{4}'' \times 1\frac{1}{2}''$ WITH $\frac{1}{4}''$ BEAD
FLOOR BOARDS R.W. $4\frac{1}{2}'' - 7''$ WIDE

BOTTOM OF ATTIC FLOOR JOISTS $7\frac{1}{2}'' \times 7\frac{1}{2}''$ AFF
ATTIC FLOOR JOISTS HEWN $5'' \times 8''$ $21'' \pm 1''$ O.C.

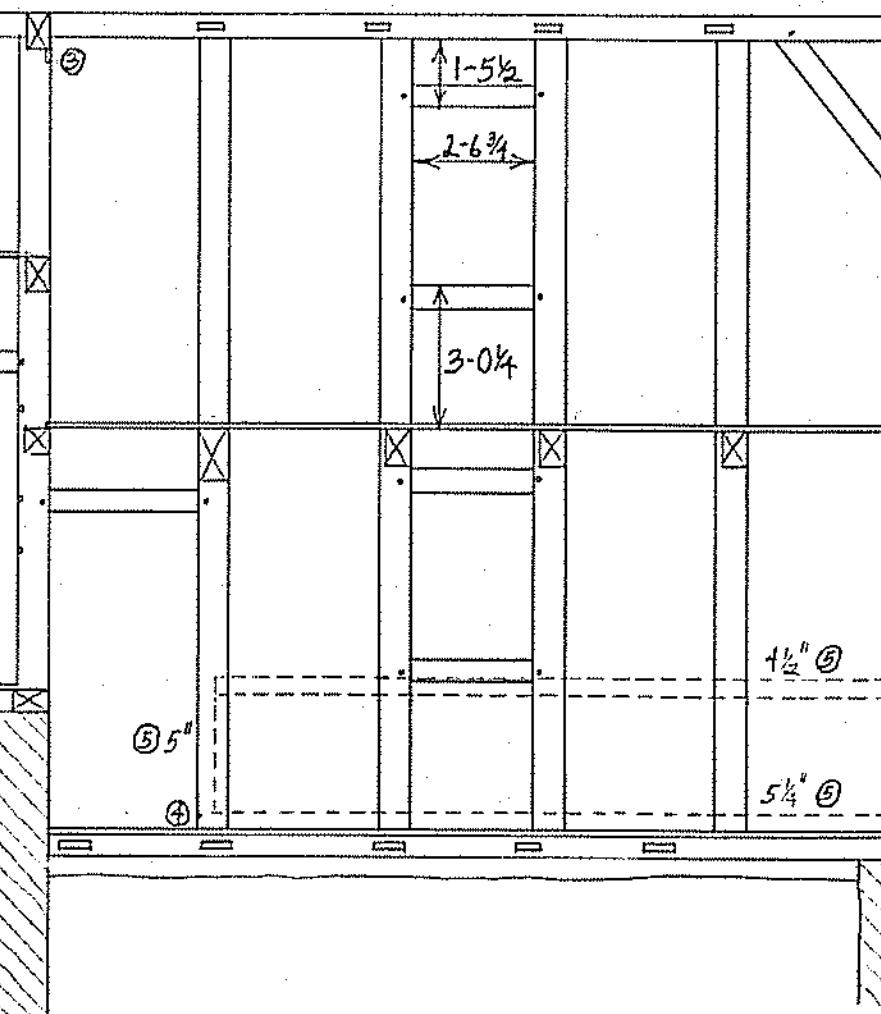
⑤ MORTISES IN WEST GILL, PLASTER LINES FOR

BASEBOARD, ARCHITRAVE, AND CHAIR RAIL MEASURED BY EDWARD A. CHAPPELL

I TIMBER FRAME DENDRO DATED 1748

II FRAME OVER BUILD CIRCA 1854

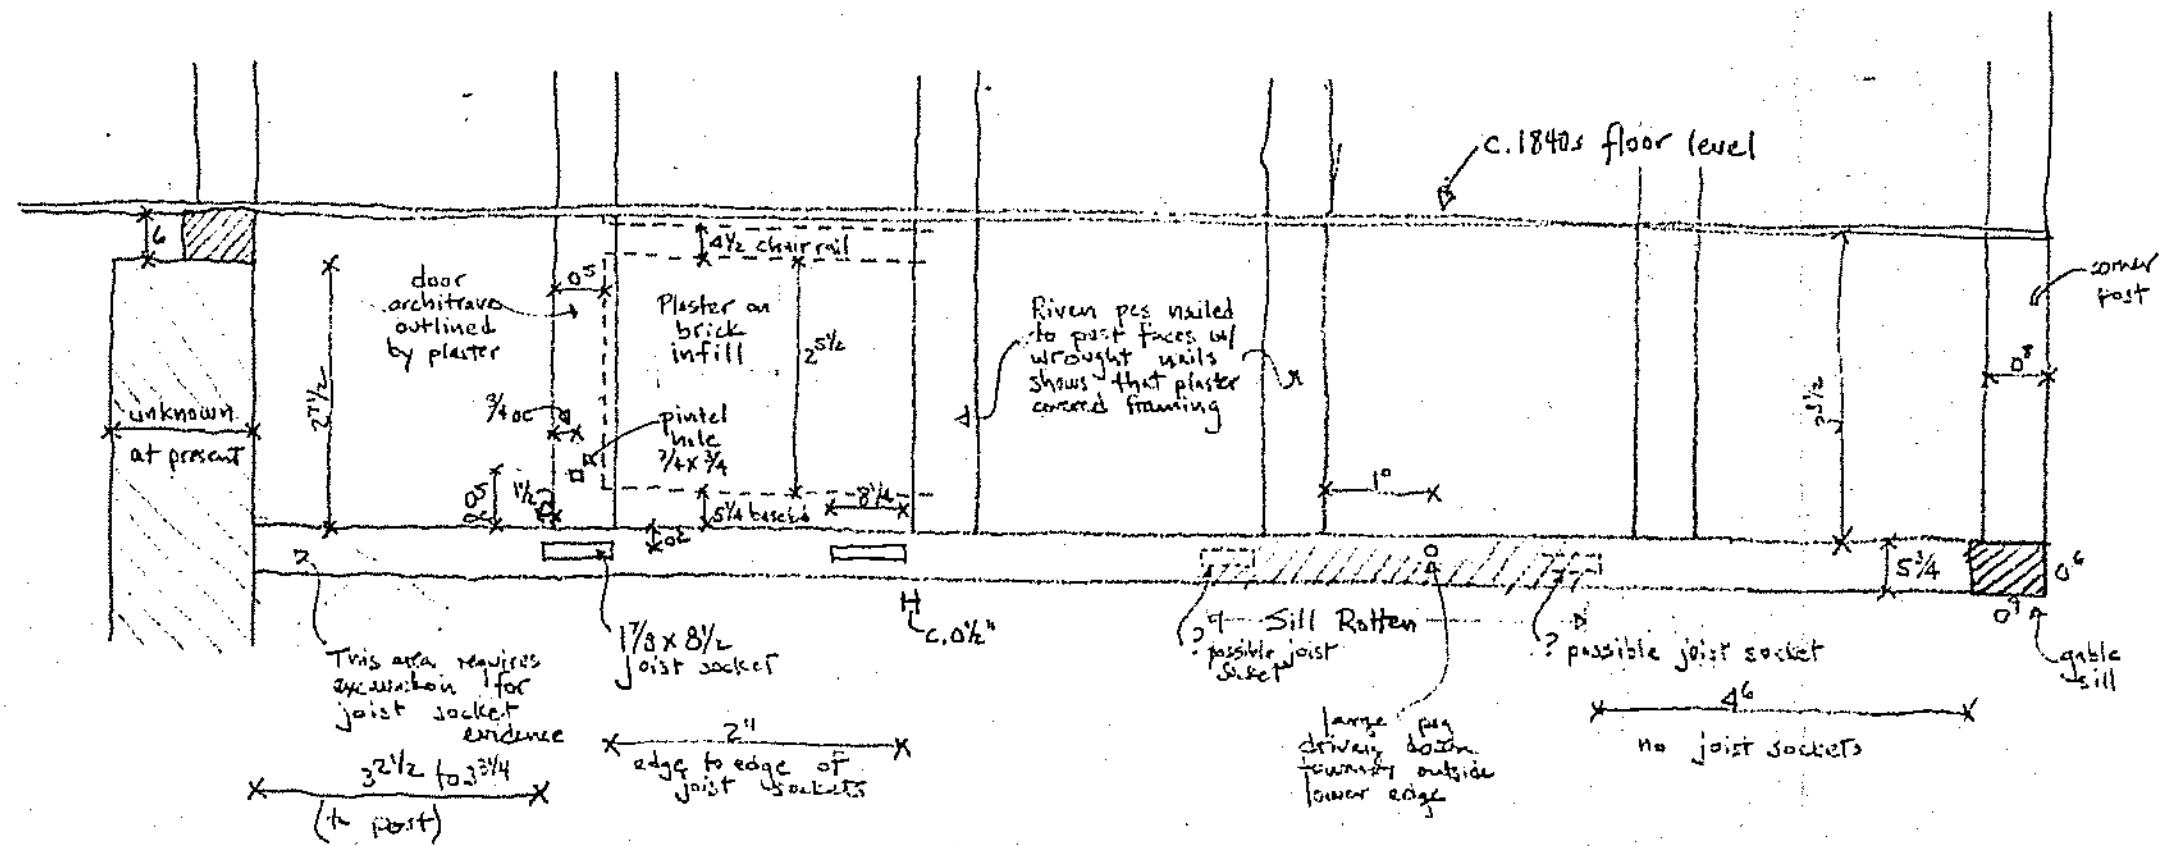
KRAMER HOUSE
SOUTH FAÇADE, WEST ROOM

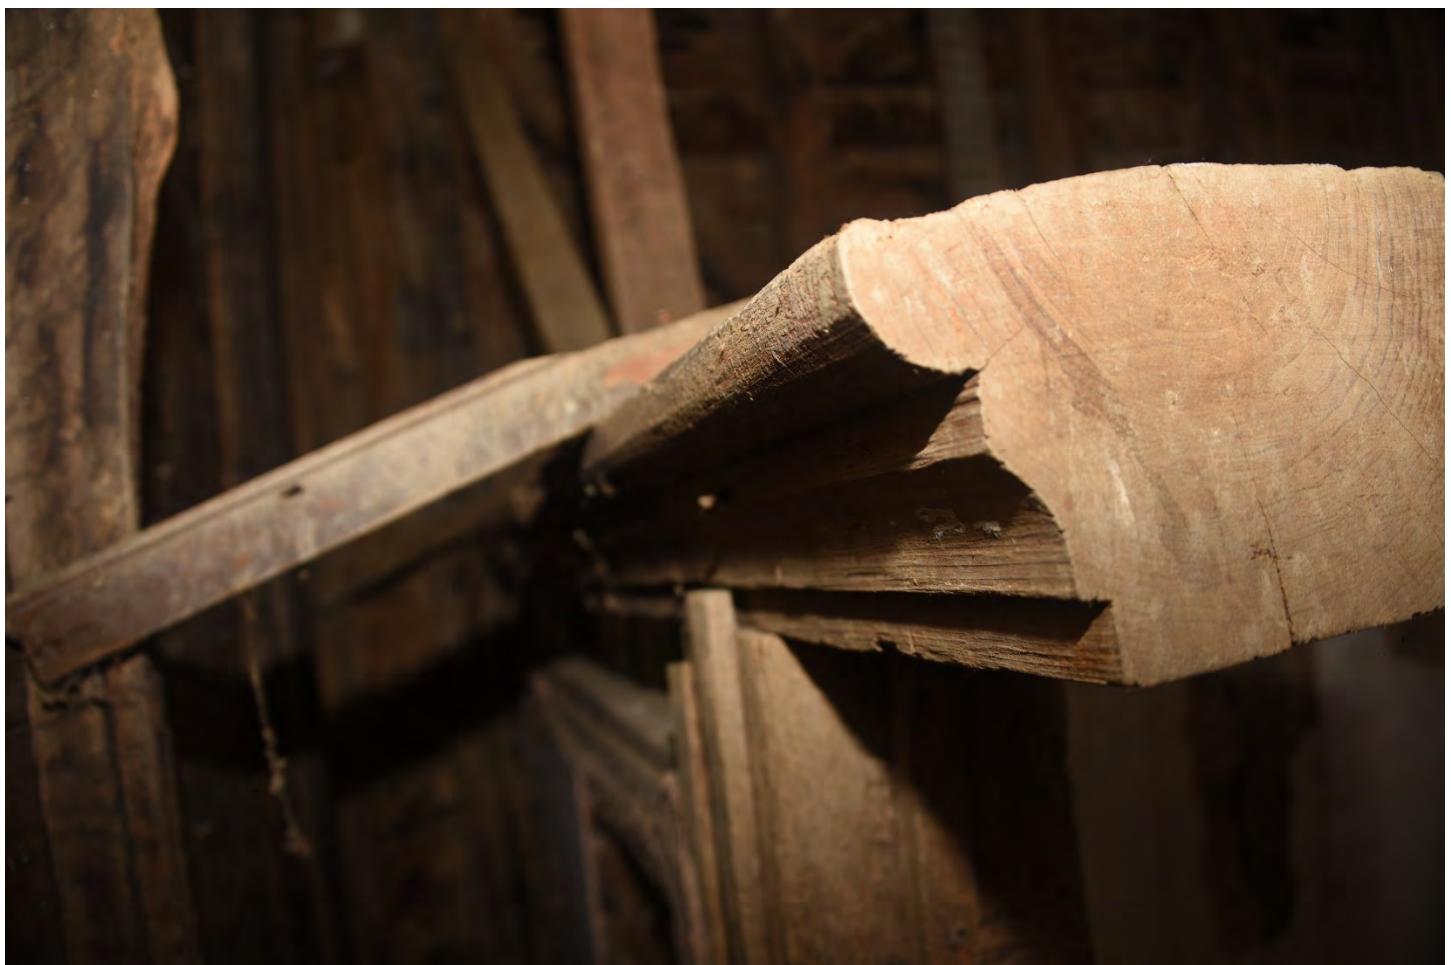
MD_FrederickCounty_Beatty-Kramer_0004.tif
North elevation, cornice moulding on top plate, covered by later curtain wall.

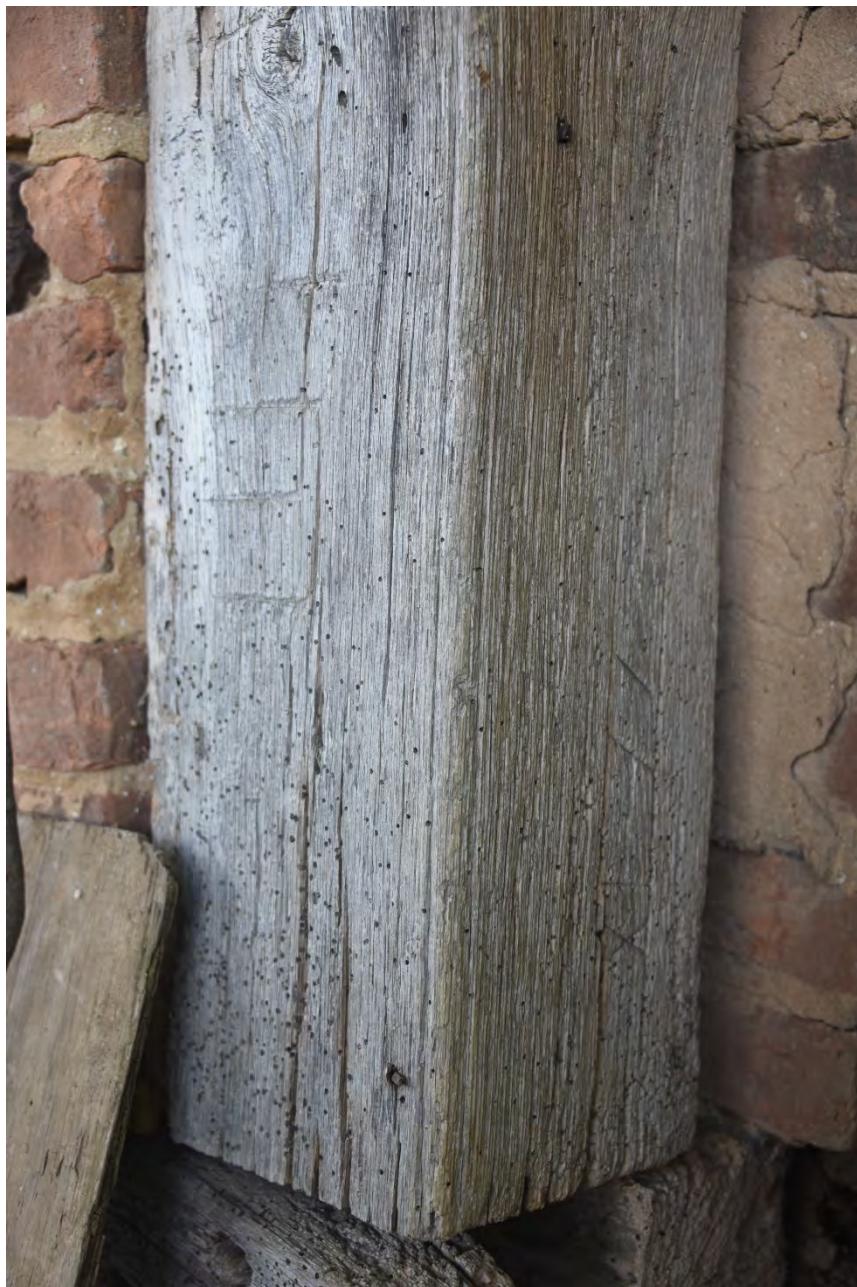
MD_FrederickCounty_Beatty-Kramer_0005.tif
Northeast corner post with corner bead and marriage marks

Corner posts measured 10" x 11" and were guttered, hewn to an ell shape, to fit the 5"-thick walls. Timber sills, about 6" x 8", were tenoned to the edges of the corner posts. The extant corner post was underpinned with a stone foundation. On the inside of the wall the sill was

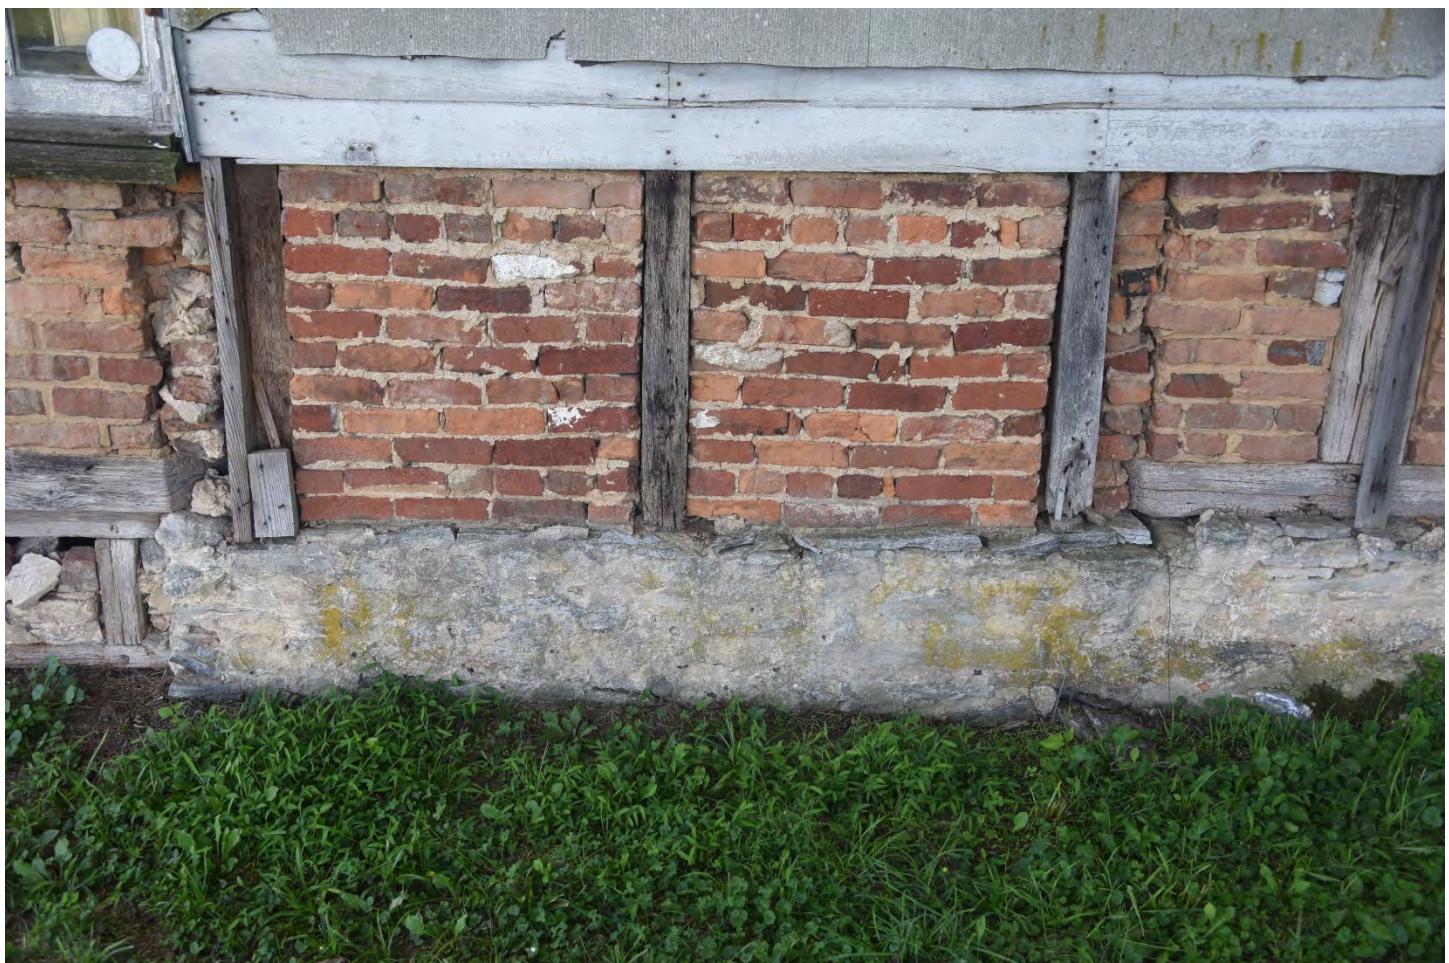
MD_FrederickCounty_Beatty-Kramer_0007.tif
East elevation, detail of foundation showing evidence of earlier fireplace.

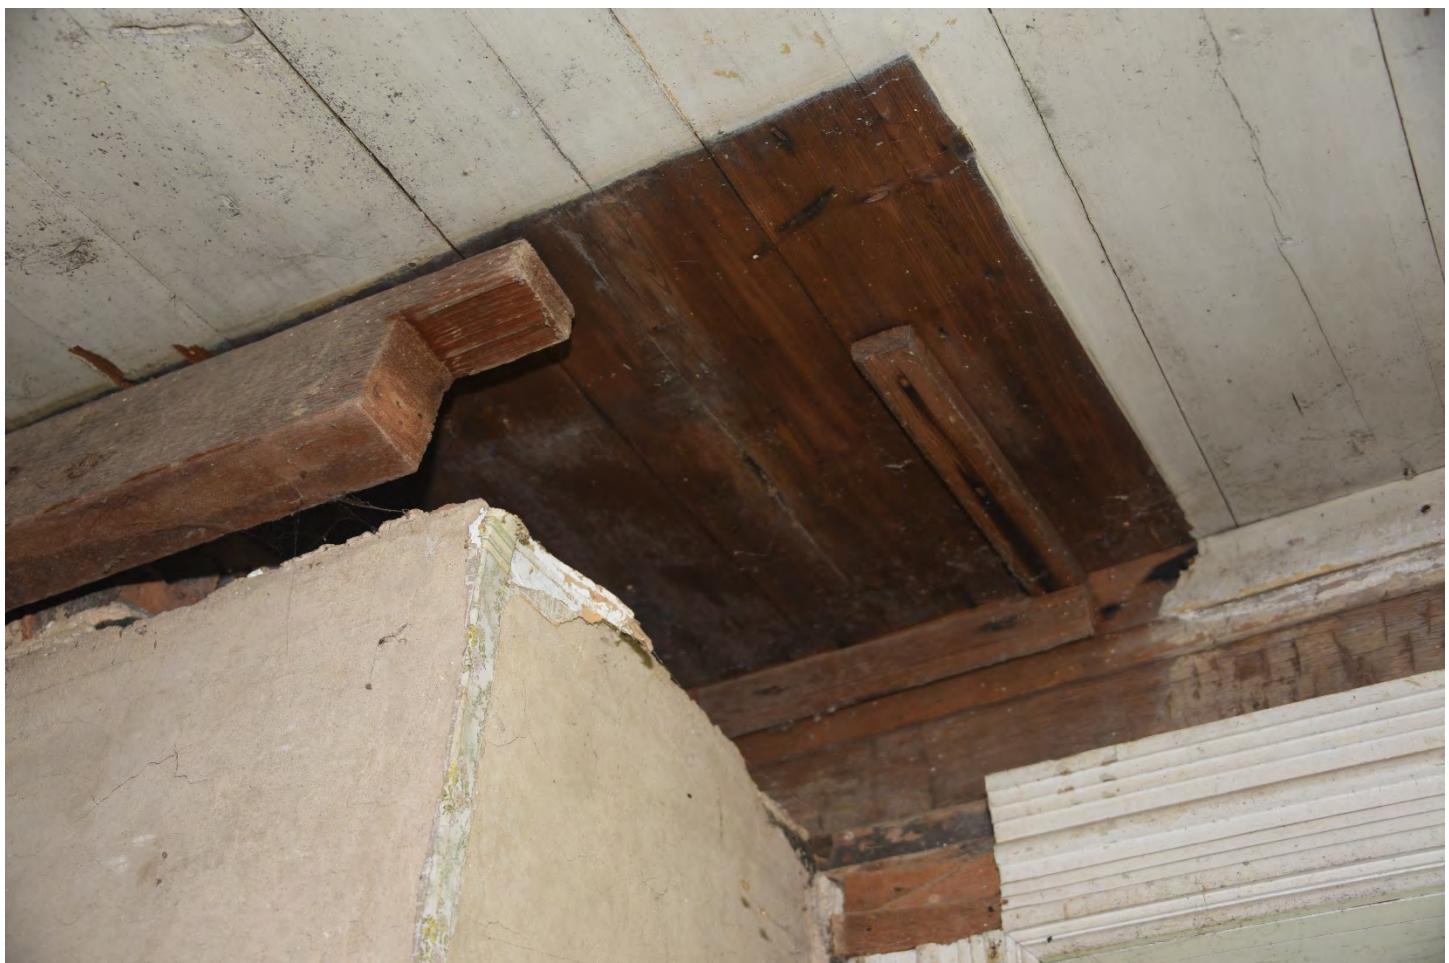
MD_FrederickCounty_Beatty-Kramer_0011.tif
East room, ghost of original cabinetry at chimney.

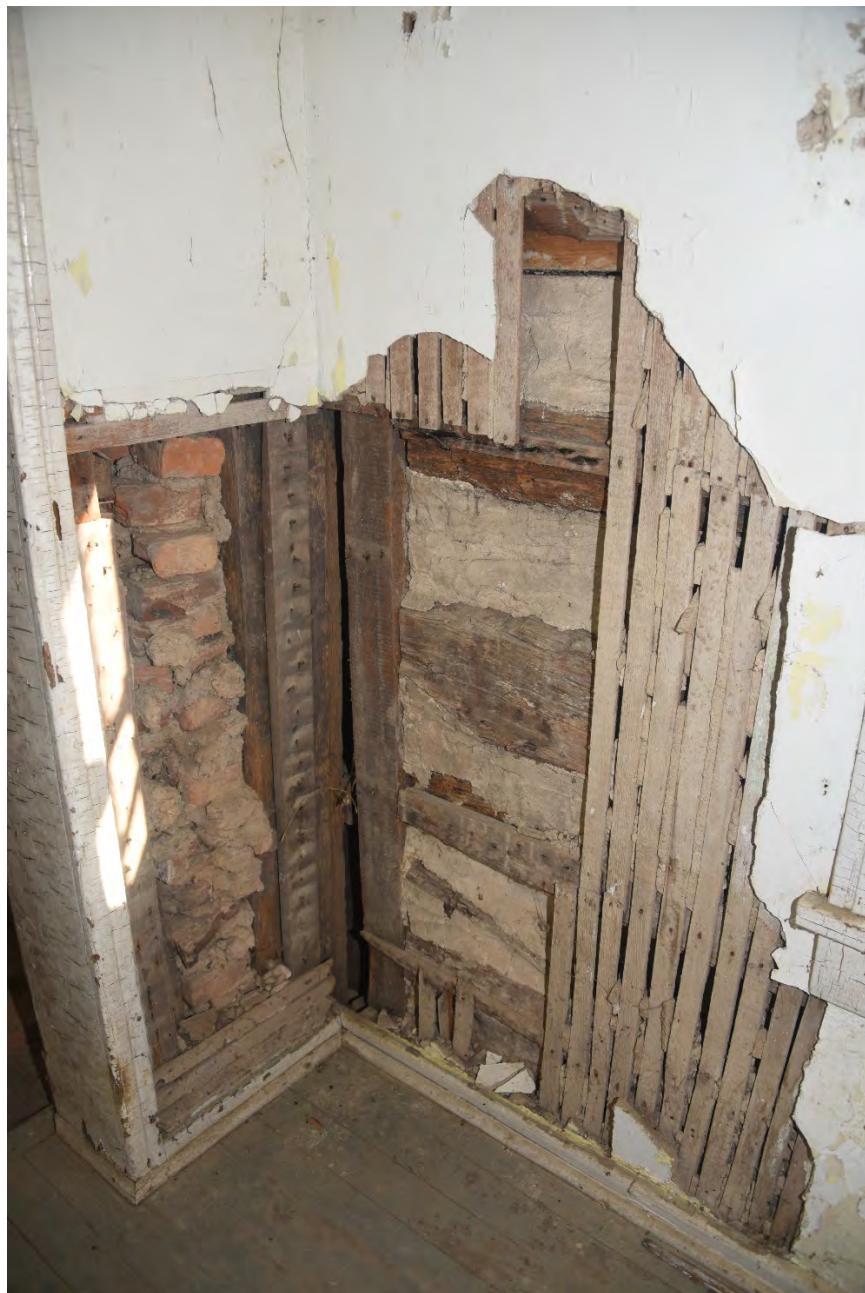
MD_FrederickCounty_Beatty-Kramer_0021.tif
West room, southeast corner showing log wall with corner post.

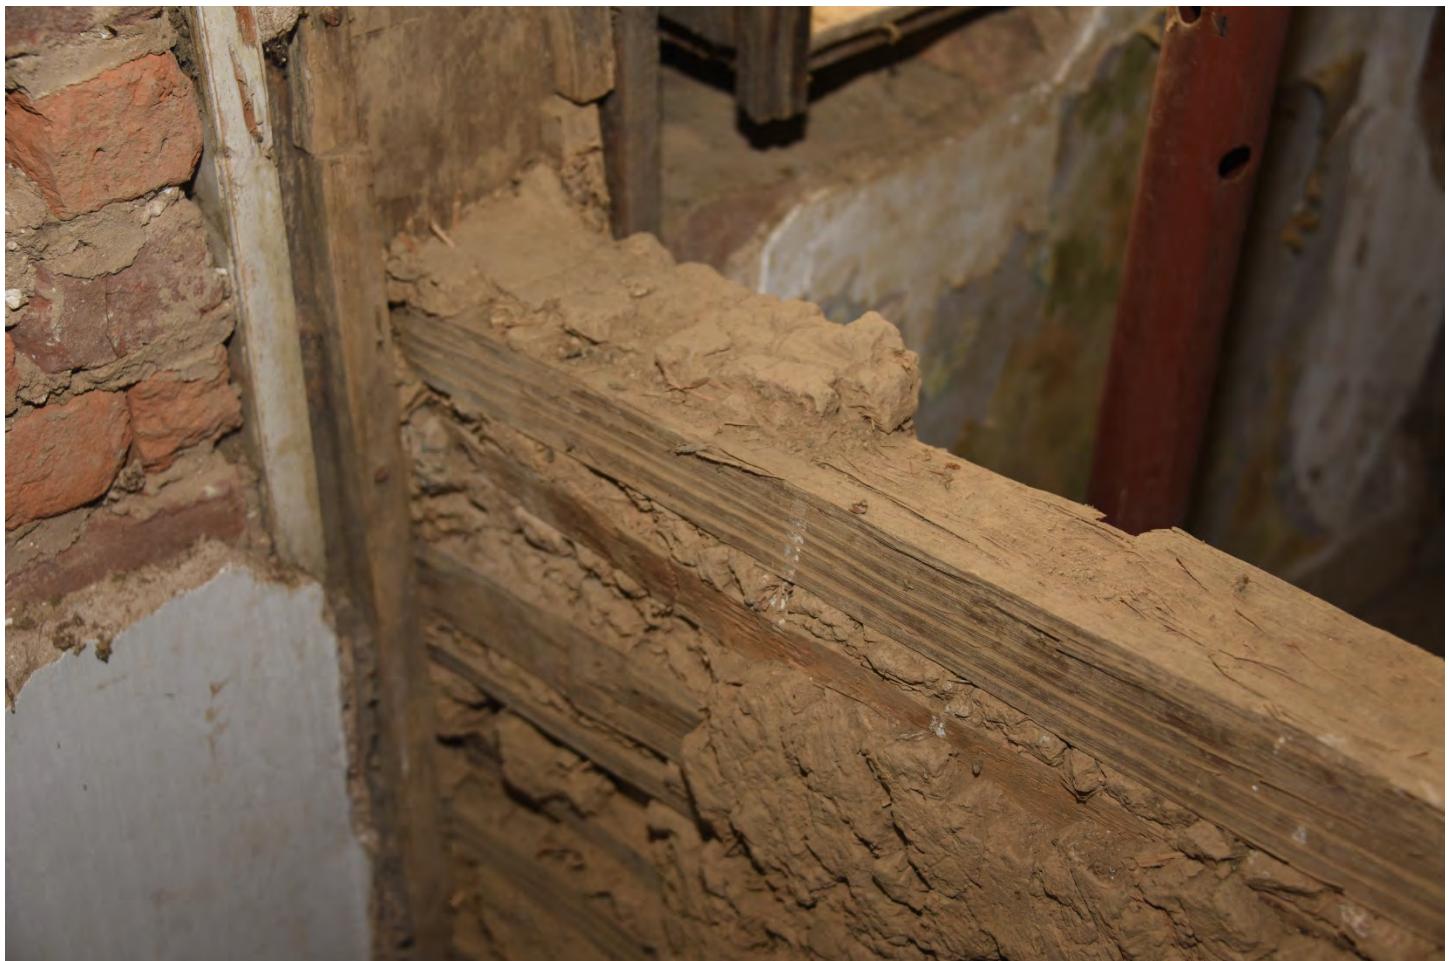
MD_FrederickCounty_Beatty-Kramer_0025.tif
East chamber, southwest corner Dutch biscuit detail.

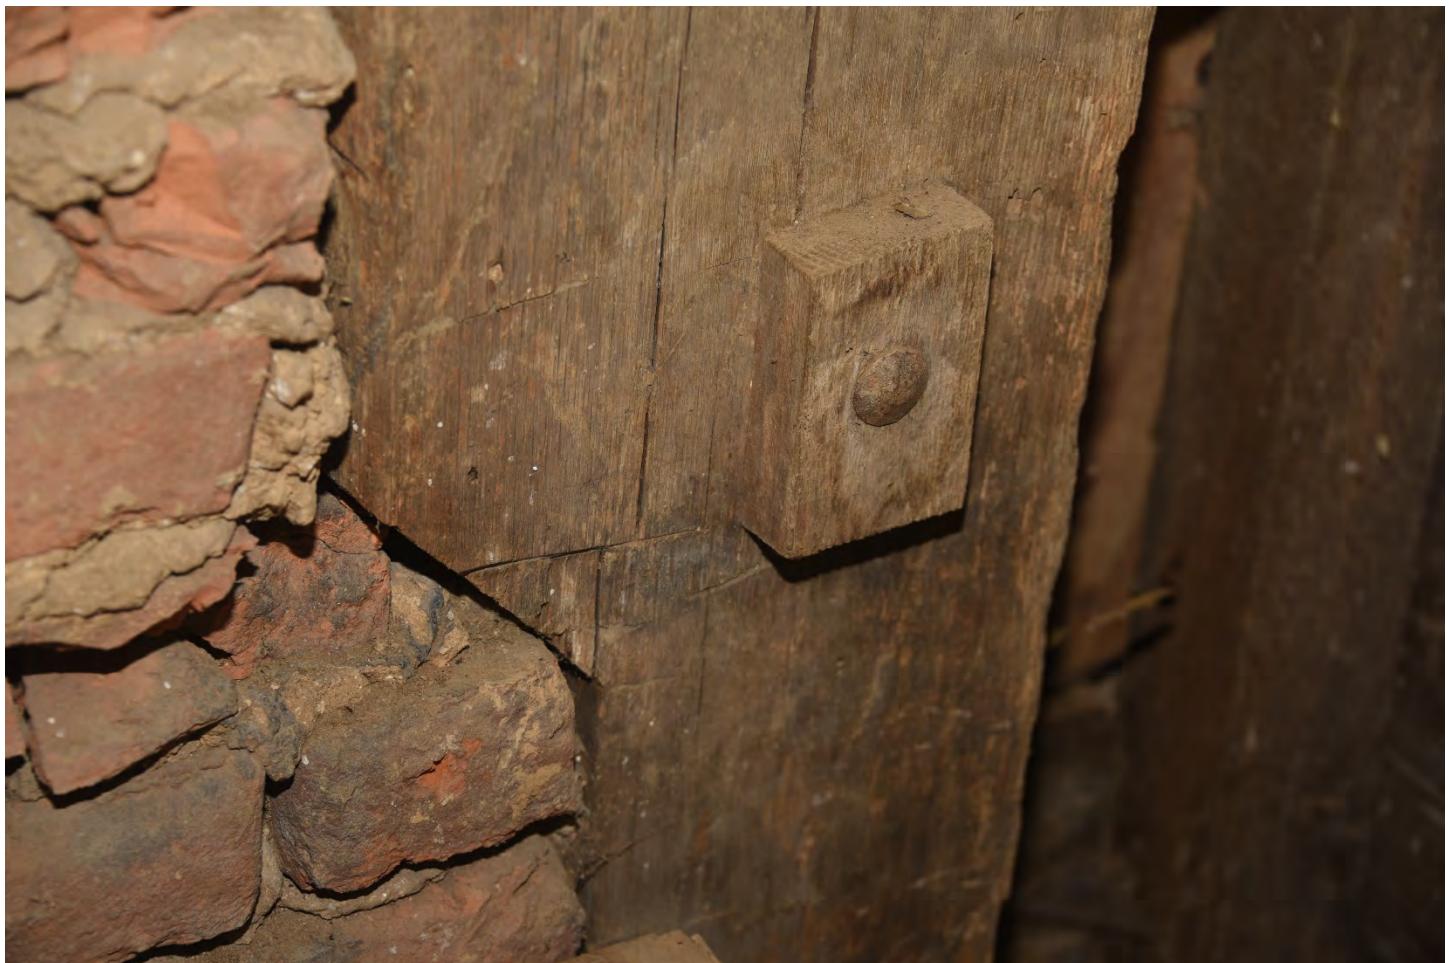
MD_FrederickCounty_Beatty-Kramer_0027.tif
Center chamber, northwest corner post with jowl

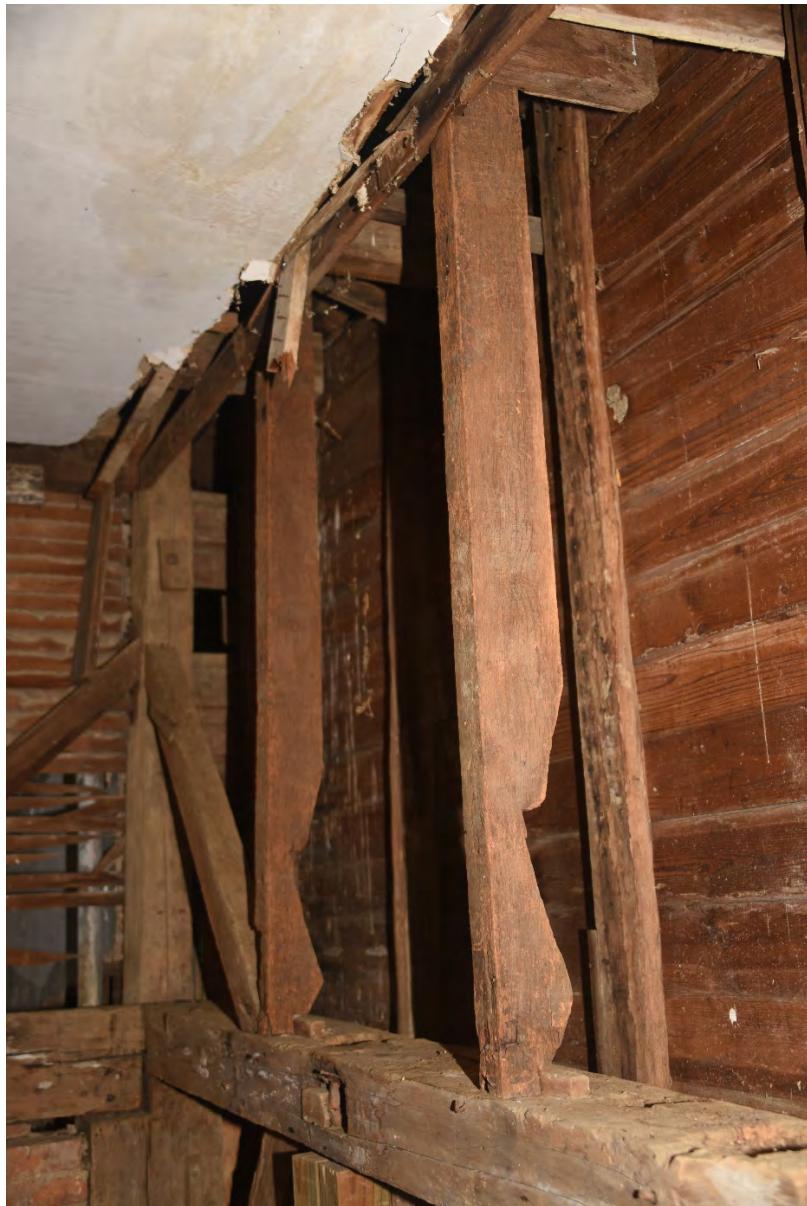
MD_FrederickCounty_Beatty-Kramer_0028.tif
Center chamber, north wall with rafters reused as studs.

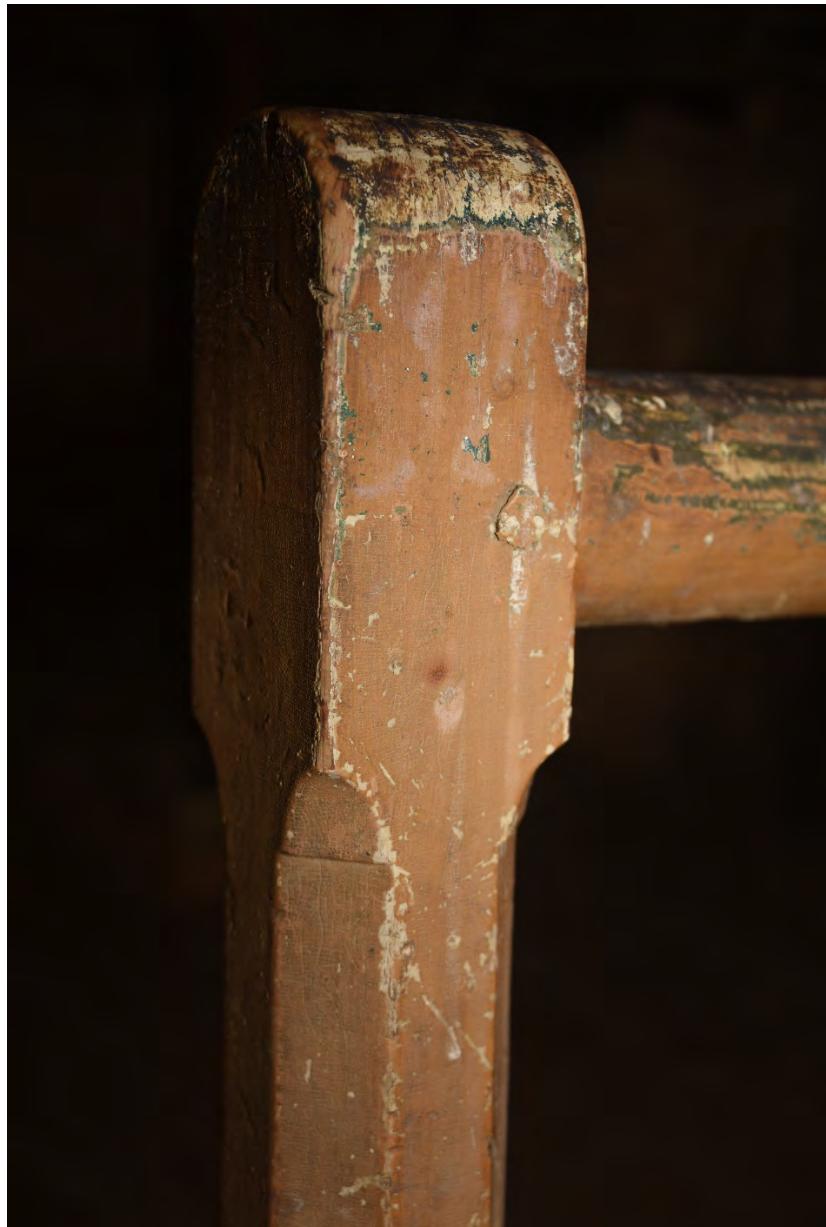
MD_FrederickCounty_Beatty-Kramer_0030.tif
Center chamber, newel detail

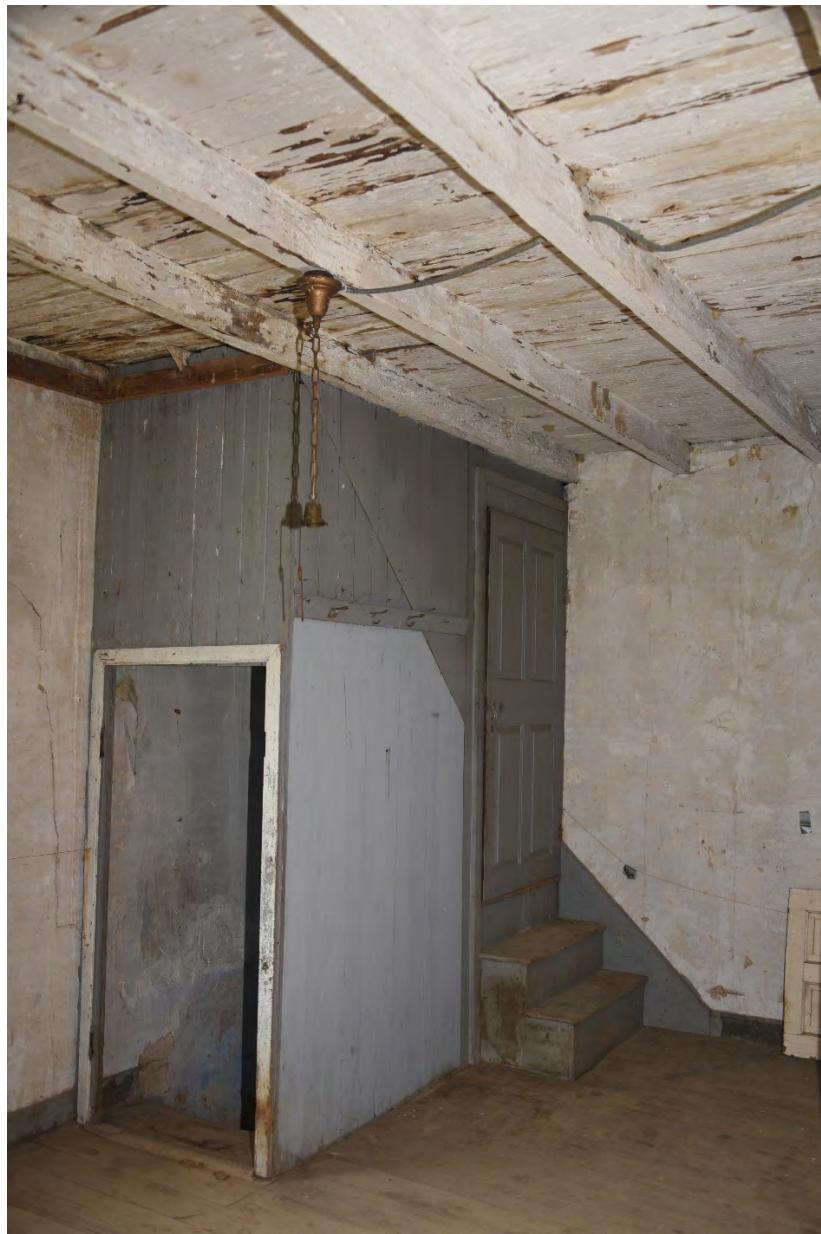
MD_FrederickCounty_Beatty-Kramer_0031.tif
West chamber, view northwest

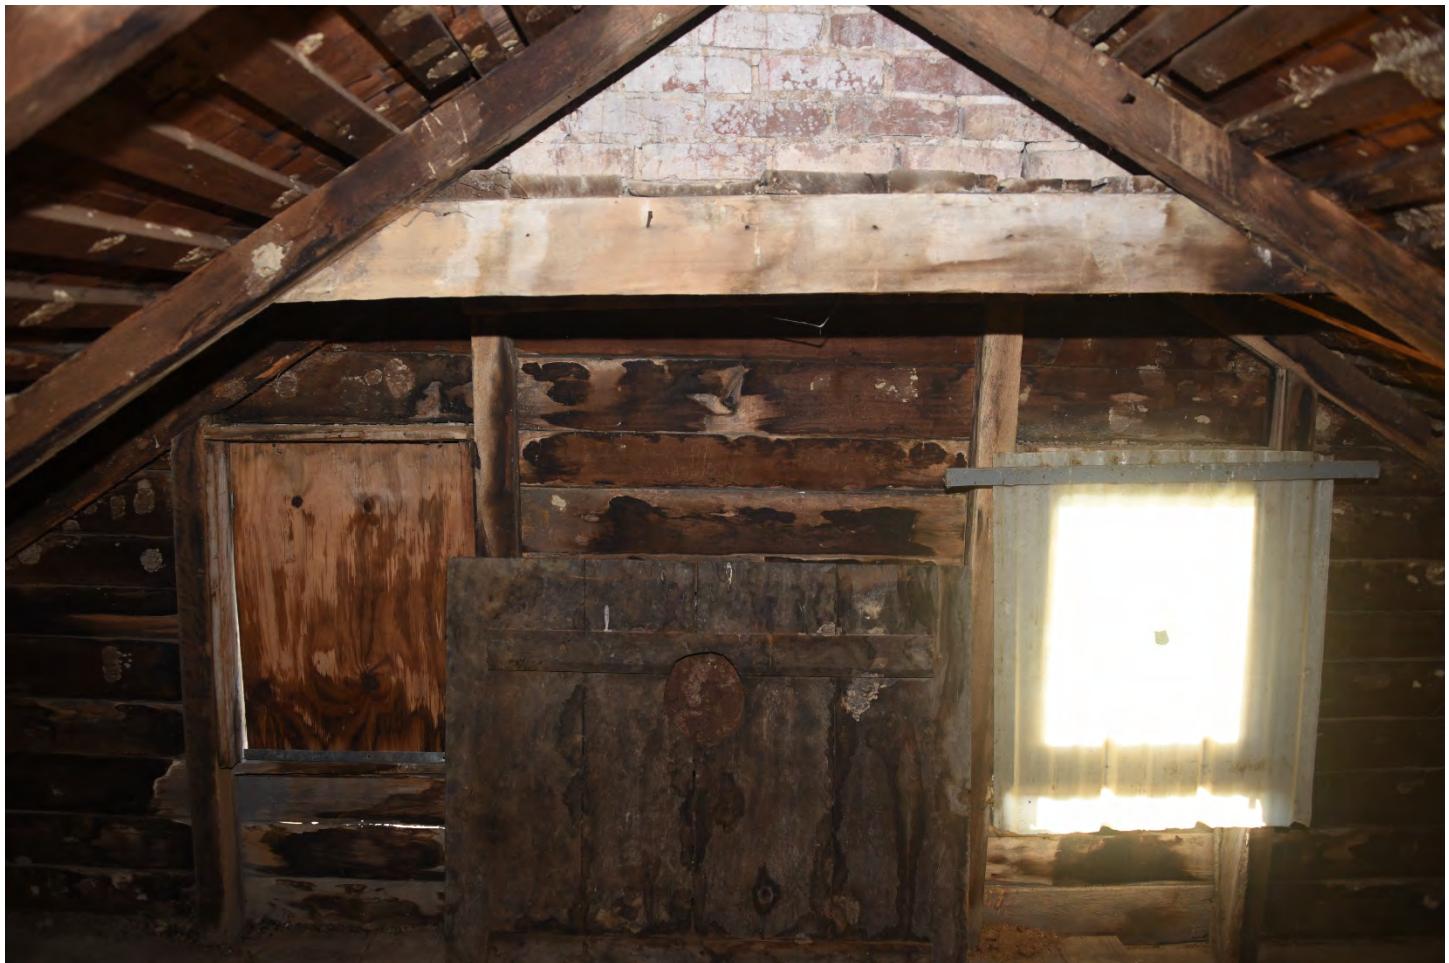
MD_FrederickCounty_Beatty-Kramer_0032.tif
Attic, west elevation showing false chimney.

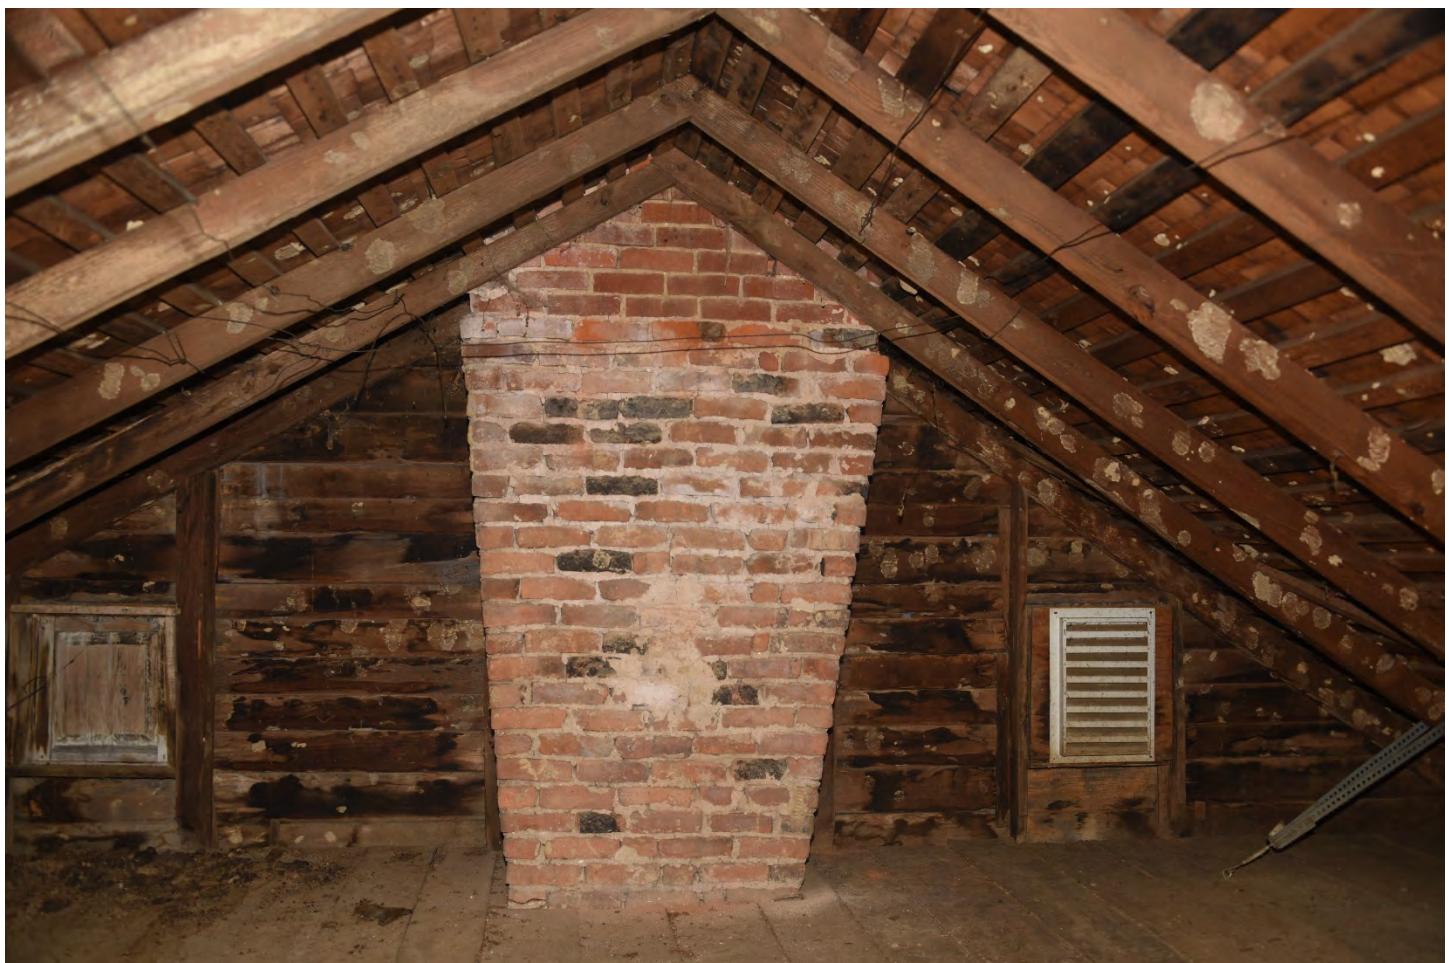
MD_FrederickCounty_Beatty-Kramer_0033.tif
Attic, east elevation.

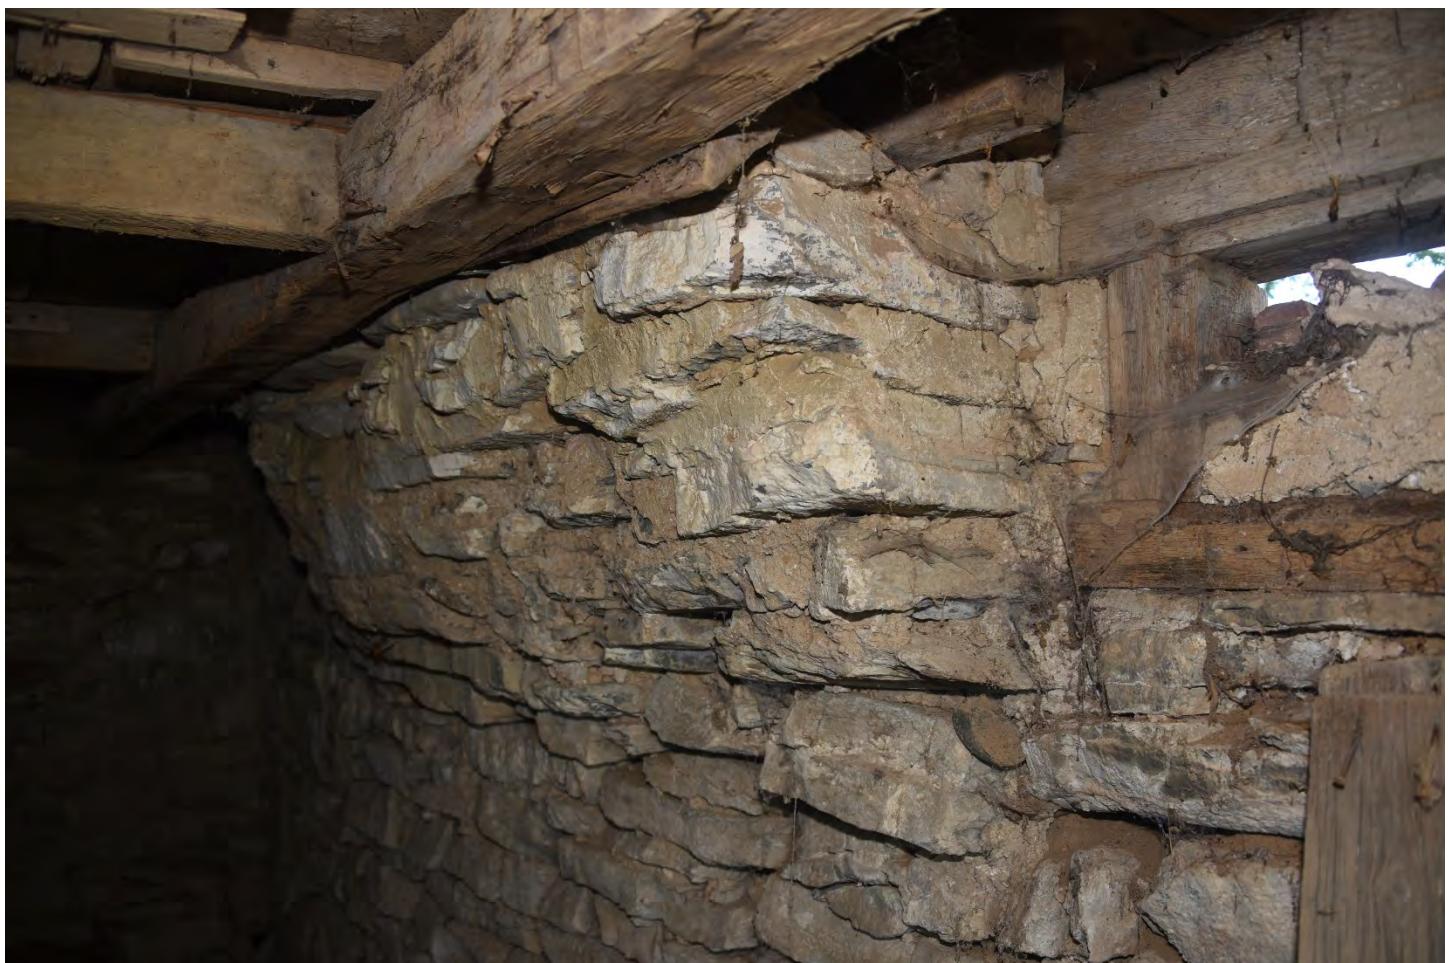
MD_FrederickCounty_Beatty-Kramer_0034.tif
East basement, east wall corbel for fireplace.
