FREDERICK COUNTY HISTORIC PRESERVATION COMMISSION STAFF REPORT

Request: Certified Local Government Evaluation of National Register eligibility of the Beatty Cramer House

Address: 9010 Liberty Road, Frederick

Historic name: Beatty-Cramer House

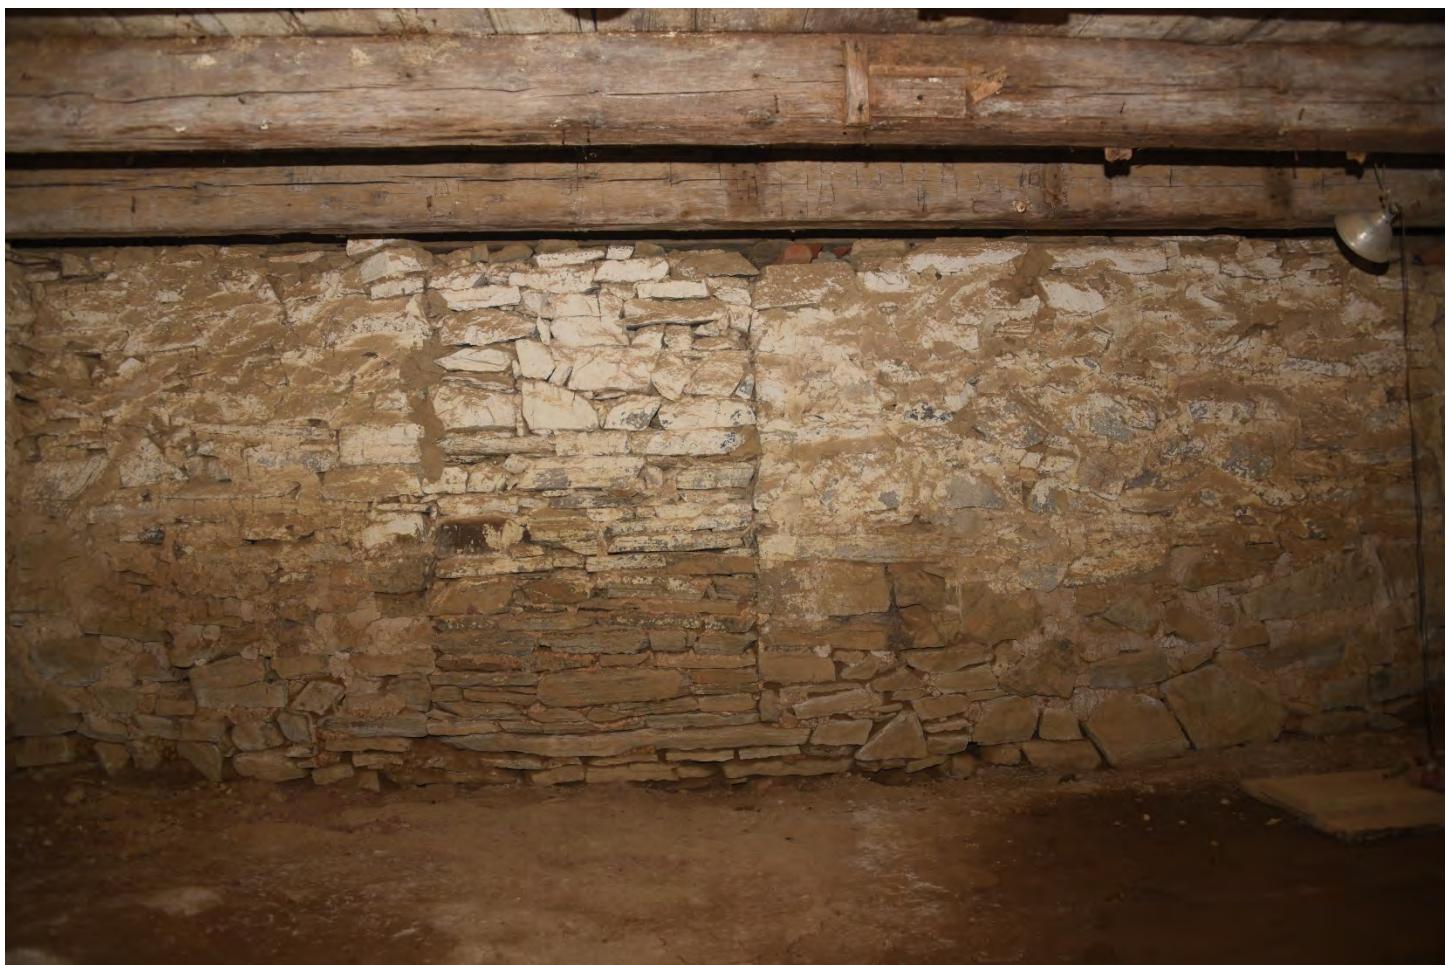
MD_FrederickCounty_Beatty-Kramer_0035.tif
East basement, west wall.

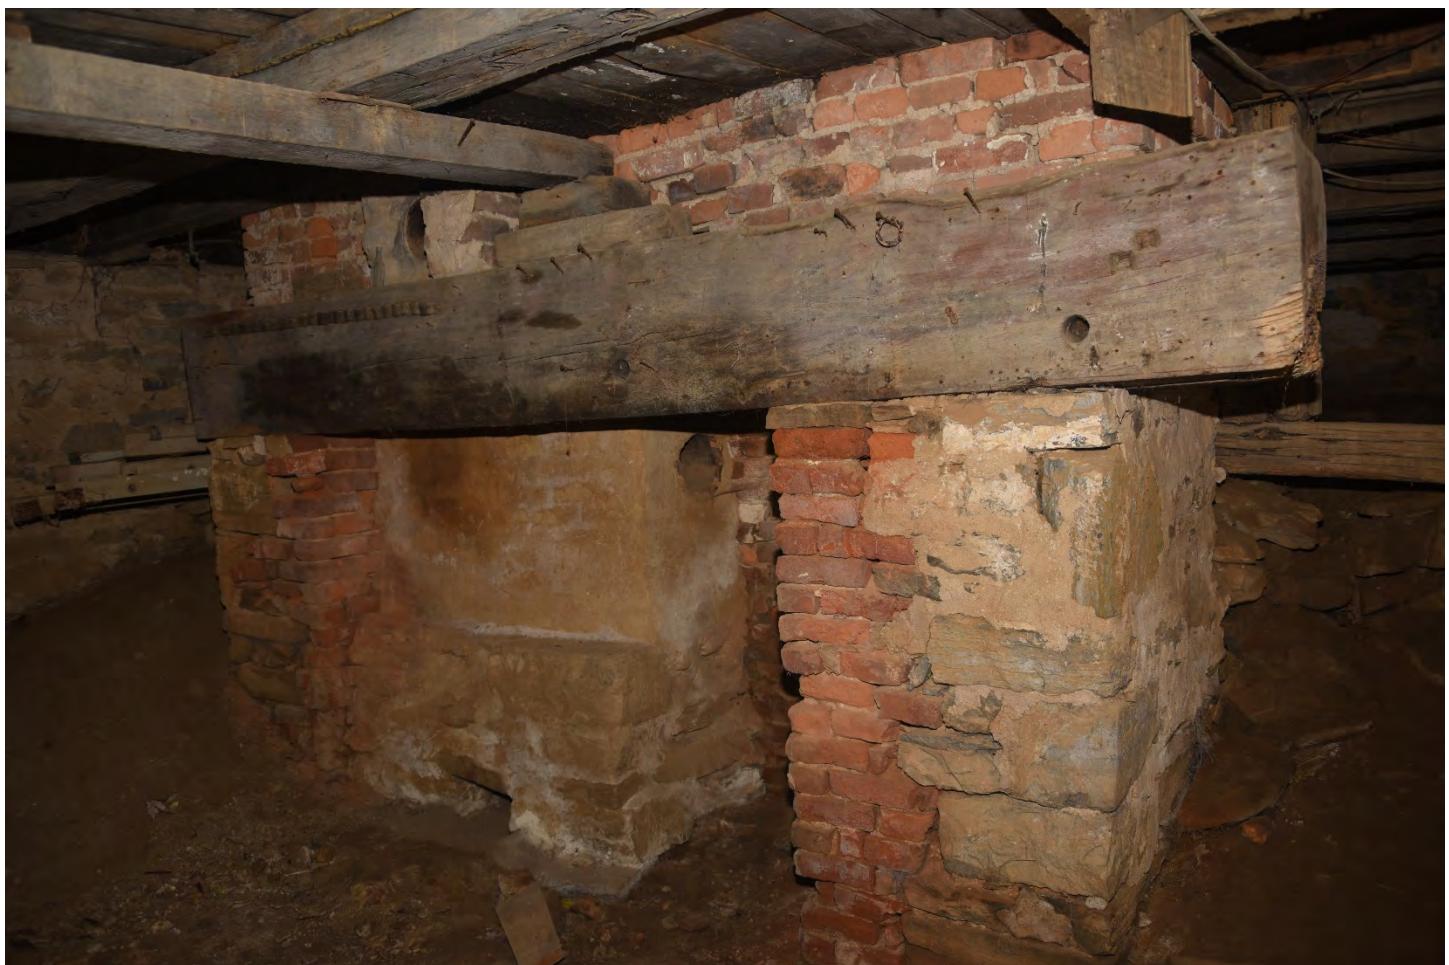
MD_FrederickCounty_Beatty-Kramer_0036.tif
West basement, fireplace on east.

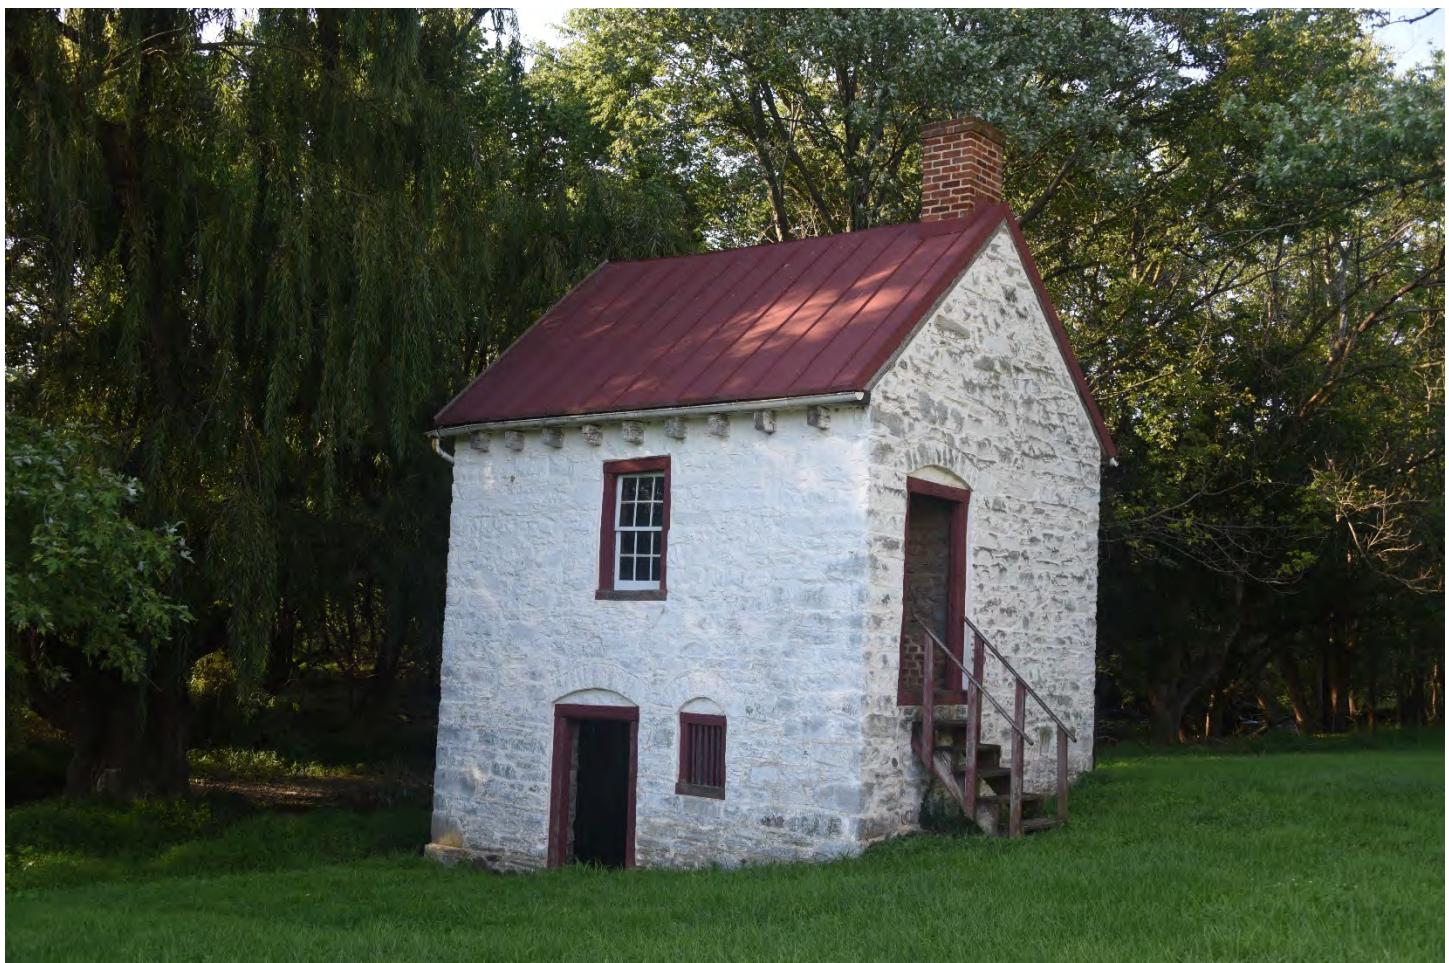
MD_FrederickCounty_Beatty-Kramer_0037.tif
Springhouse, south and east elevations.

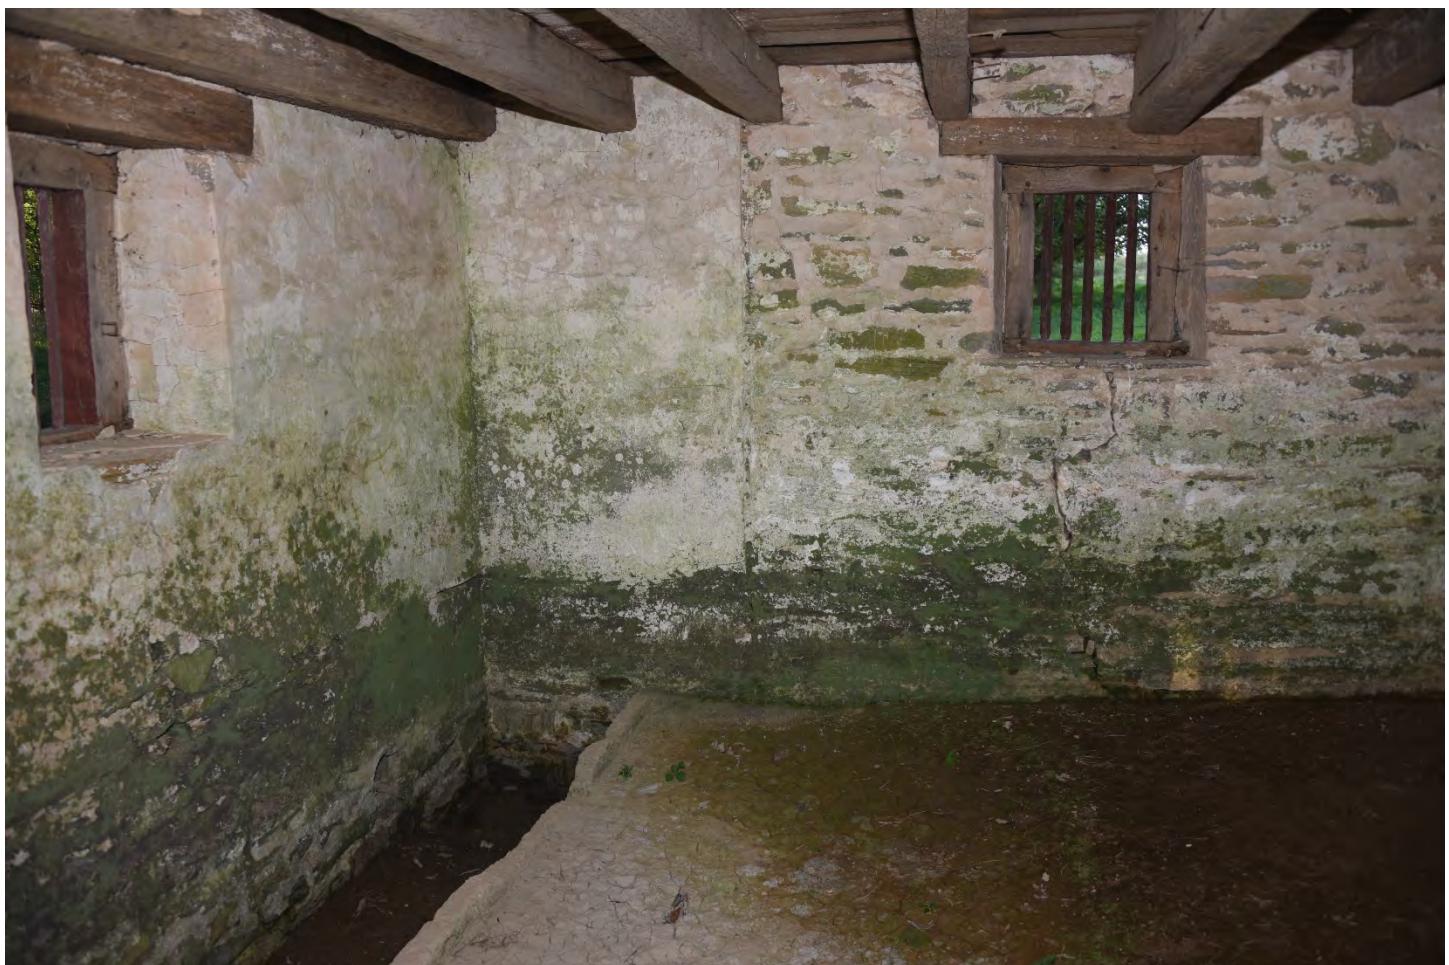
MD_FrederickCounty_Beatty-Kramer_0038.tif
Springhouse, lower story, view northwest.

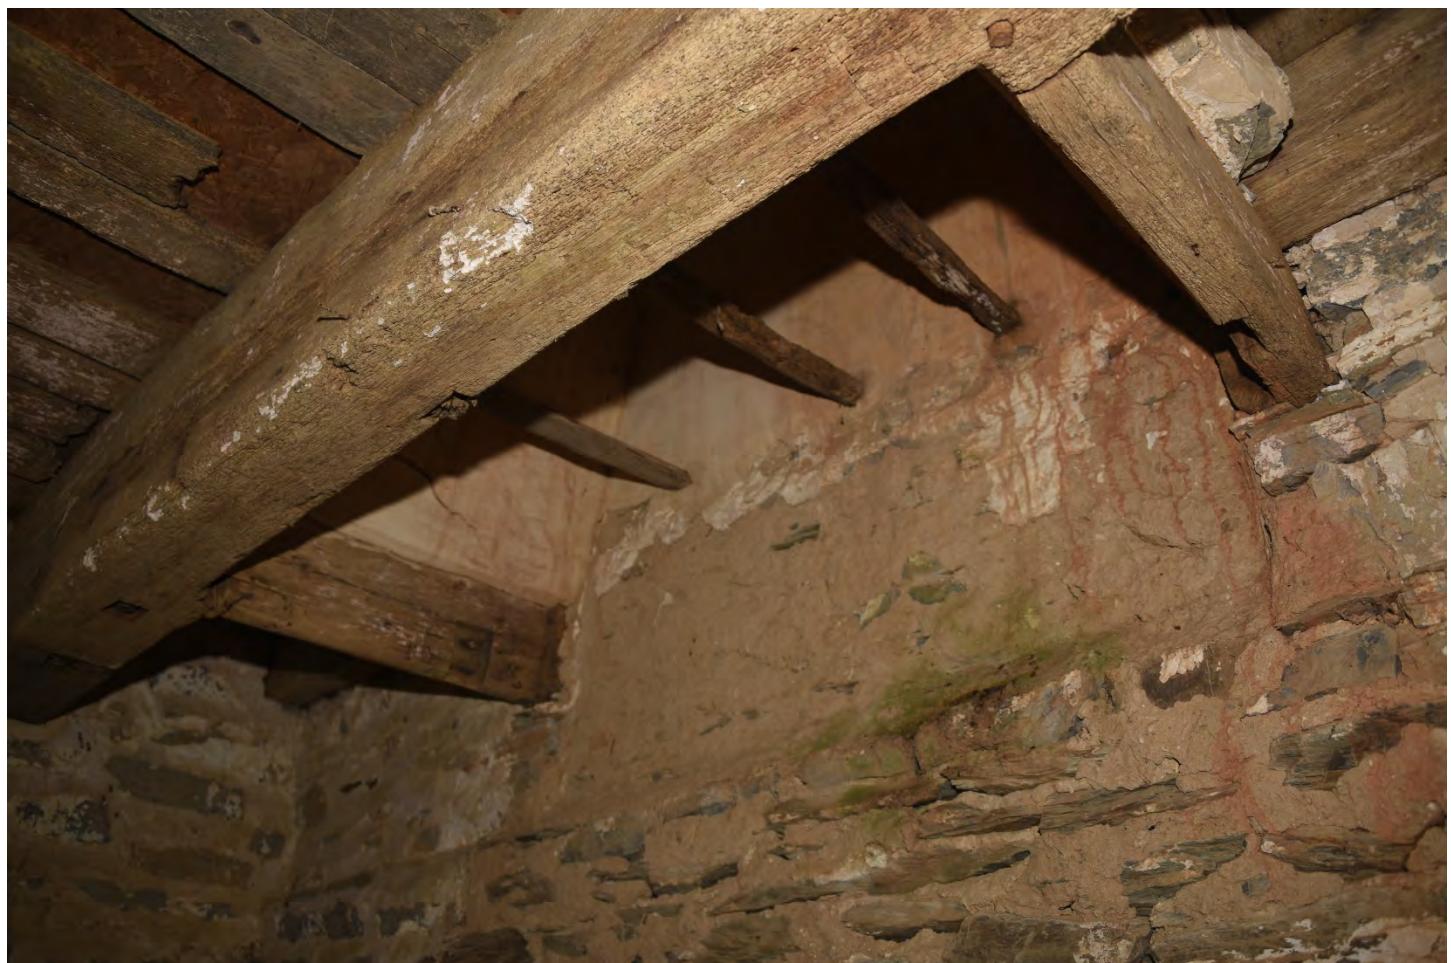
MD_FrederickCounty_Beatty-Kramer_0039.tif
Springhouse, lower story, fireplace hood on east.

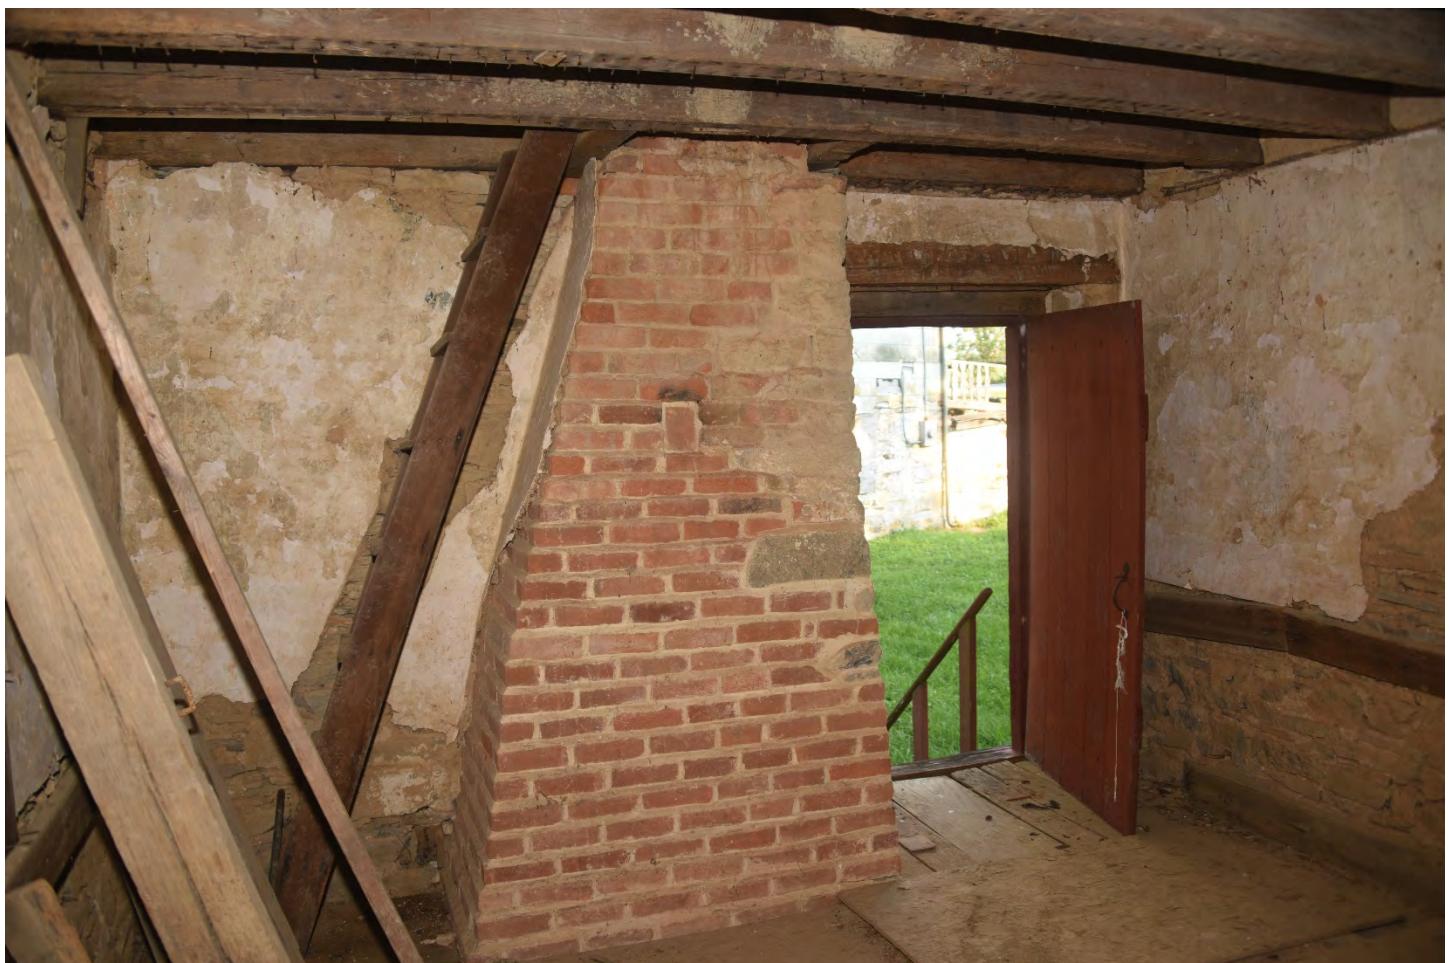
MD_FrederickCounty_Beatty-Kramer_0040.tif
Springhouse, upper story, view southeast.

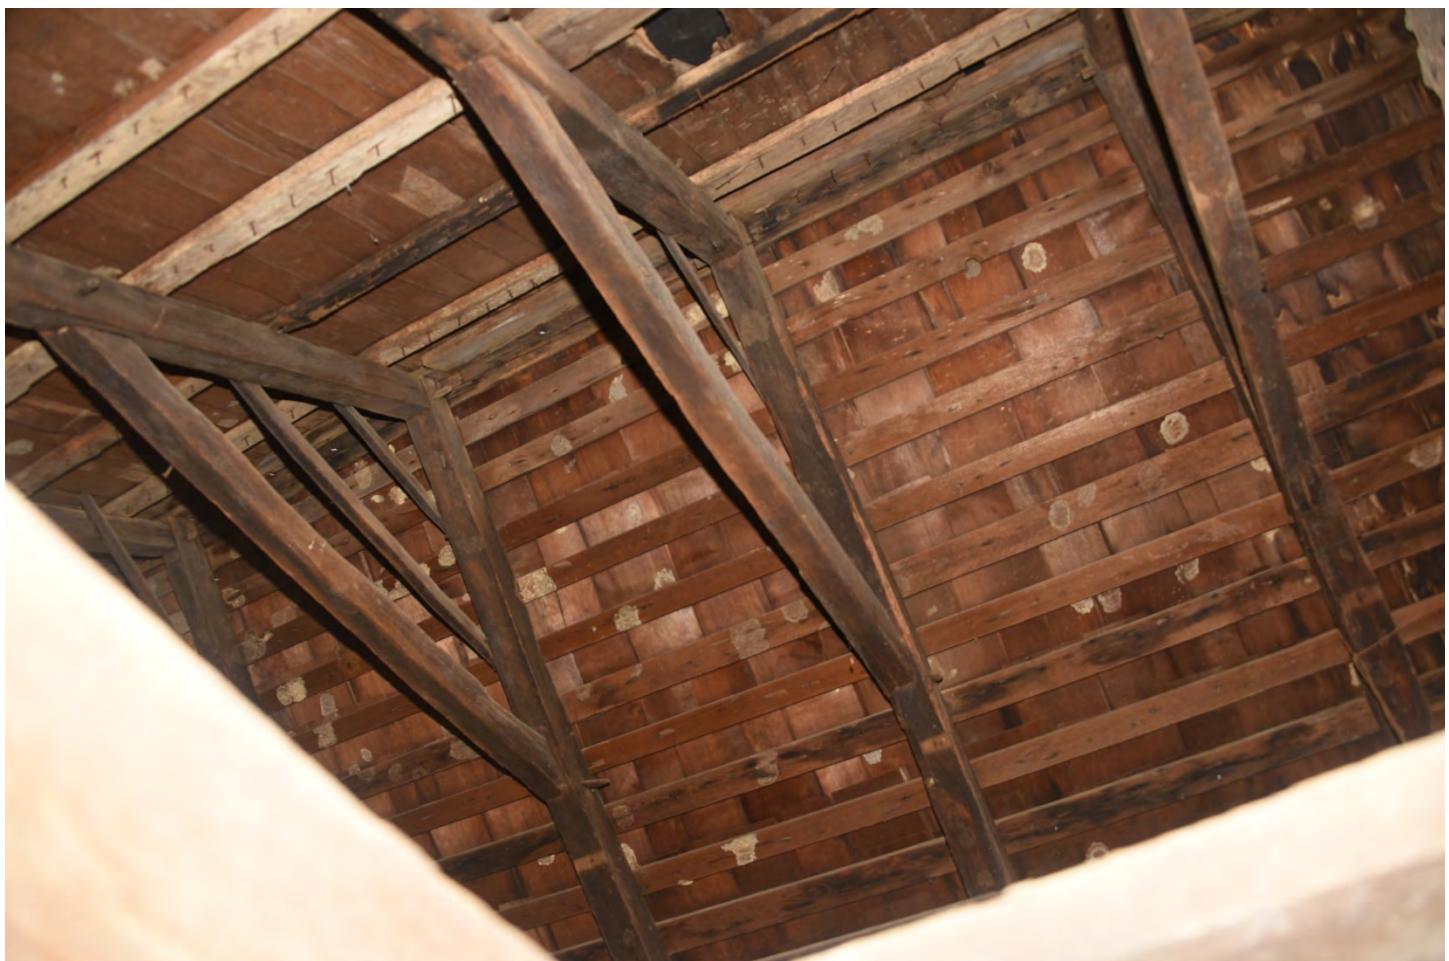
MD_FrederickCounty_Beatty-Kramer_0041.tif
Springhouse, roof frame.

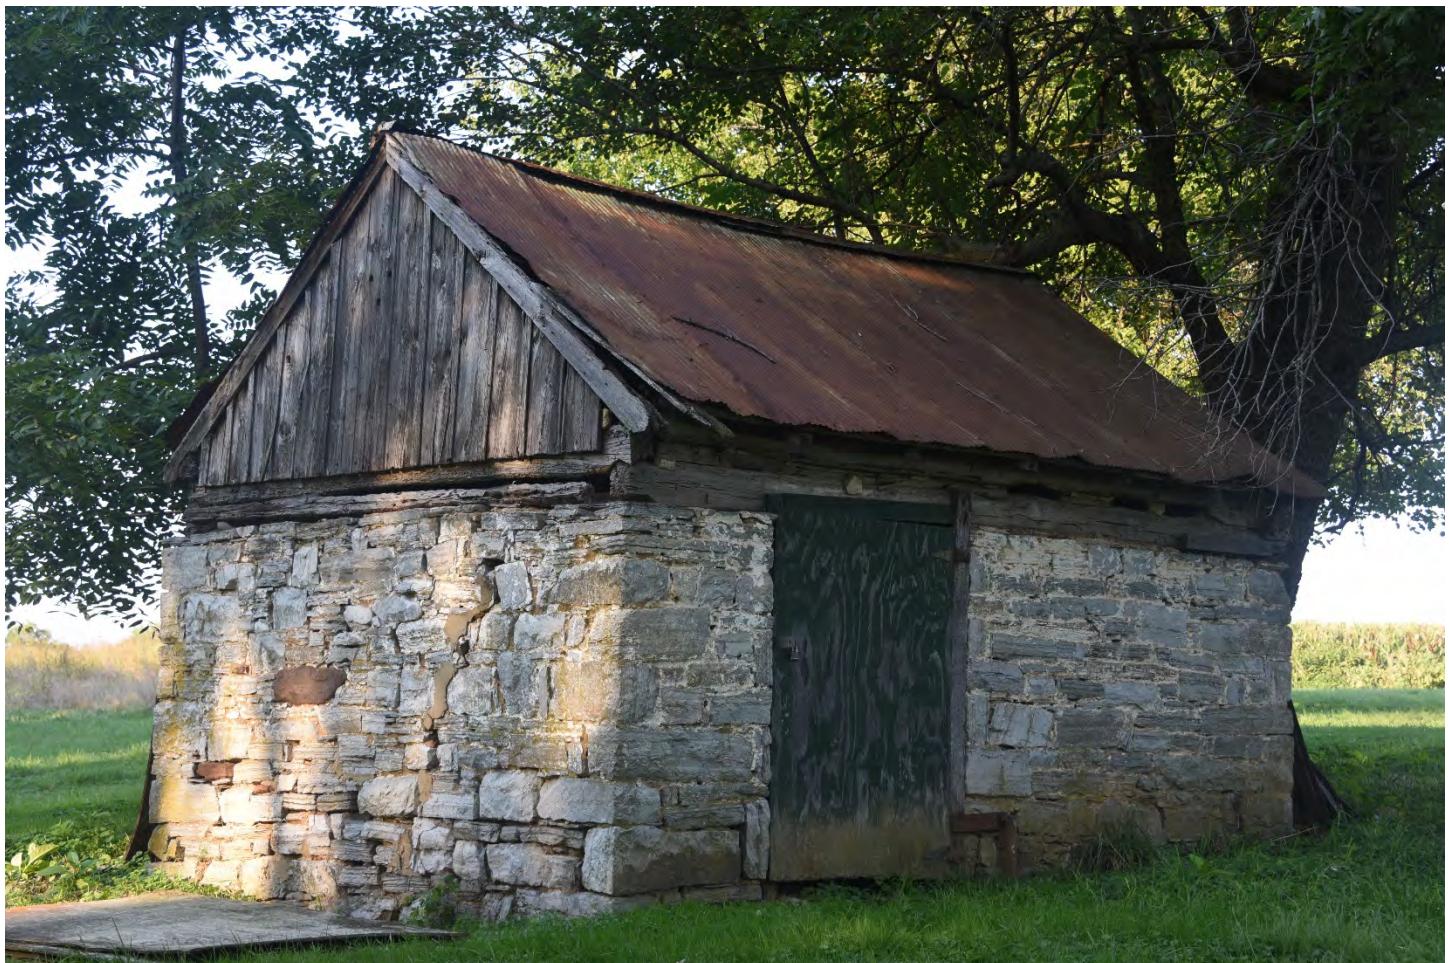
MD_FrederickCounty_Beatty-Kramer_0042.tif
Smokehouse, west and south elevations.

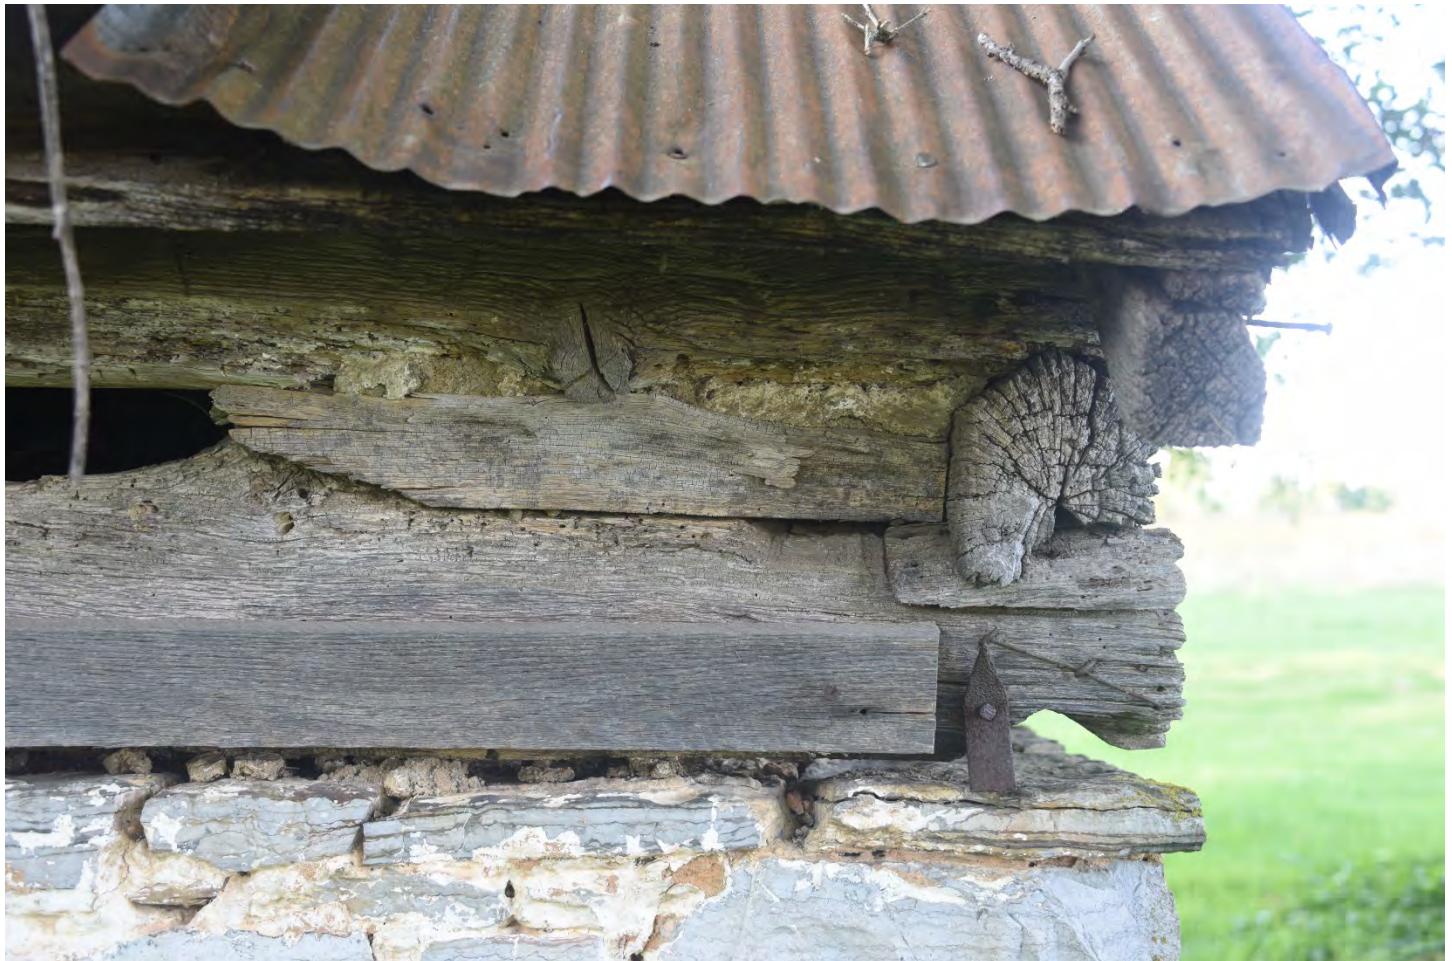
MD_FrederickCounty_Beatty-Kramer_0043.tif
Smokehouse, south elevation, east corner of original log structure.

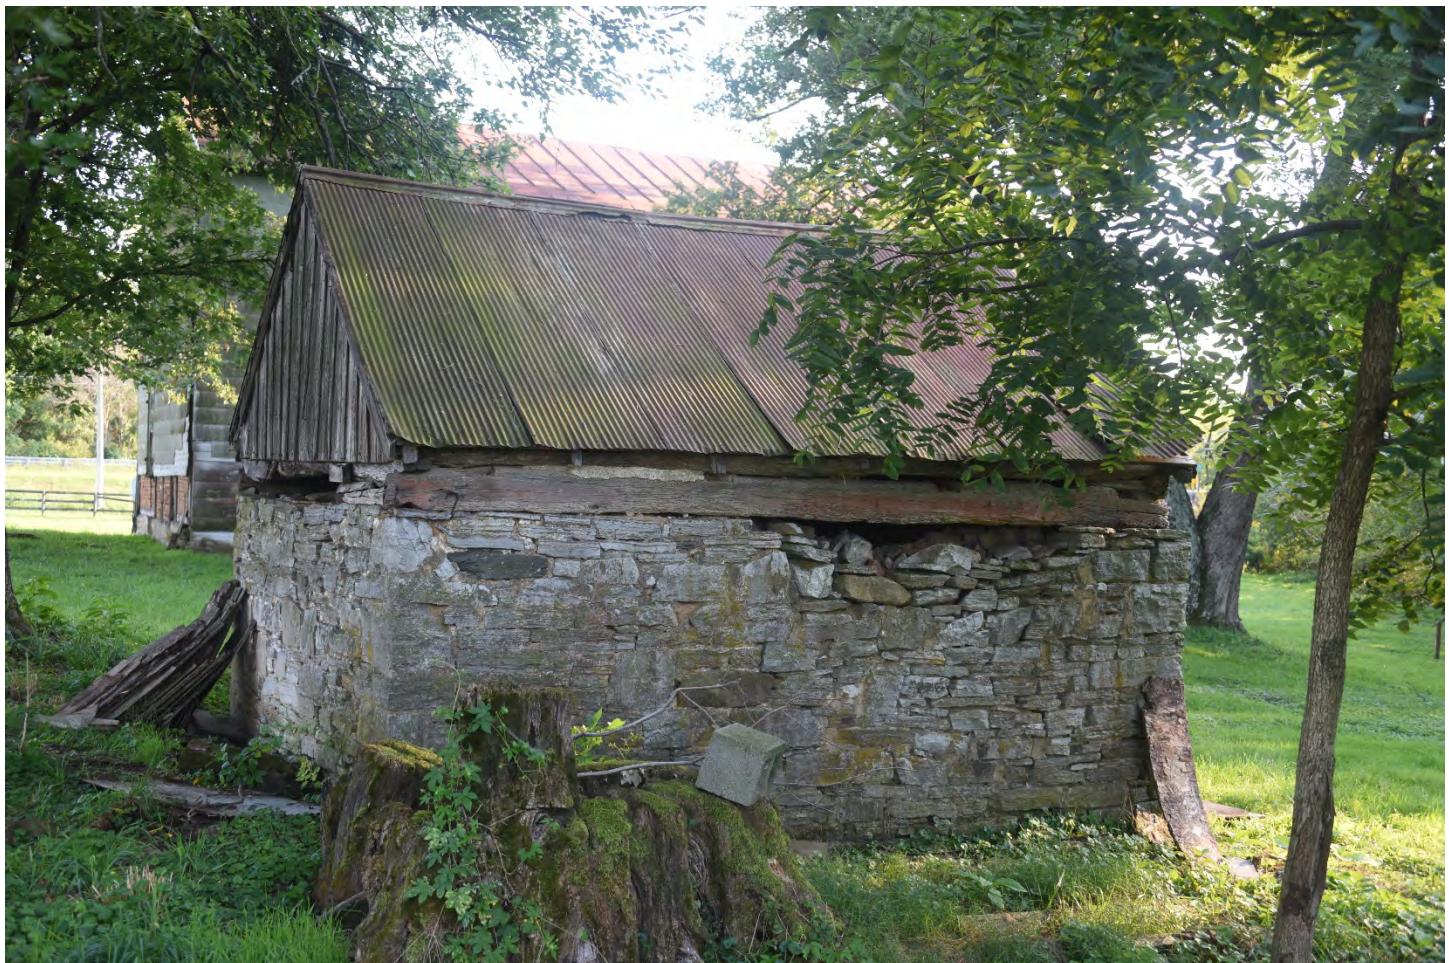
MD_FrederickCounty_Beatty-Kramer_0044.tif
Smokehouse, east and north elevations.

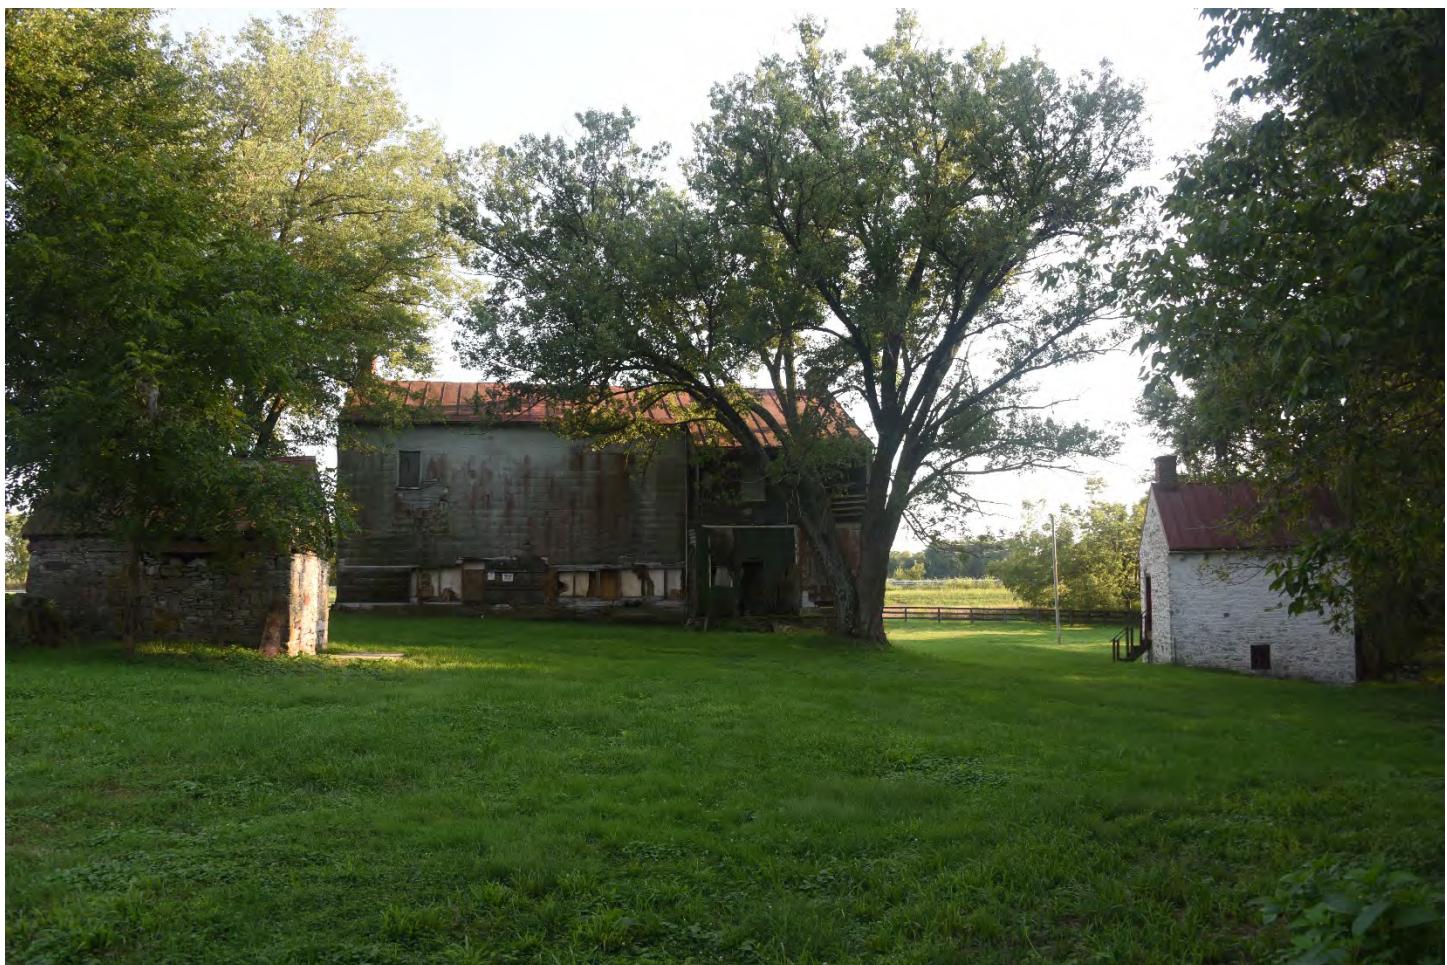
MD_FrederickCounty_Beatty-Kramer_0045.tif
Smokehouse, house, and springhouse, view from north.
