Source Water Assessment for the Bradford Estates Water System Frederick County, Maryland

Prepared By
Maryland Department of the Environment
Water Management Administration
Water Supply Program
December 2002

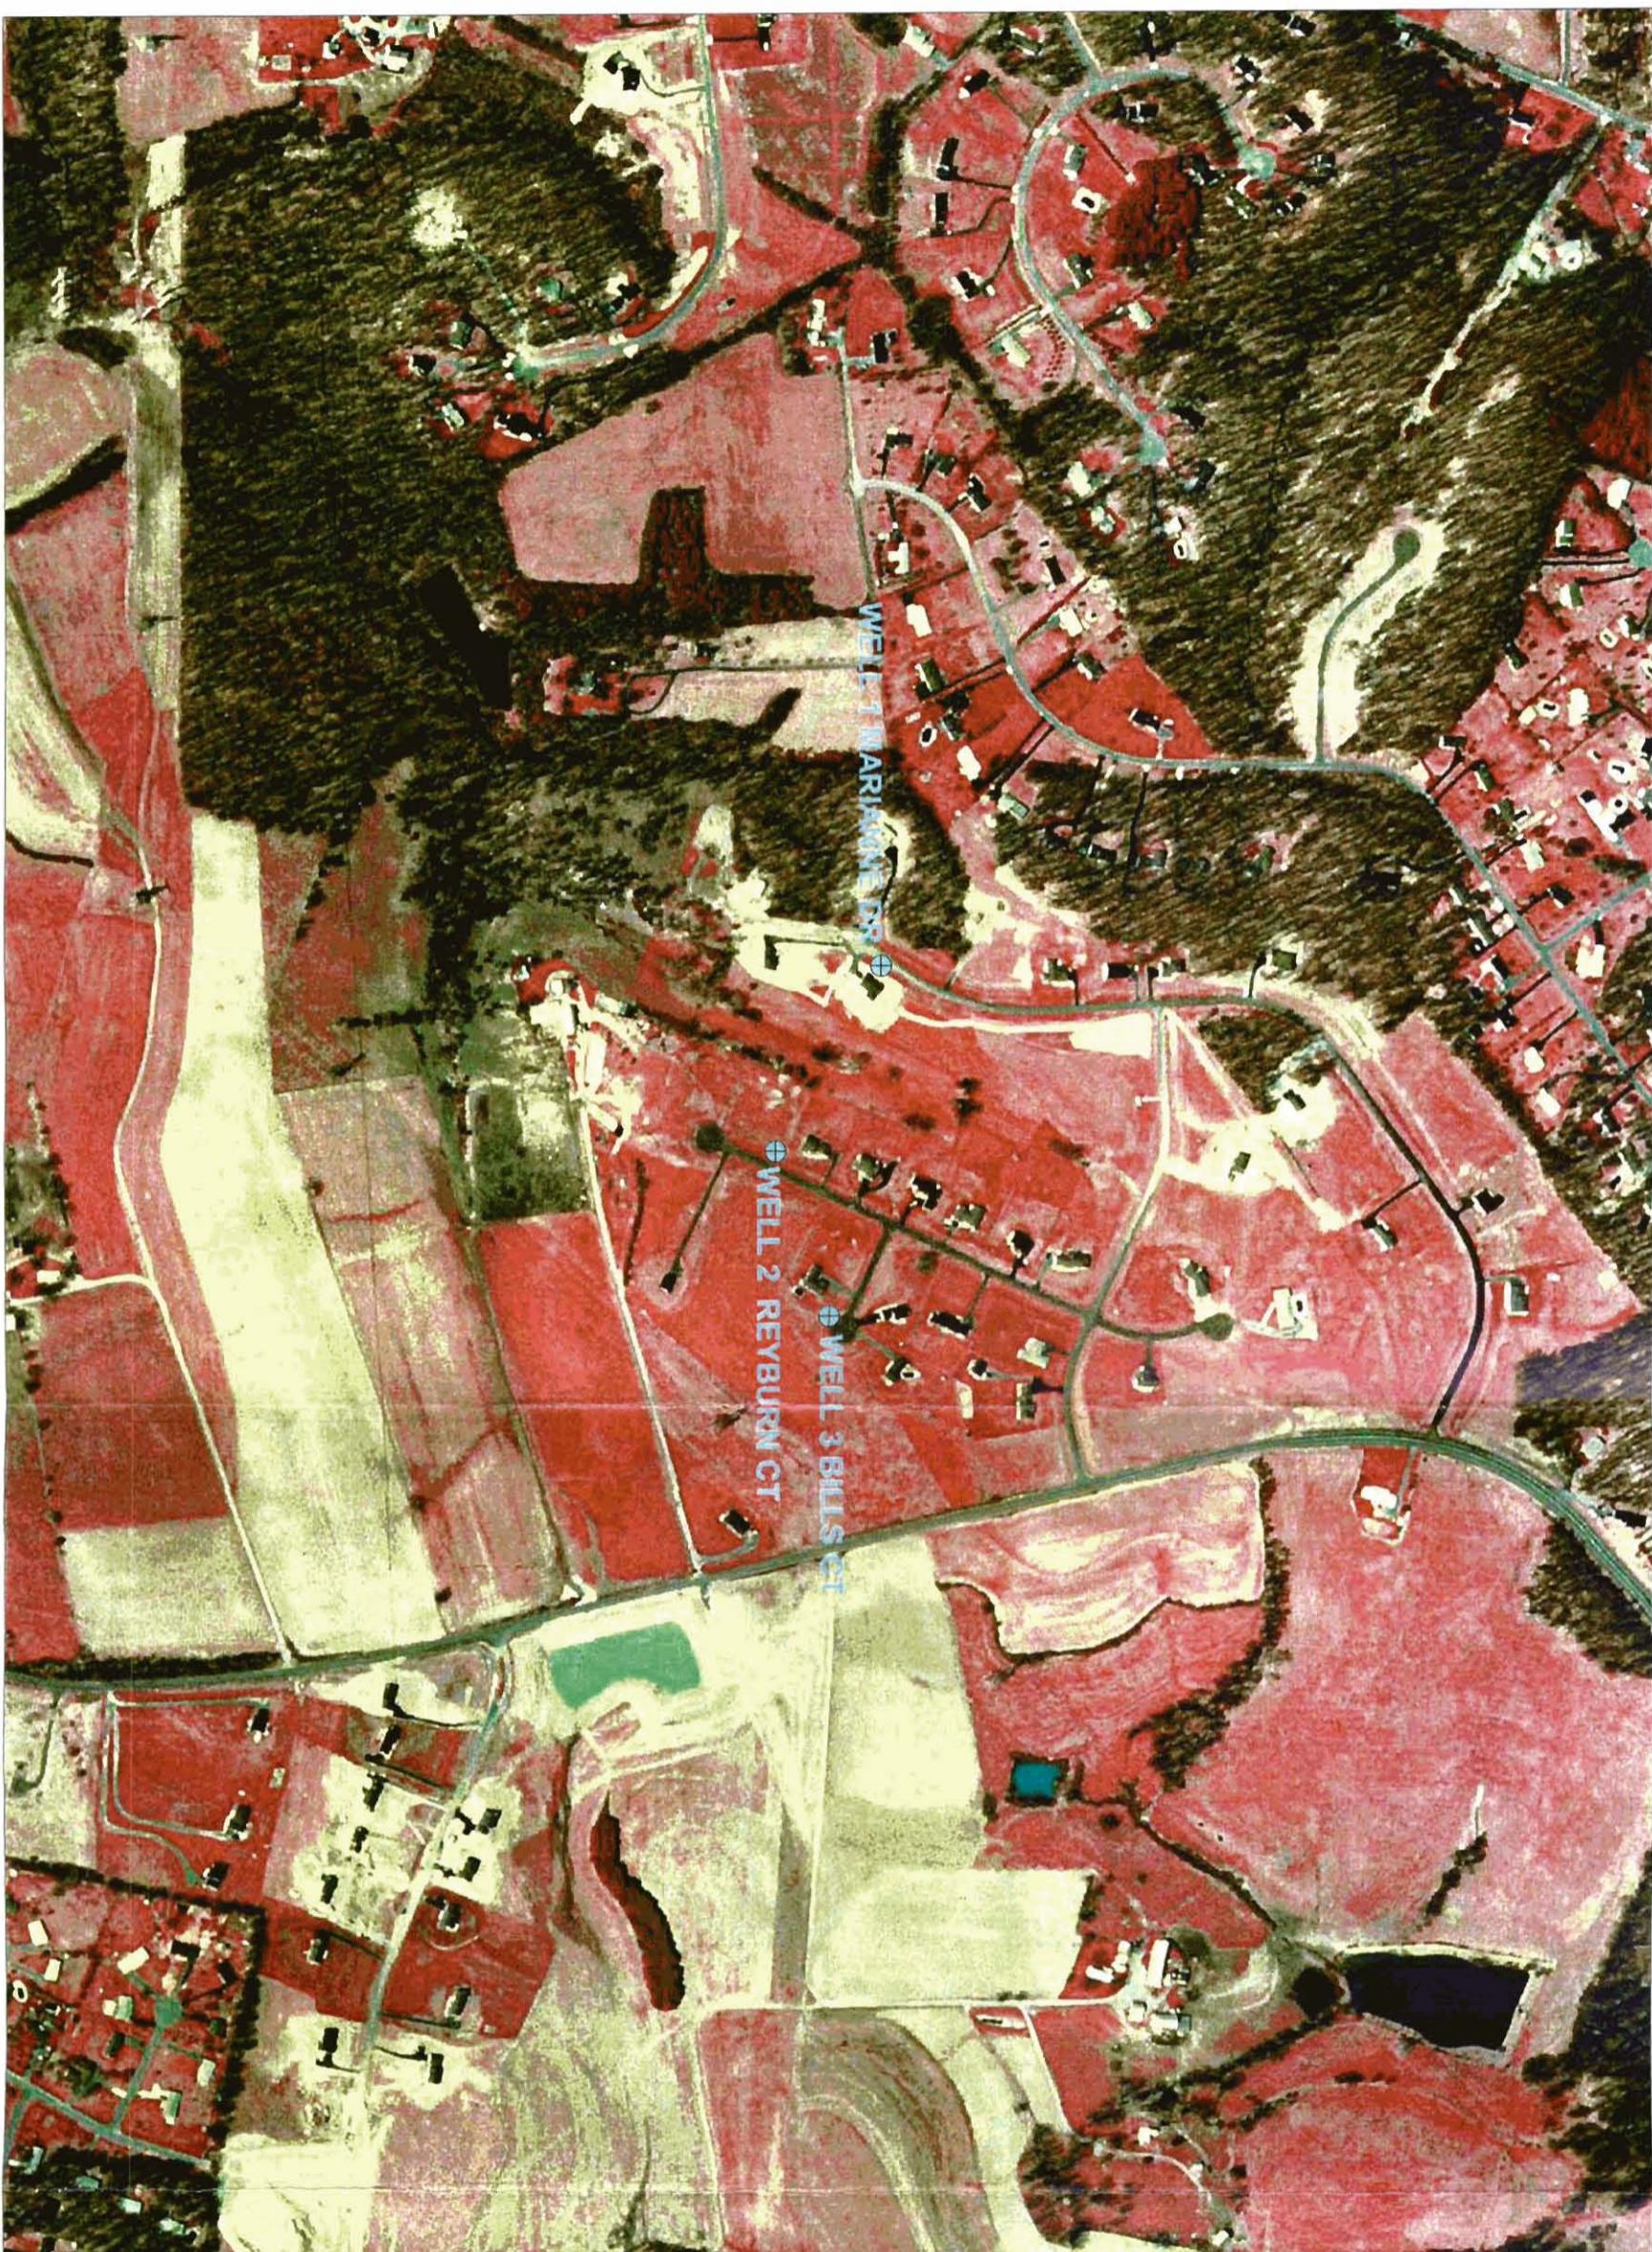
Figure 1.
Bradford Estates
Water Sources

Base Photo: DNR DOQQ
Damascus NW 4/8/93

Well information was obtained from the Water Supply Program's database, site visits, well completion reports, sanitary survey inspection reports, and published reports. The Bradford Estates system currently obtains its water supply from two of the three wells that are located adjacent to residential properties within the community (Fig. 1). The third well (Well 1) is not currently connected to the system, but it may be used in the future if feasible and is therefore included in this report. A review of the well completion reports and sanitary surveys of Bradford Estates' water system indicates the wells were drilled after 1973 and should meet construction standards for grouting and casing. A summary of the well information is located in Table 1.
