## **Appendix C: Concept Designs**

Brown and Caldwell

Project: Potomac Direct Watershed Assessment

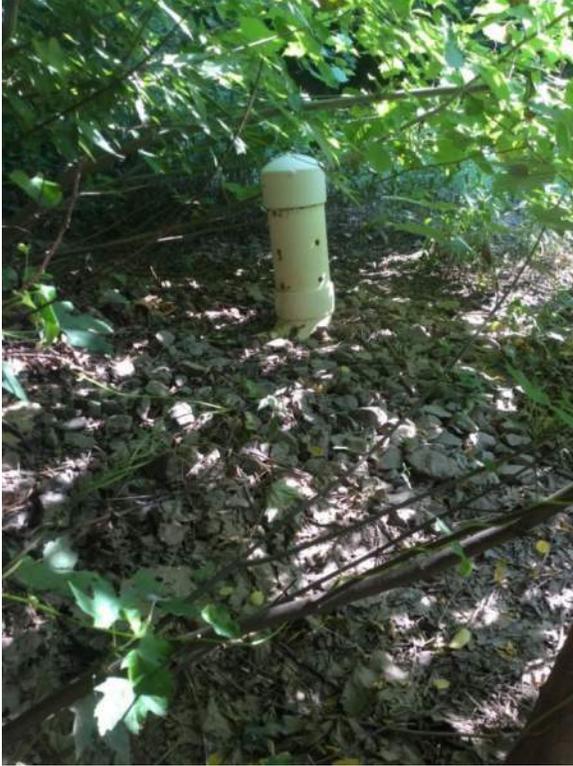
**Photo 1: View of low flow control structure.**

The concept retrofit plan proposes to provide permanent storage by excavating two feet below the existing BMP bottom elevation and removing the existing weir wall to be replaced with a concrete riser with an inverted low flow pipe. The facility was designed with the intent of limiting thermal impacts to a downstream III-P stream, however the stream was recently re-designated as I-P. With the new stream designation, modification of the existing weir structure may be a more appropriate means of creating a permanent pool. While the facility is already in a forested area; additional tree plantings may be added to further reduce thermal impacts.

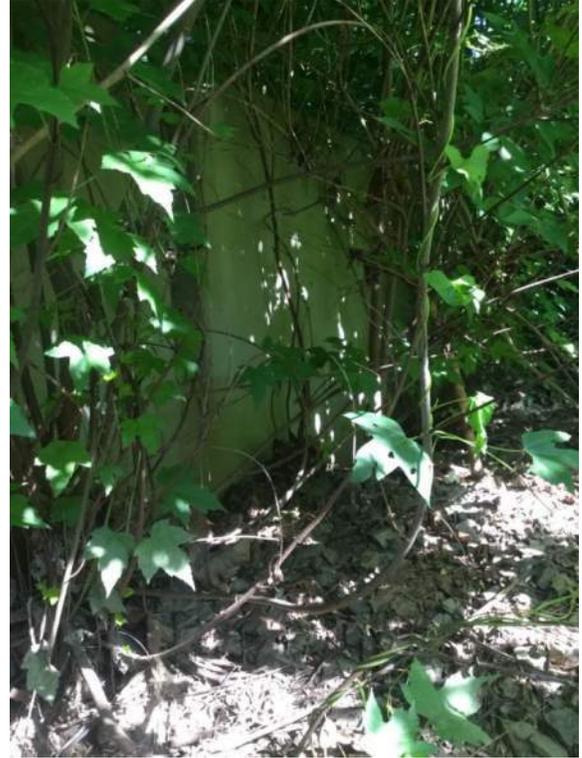
**Photo 2: View of facility's weir wall.**

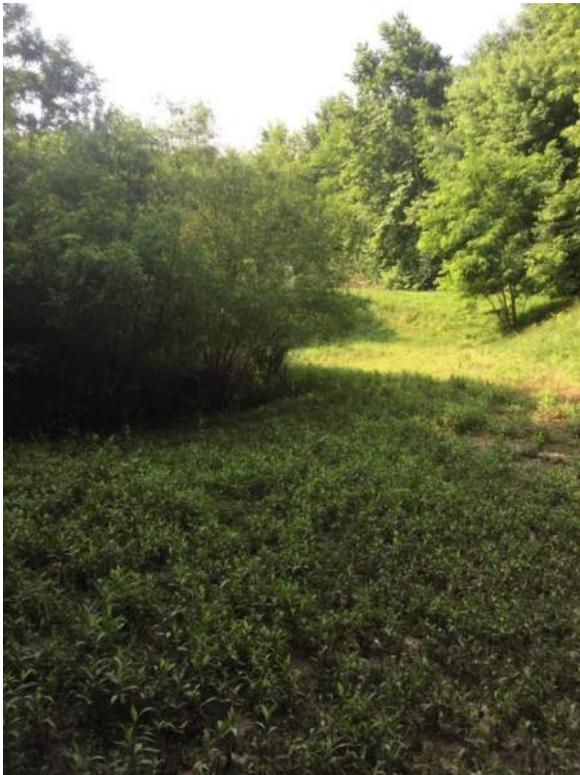
**Photo 3: Overall view of facility looking south.**

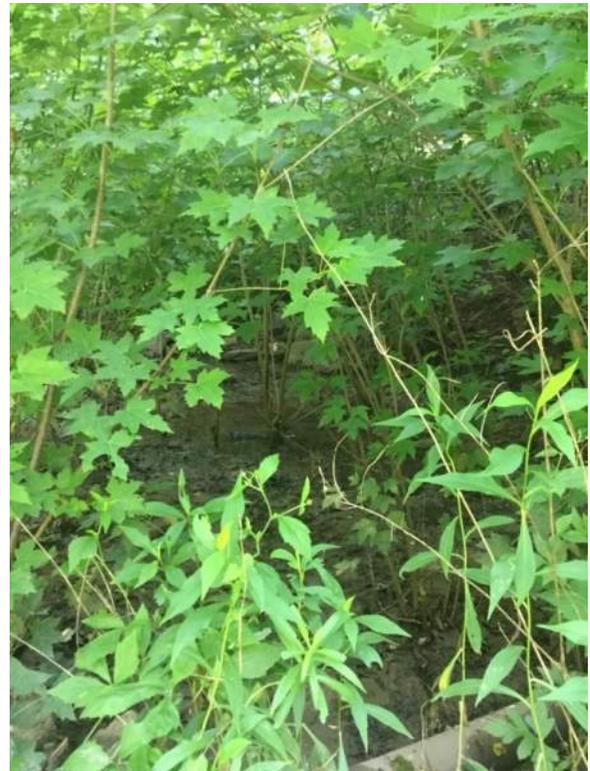
The facility has one inflow point and a large amount of ponding, erosion, and overgrown vegetation. The as-builts provided by Frederick County shows an existing 24” CMP. The condition of the inflow could not be determined. All other flow is received via sheet flow from the surrounding areas.

**Photo 4: View of ponding in inflow area.**

Overall, the facility appears to be in good condition, but does not meet criteria for water quality treatment and is a candidate for retrofit. Maintenance may be warranted as the inflow is experiencing some erosion and the spillway condition could not be assessed due to the density of vegetation.

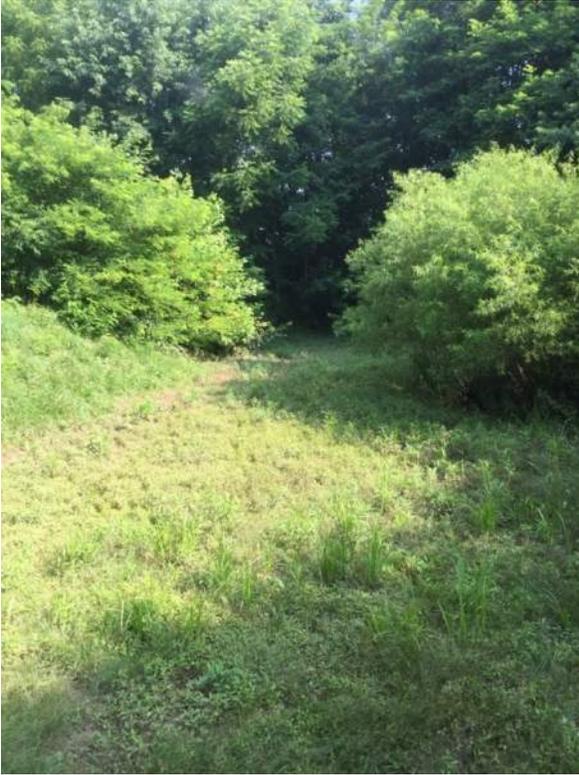
**Photo 5: Overall view of facility looking North**

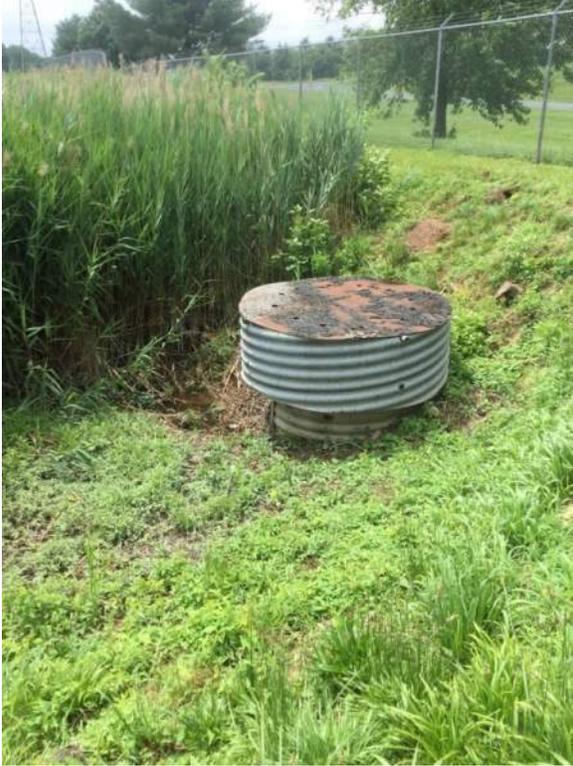
Overall, the facility appears to be in good condition, but does not receive treatment credit for water quality due to its use of a CMP riser. Flow could not be observed entering the facility during the site visit but was observed at the facility's outfall. The downstream channel was in moderate condition with small portions of erosion. No major problems were observed in the BMP but would make a candidate for retrofit.

**Photo 1: View of CMP Riser, looking southeast**

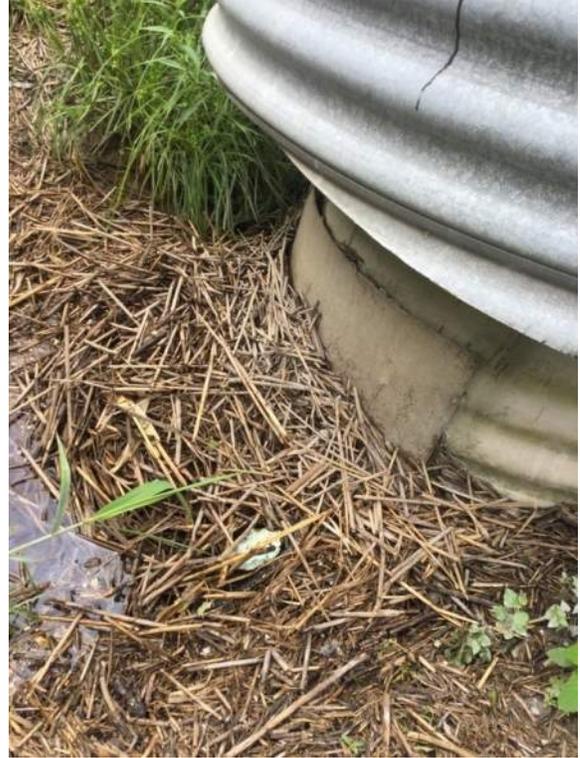
**Photo 2: Low flow orifice buried under vegetation**

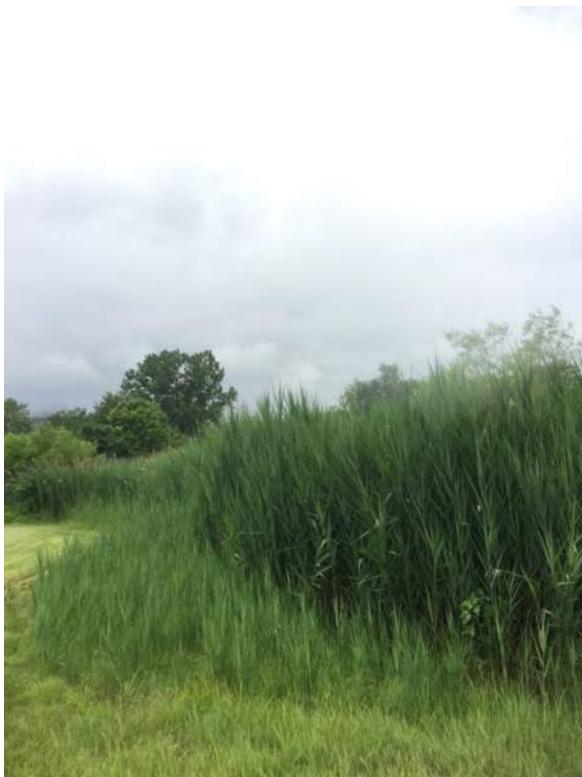
**Photo 3: Overall view of BMP, looking to the south**

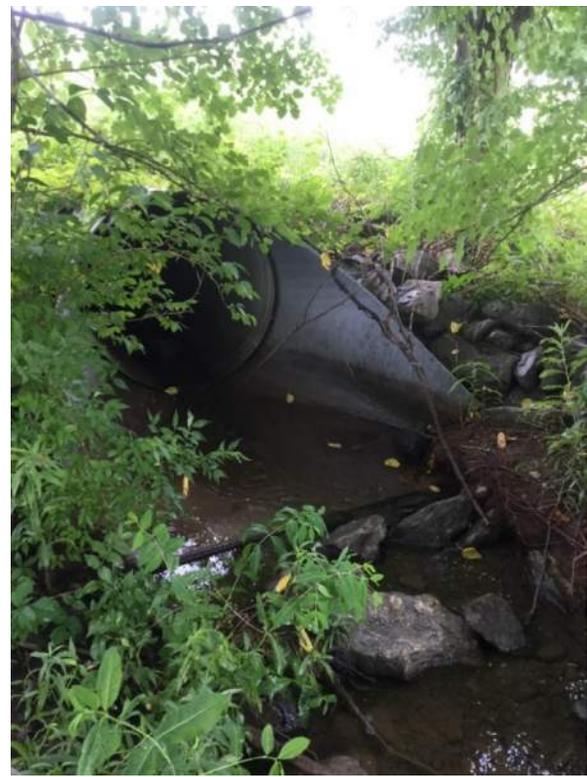
**Photo 4: Overall view of BMP, looking to the south of the facility**

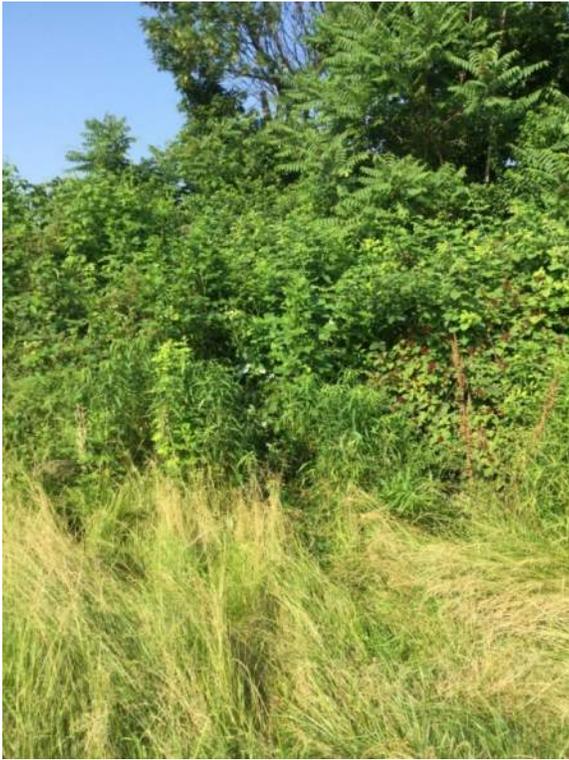
**Photo 1: View of outfall area looking southwest.**

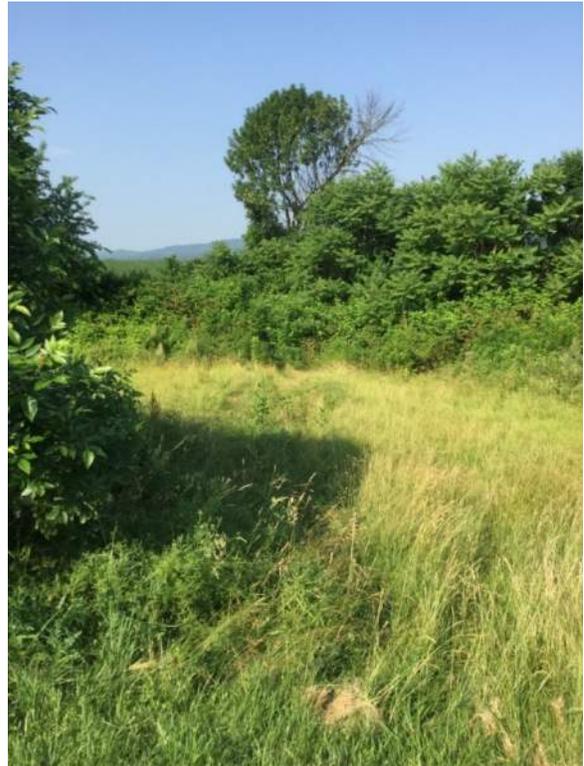
**Photo 2: Overall view of facility looking southwest.**

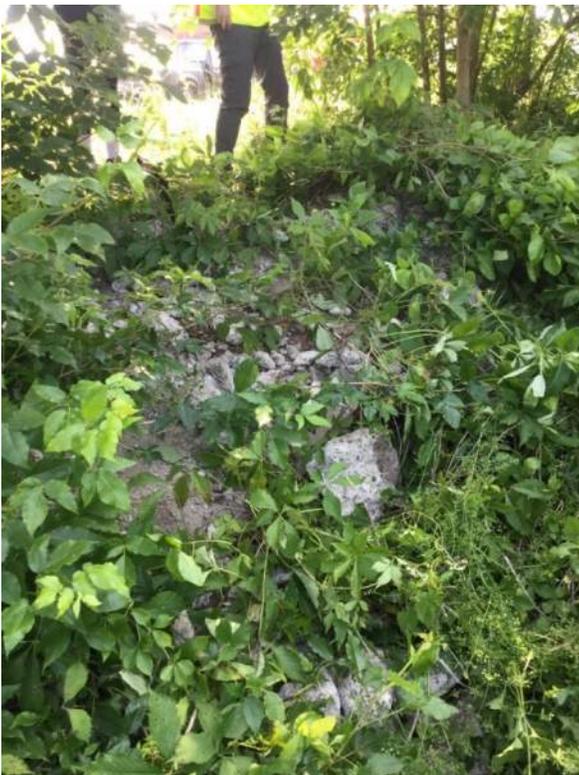
The inflow for this facility could not be located due to dense vegetation. The as-builts provided by Frederick County show an existing 15” RCP. The condition of the inflow could not be determined. All other flow is received via sheet flow from the surrounding areas.

**Photo 3: View of inflow channel looking northeast.**

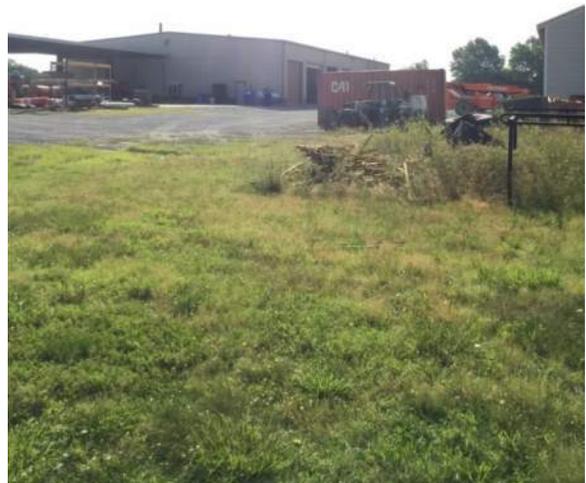
**Photo 4: View of drainage area looking northeast.**

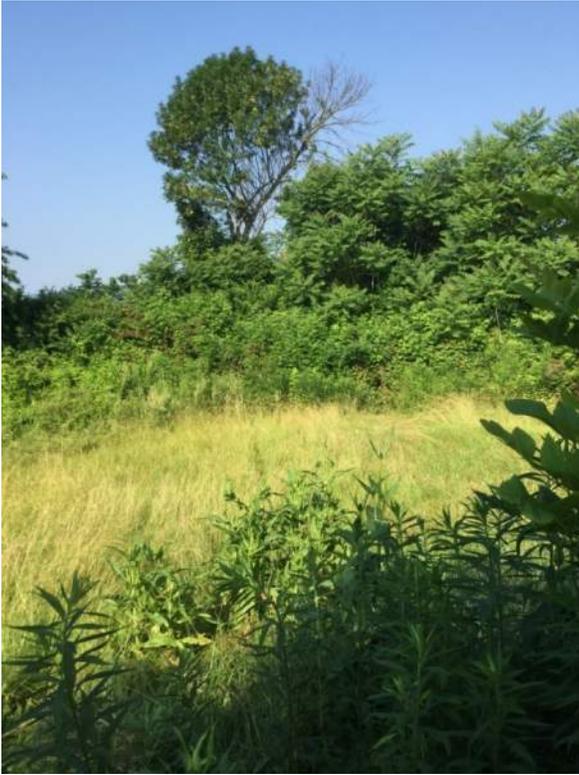
**Photo 5: Overall view of facility looking northwest.**

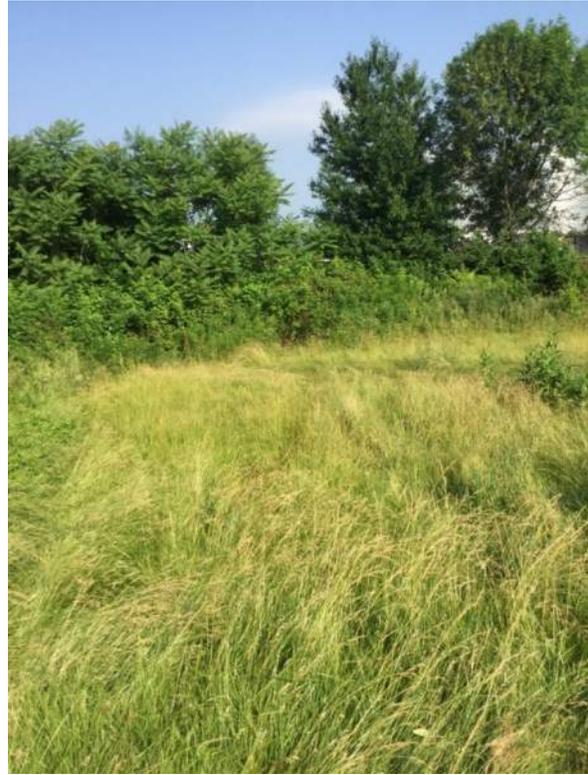
**Photo 6: Overall view of facility looking west.**

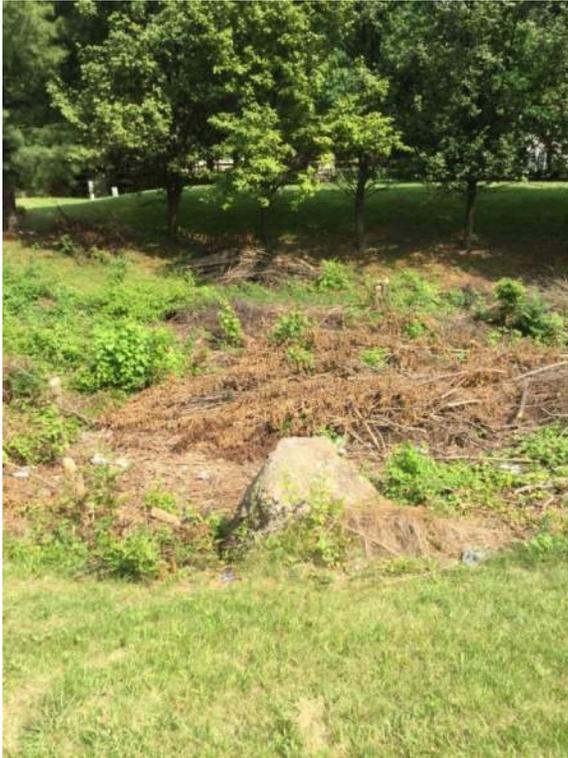
**Photo 1: Overall view of the facility looking North.**

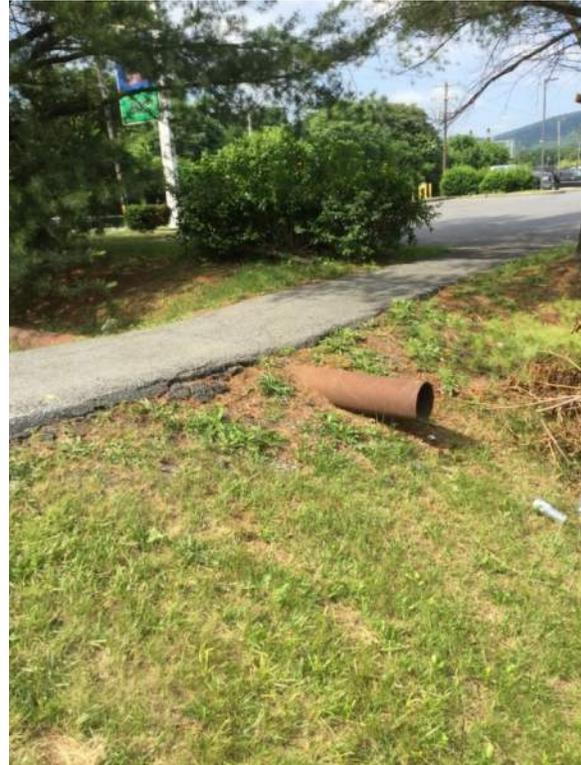
**Photo 2: View of unknown pipe inflow looking south.**

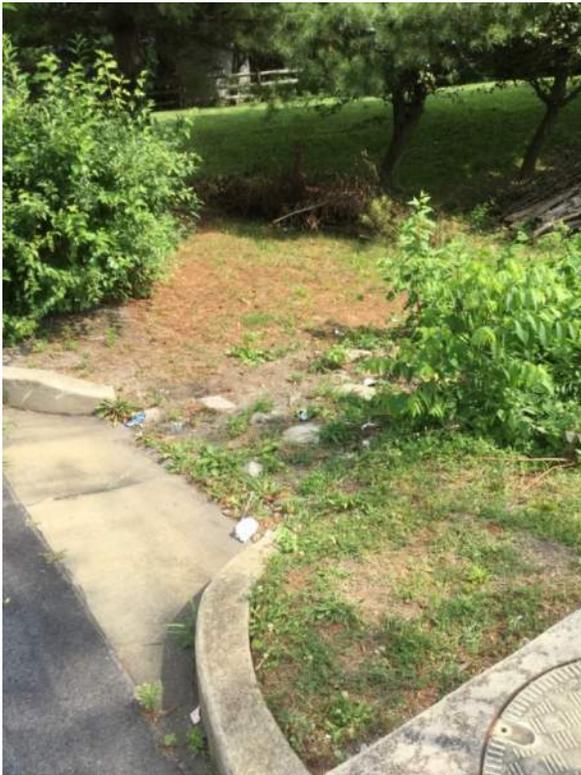
**Photo 3: View of inflow curb cut looking North.**

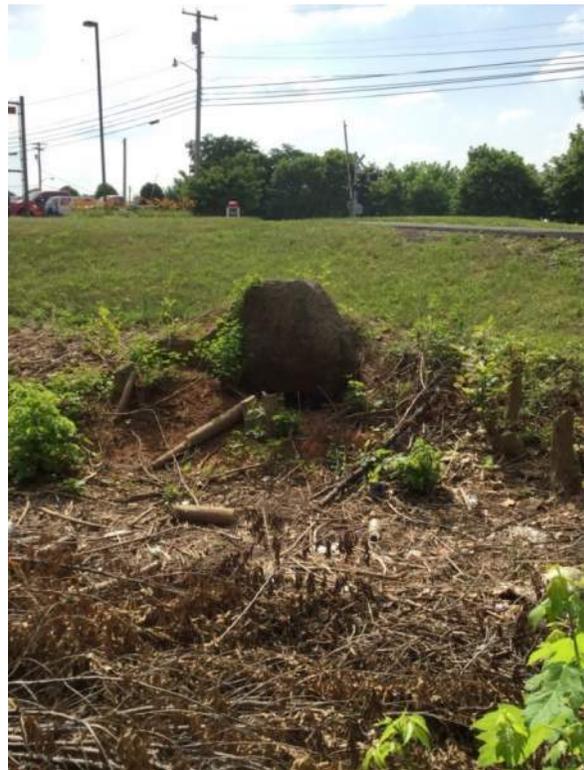
**Photo 4: Overall view of facility looking to the east.**

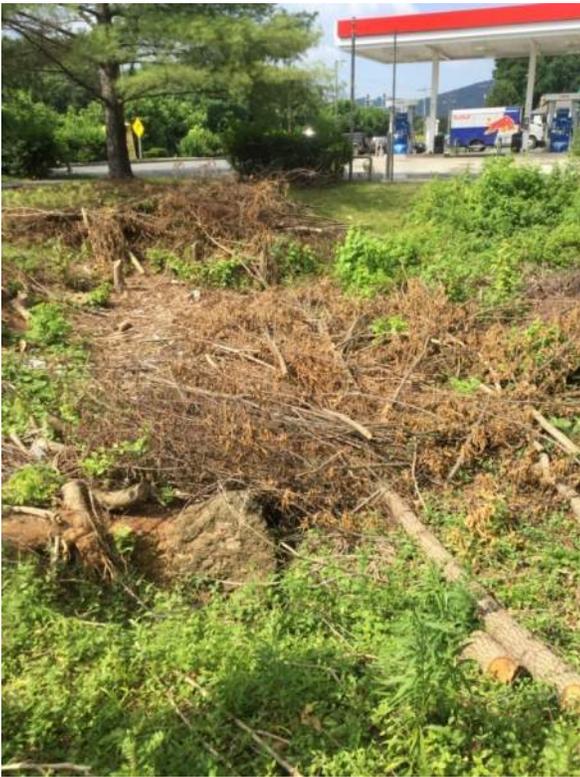
Overall, the facility appears to be in good condition, but does not meet criteria to treat for water quality as there are no current as-builts. The BMP is next to a gas station which could present hotspot concerns. Debris cleanout is needed in the curb cut inflow channel. The facility is a candidate for retrofit or may receive credit if current as-builts are created.

**Photo 5: Overall view of facility looking west.**

BMP # 103 was originally designed as an infiltration basin. This facility has been identified as an opportunity for a bioretention area. The proposed retrofit will provide both water quality treatment for the originally designed 1.1 acres, including 0.9 acres of impervious. The concept retrofit plan proposes to provide permanent storage by adding two feet of bioretention mix above the existing BMP bottom elevation. According to USDA soil survey information the BMP is on an area with well-draining A and B soils, therefore an underdrain and outfall configuration may not be necessary. Detailed soil studies will be necessary for final design.

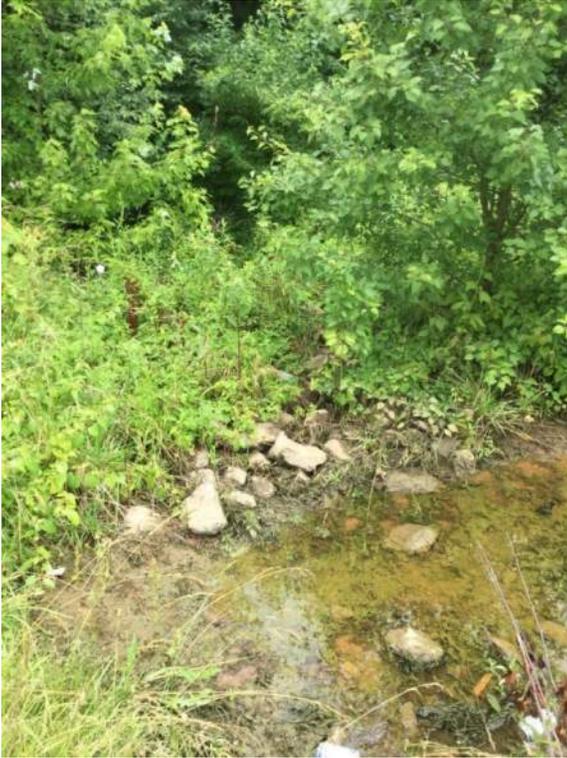
**Photo 1: View of inflow looking north.**

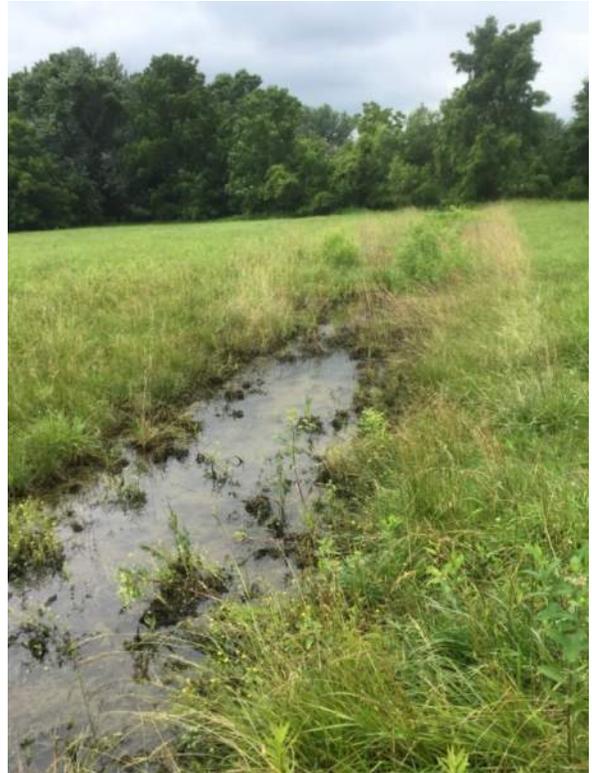
Overall, the facility appears to be in poor condition, with ill-defined topography, no distinguishable banks and poor drainage. The facility currently does not meet criteria for water quality and is a candidate for retrofit.

**Photo 2: Overall view of facility looking south.**

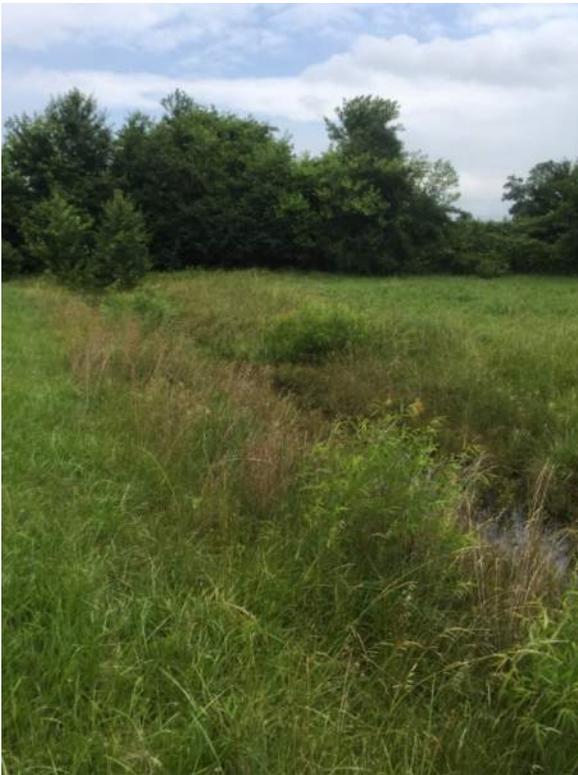
**Photo 3: Overall view of the facility looking northeast.**

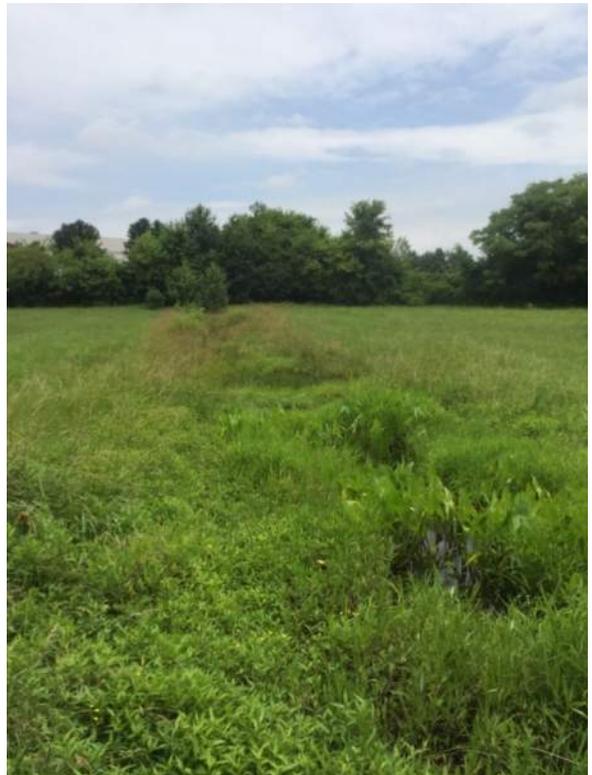
**Photo 4: View of the facility's outfall channel.**

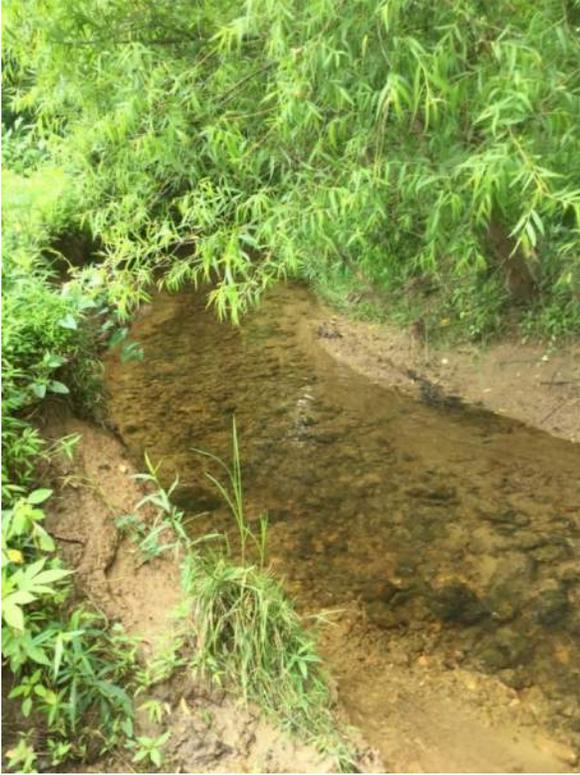
**Photo 5: View of downstream stream channel.**

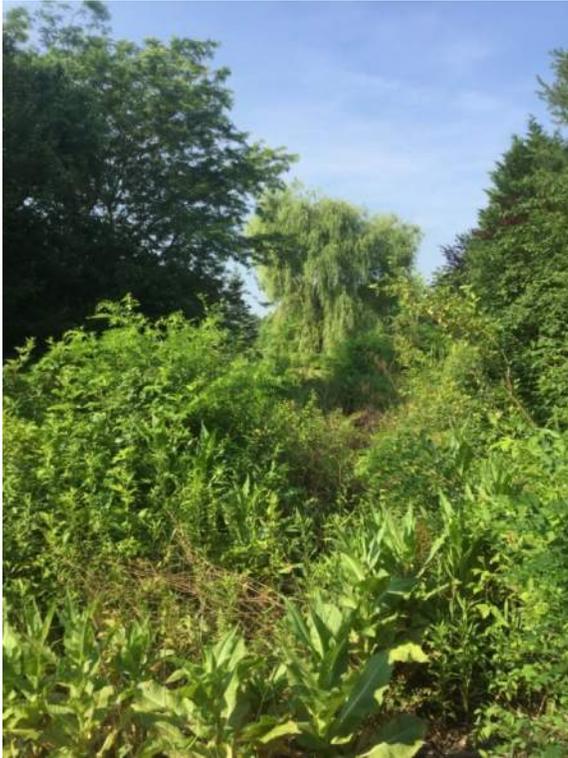
**Photo 1: View of inflow looking north.**

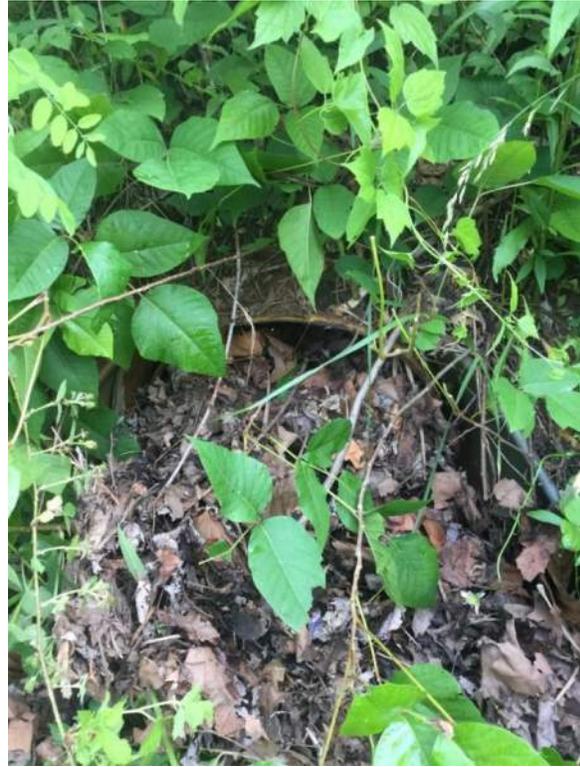
**Photo 2: View of CMP inflow.**

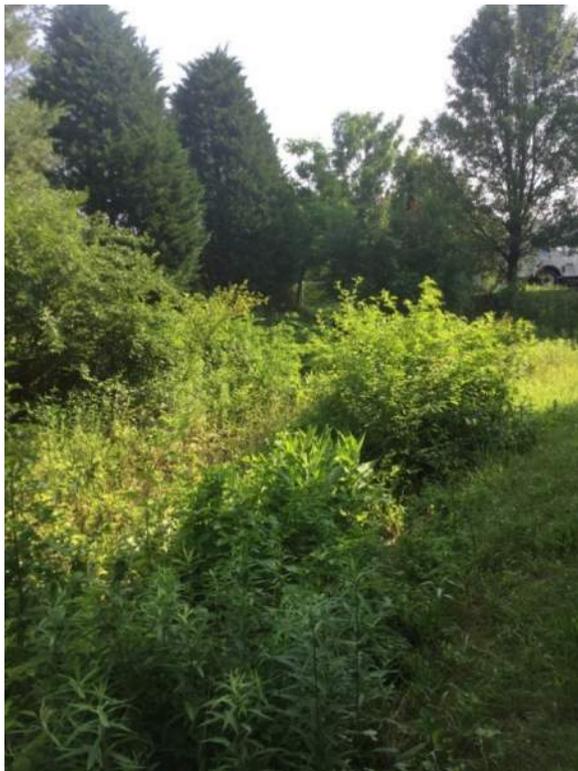
Overall, the facility appears to be in good condition, but does not meet the criteria to treat for water quality and is a candidate for retrofit.

**Photo 3: Overall view of facility looking north.**

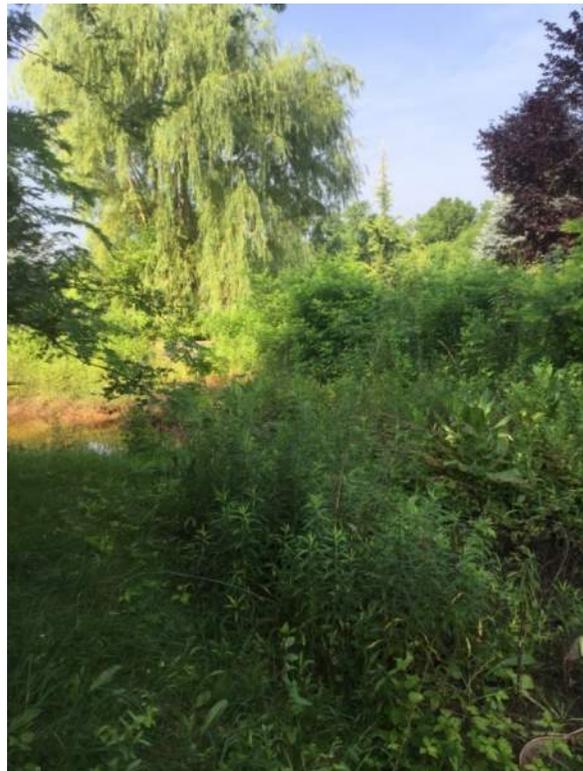
**Photo 4: Overall view of facility looking to the south.**

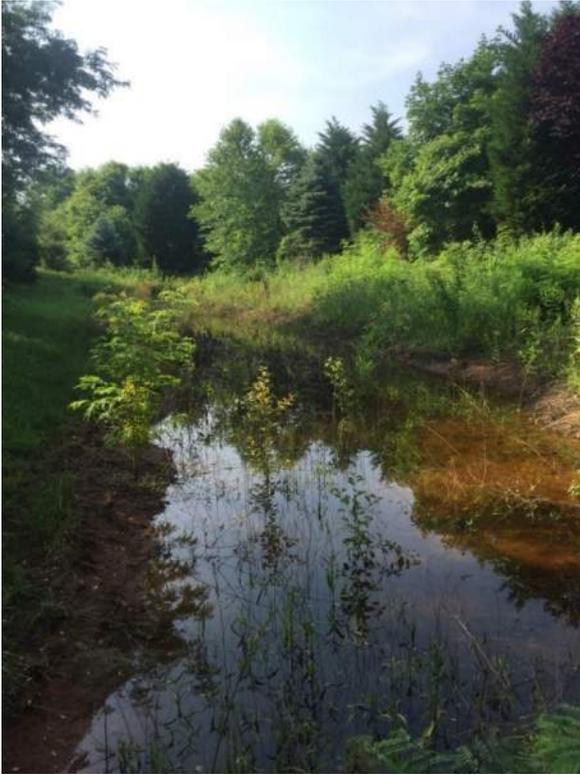
**Photo 5: Overall view of facility looking southeast.**

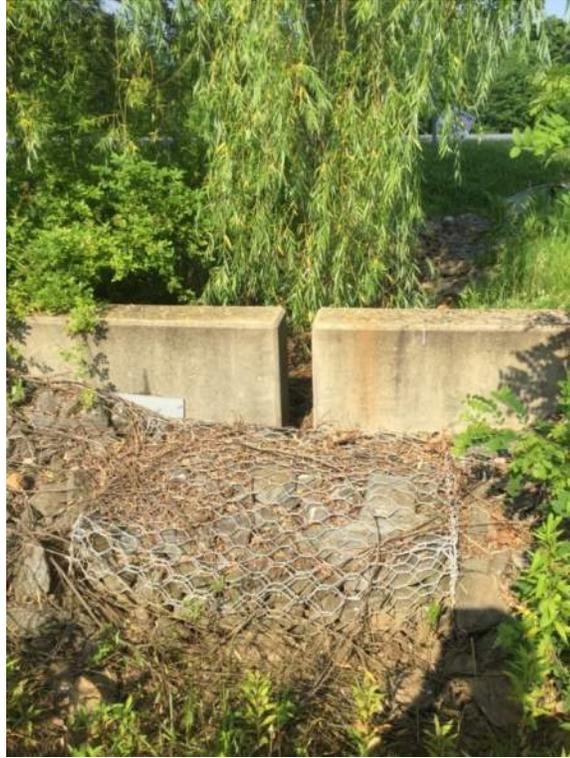
According to the County's BMP Database, the control structure for this facility is a notched weir. At the time of the site visit, the spillway was in good condition.

**Photo 6: View of existing weir wall.**

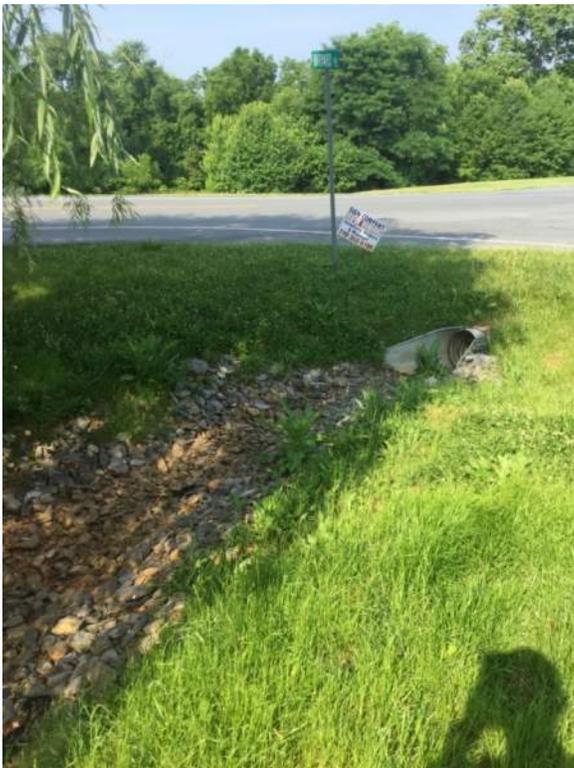
Outflow occurs via the weir to a riprap channel that discharges to an existing 18" CMP that runs under Harvard Place and seems to be in good condition. The rip rap channel has evidence of erosion and overgrown vegetation.

**Photo 7: View of existing outfall channel.**

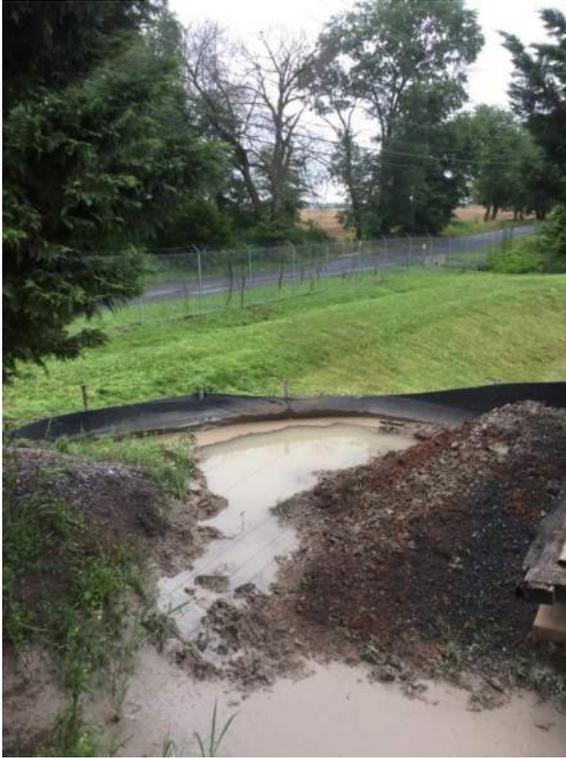
**Photo 1: View of super silt fence on northwestern side of the facility.**

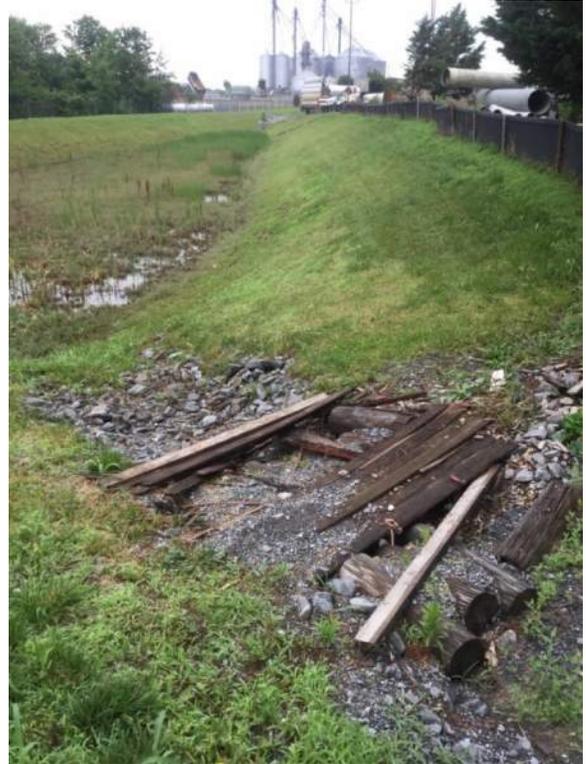
**Photo 2: View of debris in inflow looking south.**

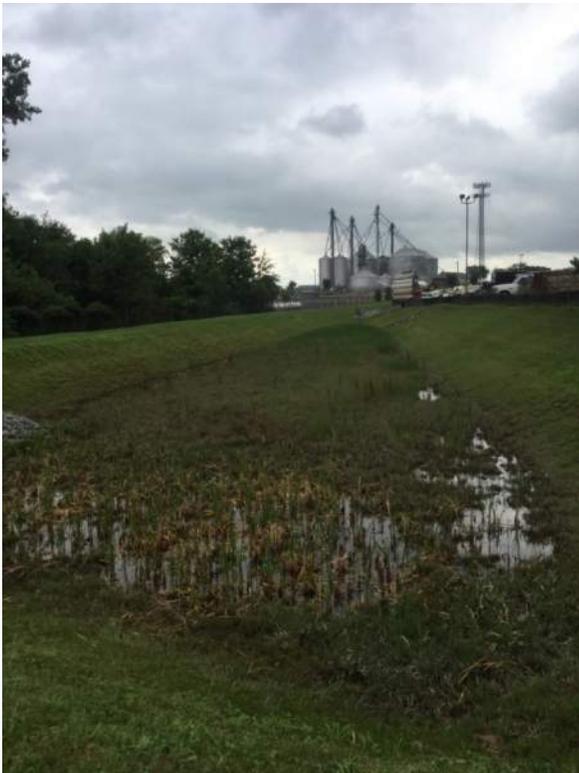
**Photo 3: Overall view of facility looking south.**

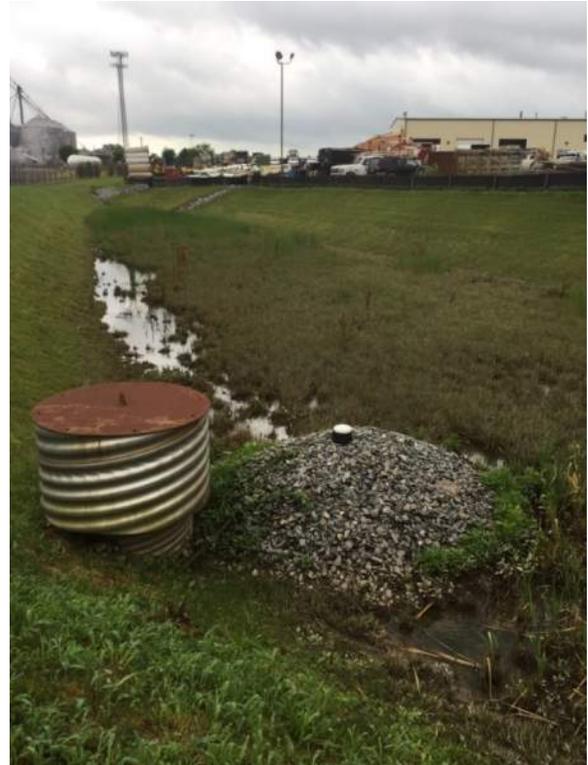
Overall, the facility appears to be in good condition, but does not meet criteria to treat for water quality as it does not meet the current stormwater standards and has a CMP riser. The property owner has made several unapproved modifications to the facility limiting its ability to properly treat the large amount of runoff draining to it. The facility is a candidate for retrofit.

**Photo 4: View of existing CMP riser.**

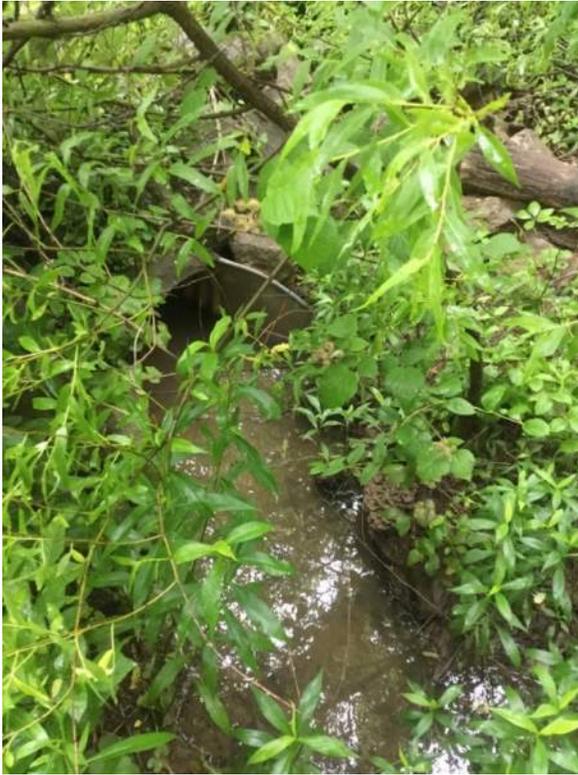
The outfall pipe is in good condition. The facility outfalls to a stream located in the northeast corner of the property.

**Photo 5: View of existing CMP outfall.**

REPLACE EXISTING CMP OUTFLOW

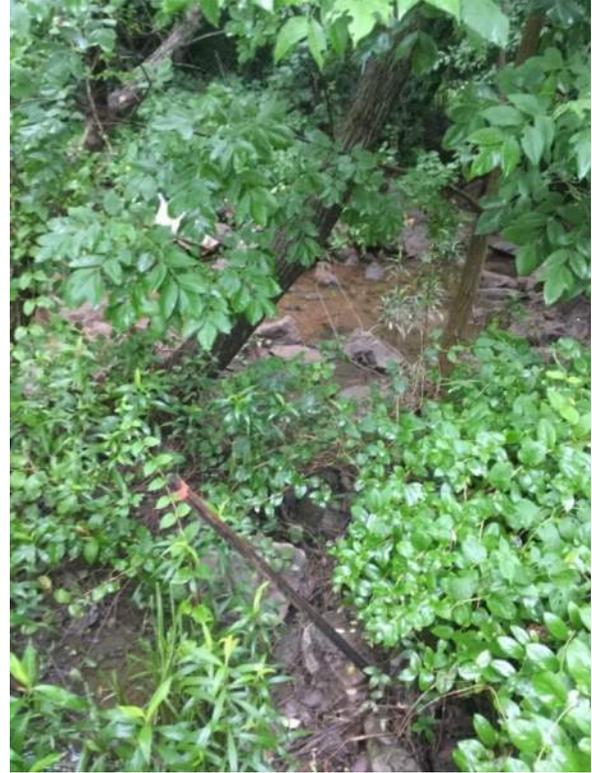
**Photo 6: View of existing outfall channel.**

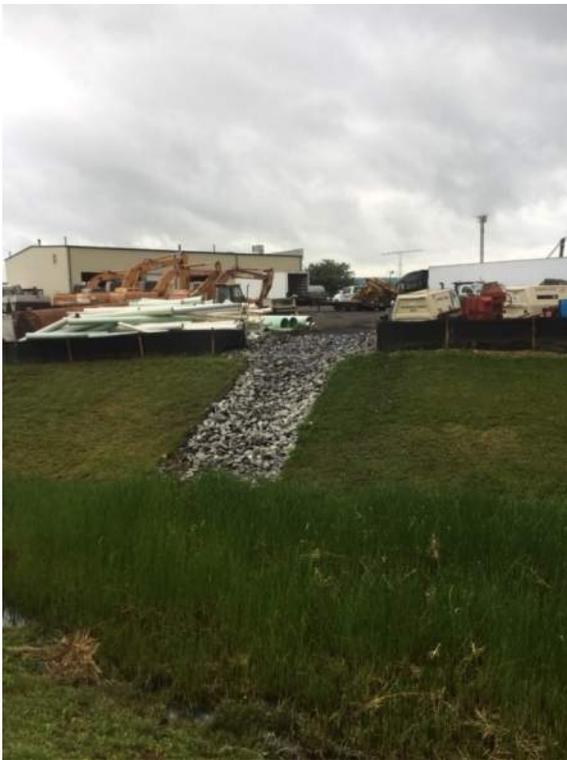
**Photo 7: View of property owner-created riprap inflow looking west.**

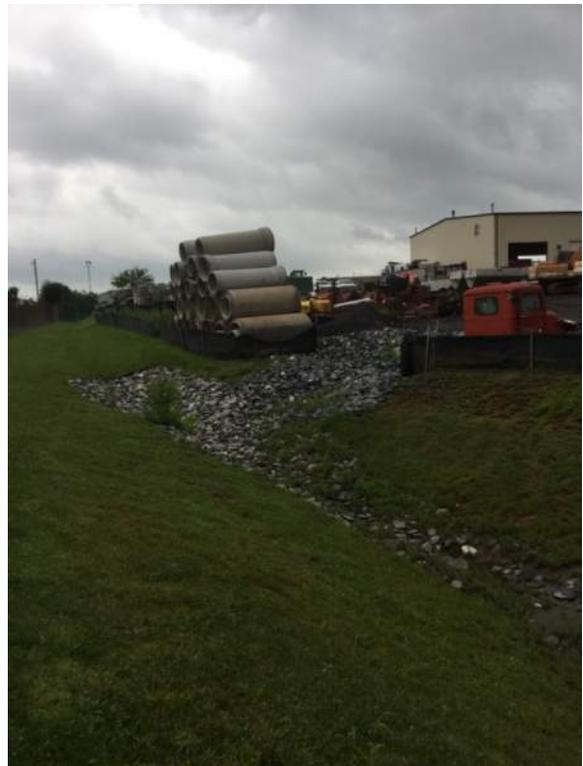
**Photo 8: View of property owner-created inflow looking south.**

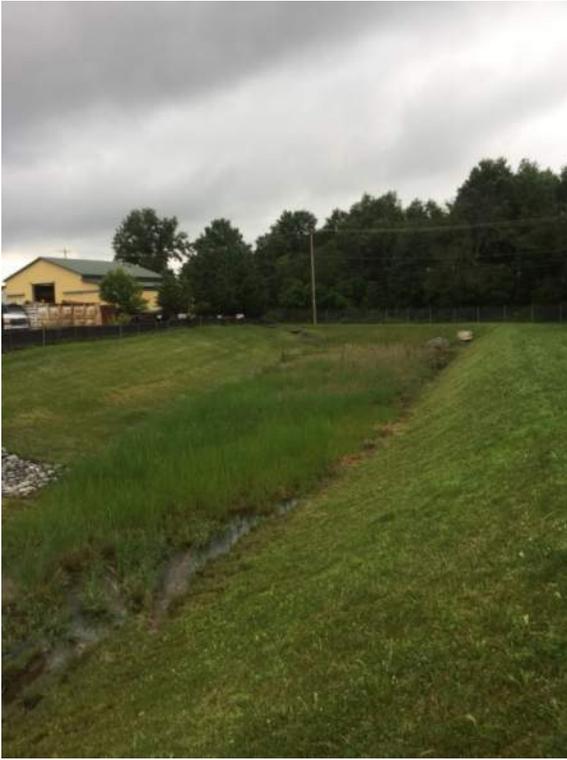
**Photo 9: Overall view of facility looking to the north.**

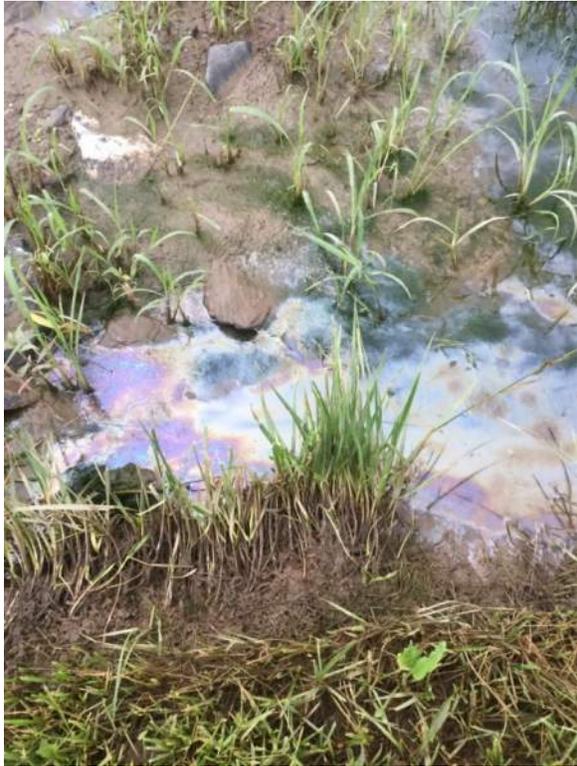
**Photo 10: Potential oil sheen found in facility.**

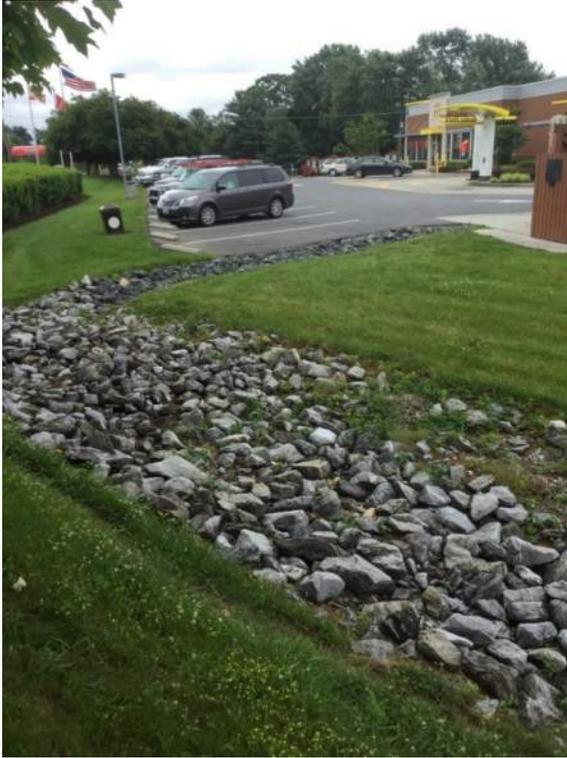
Inflow to the facility consists of sheet flow and two riprapped channels. The riprapped channels have minor sedimentation and vegetation and are in good condition.

**Photo 1: View of inflow looking east.**

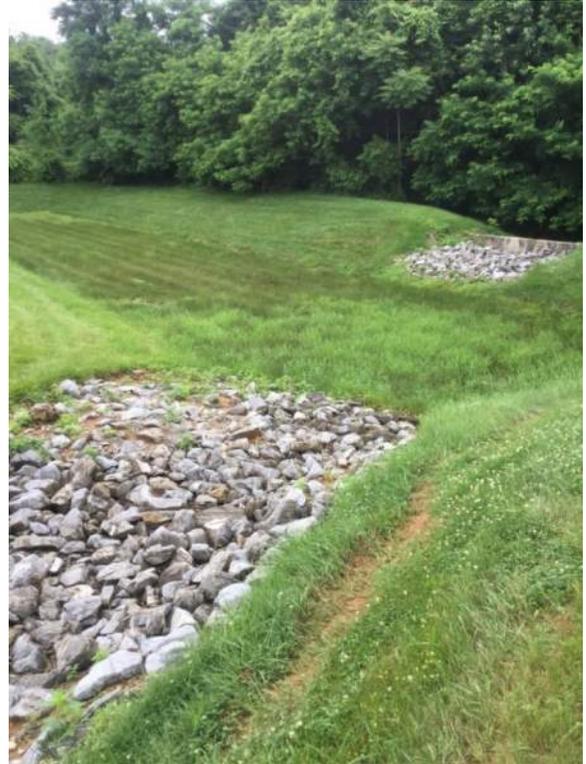
Overall, the facility appears to be in good condition, but does not meet criteria to treat for water quality and is a candidate for retrofit or creating updated as-builts.

**Photo 2: Overall view of facility looking west.**

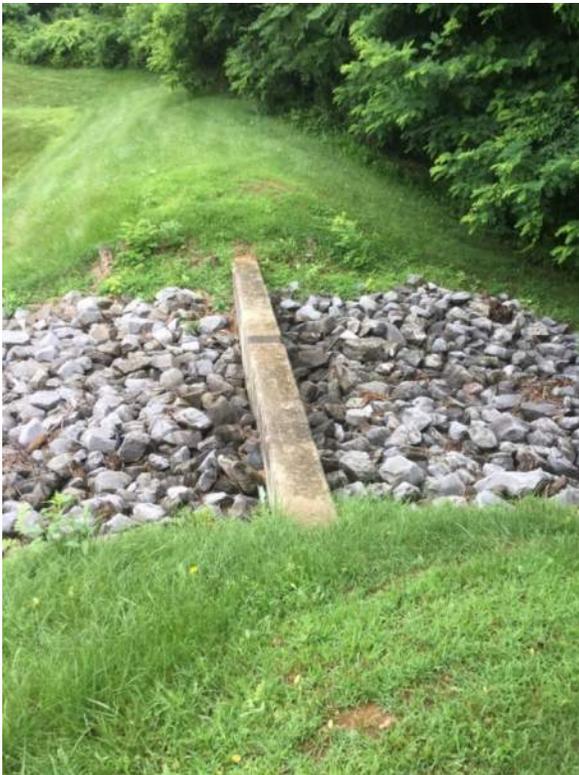
The notched weir control structure discharges to a riprapped channel in good condition.

**Photo 3: View of existing weir wall looking south.**

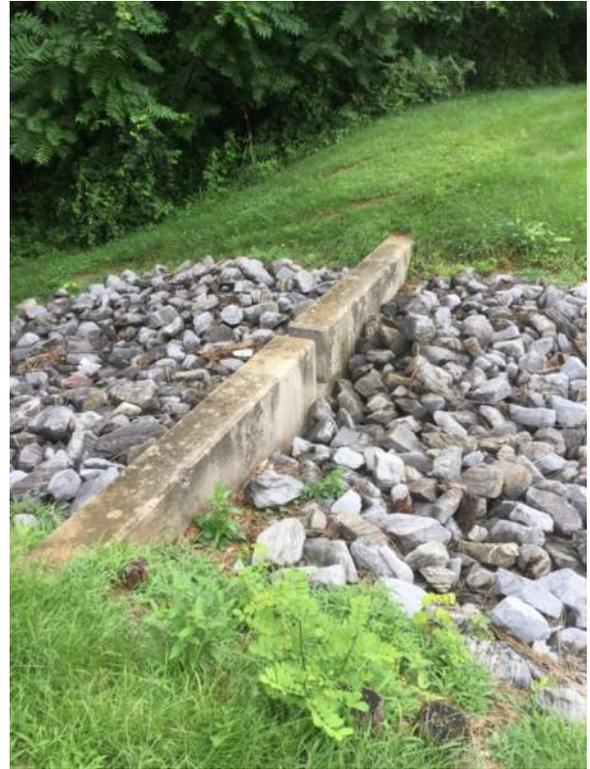
**Photo 4: View of existing weir wall looking north.**

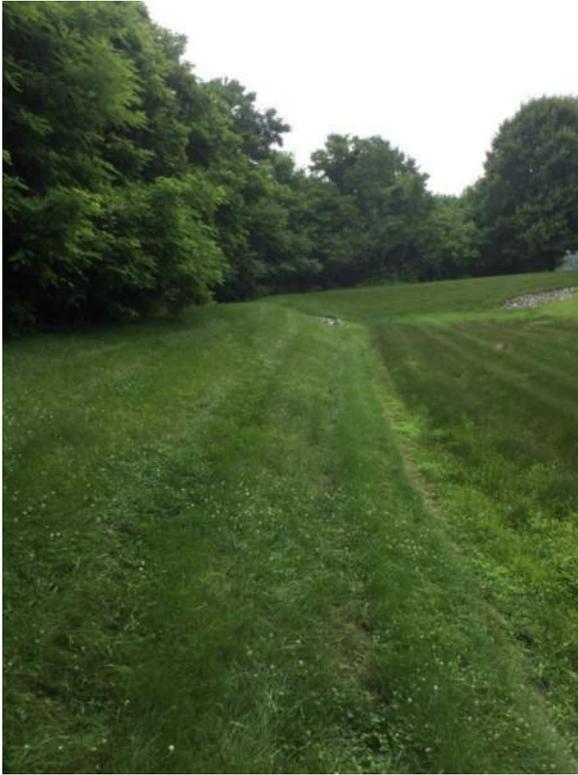
The facility has a seven-foot vegetated embankment in good condition.

**Photo 5: View of embankment, looking north.**
