## **Appendix C: Concept Designs**

Brown and Caldwell

Project: Potomac Direct Watershed Assessment

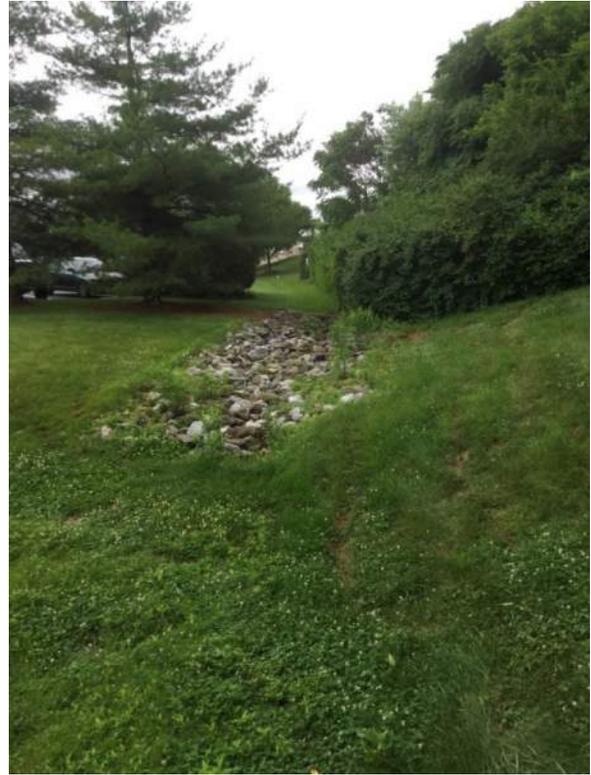
**Photo 6: View of grass swale inflow looking east.**

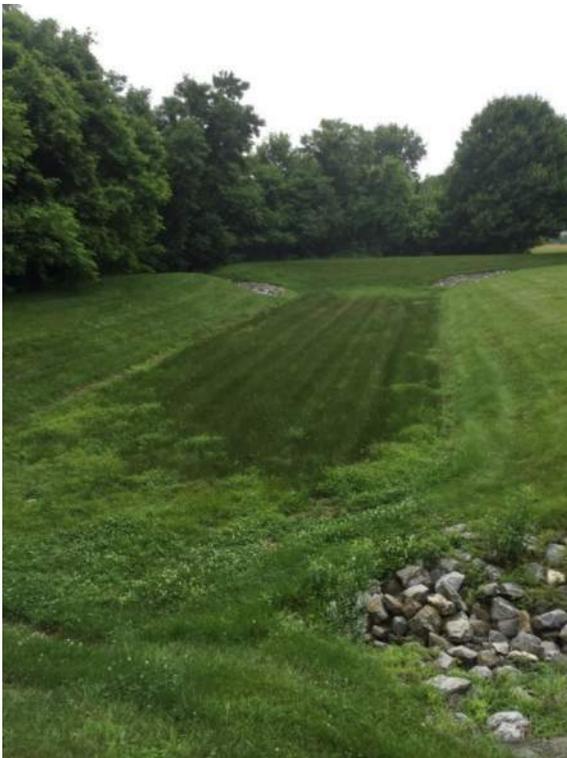
**Photo 7: Overall view of facility looking north.**

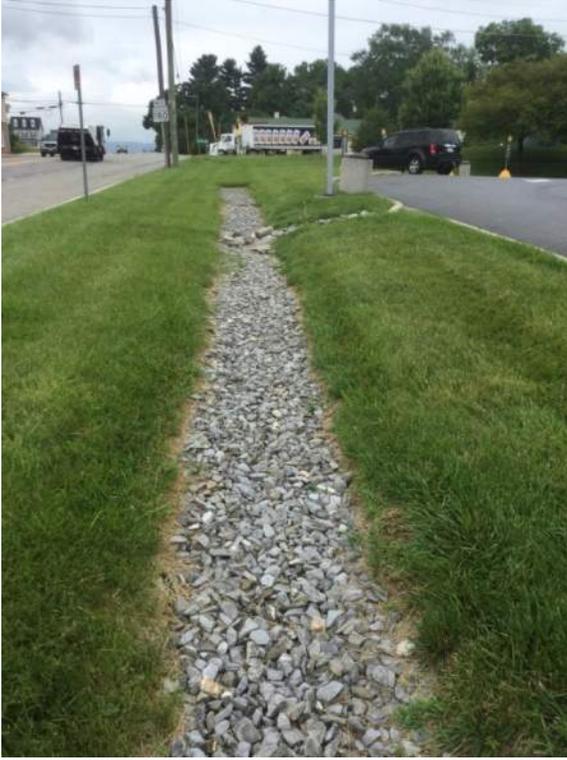
Overall, the facility appears to be in good condition, but the overflow inlet needs maintenance. This facility does not meet criteria to treat for water quality. The facility is a candidate for retrofit or creating updated as-builts.

**Photo 1: Overall view of facility looking southwest.**

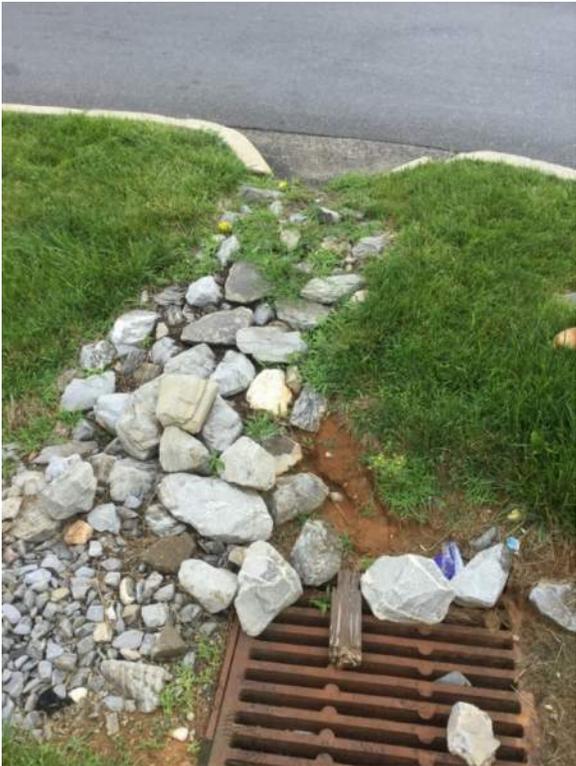
Outflow is collected by an inlet located at the northeastern end of the facility. The inlet primarily serves as overflow as this is an infiltration device.

**Photo 2: View of downstream inlet and curb cut.**

The proposed retrofit includes replacing the existing infiltration trench with two feet of bioretention mix. A perforated PVC underdrain is to be added and tied into the existing downstream inlet, however no major modification of the inlet is necessary. A curb cut is proposed on the western side of the facility for additional inflow.

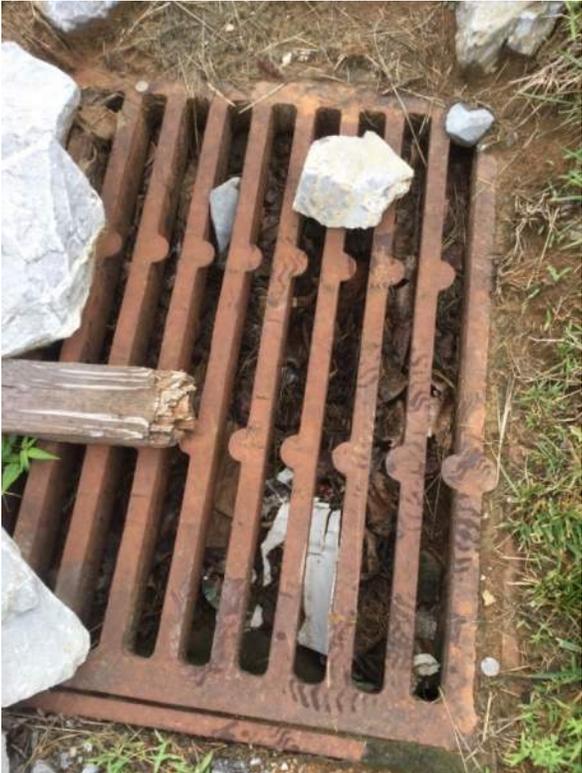
**Photo 3: View of downstream inlet.**

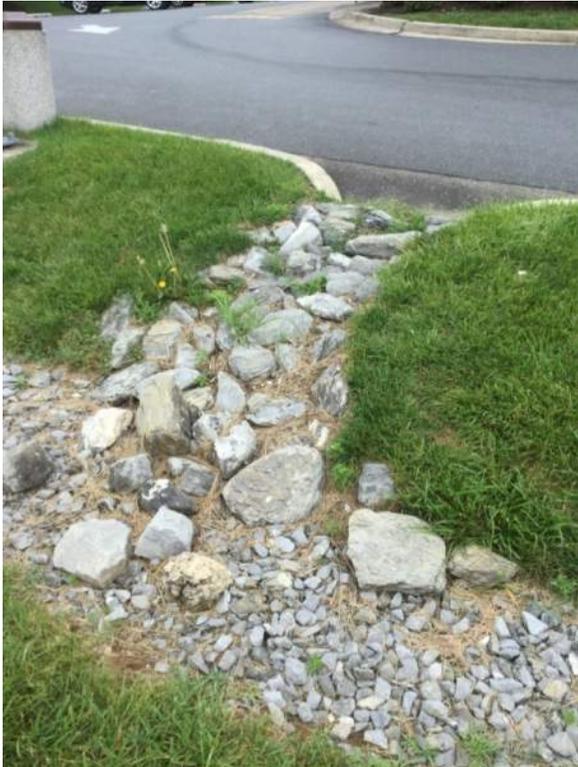
The facility has two inflow points consisting of curb cuts with riprap in good condition.

**Photo 4: View of existing curb cut near center of facility.**

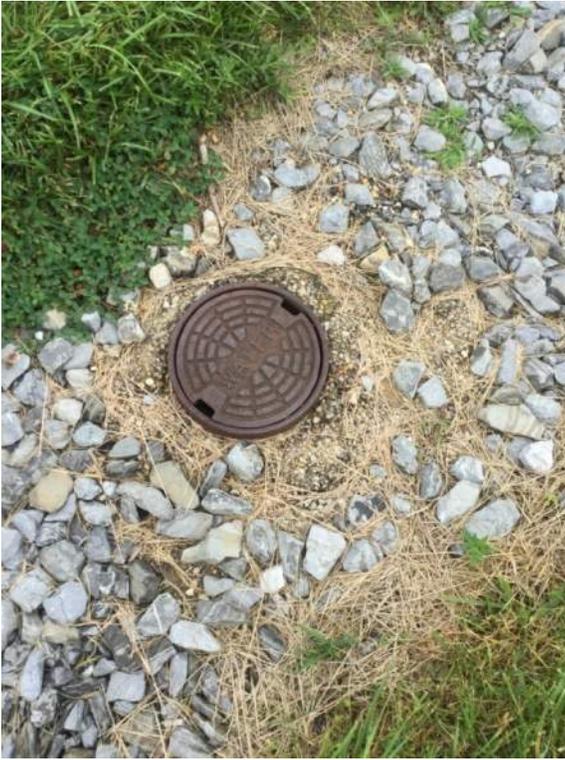
The facility receives just over 0.1 acres of sheet flow from a parking lot which is a typical configuration for a bioswale facility. According to the MDE Stormwater Design Manual bioswales can treat a maximum drainage area of 1 acre. The proposed drainage area to BMP #317 is 0.1 acres and is composed of largely B soils with a portion of C soils. Additional investigation is necessary to determine if the existing underground water pipe that crosses under the facility will cause conflicts during construction.

**Photo 5: Potential underground utility conflict.**

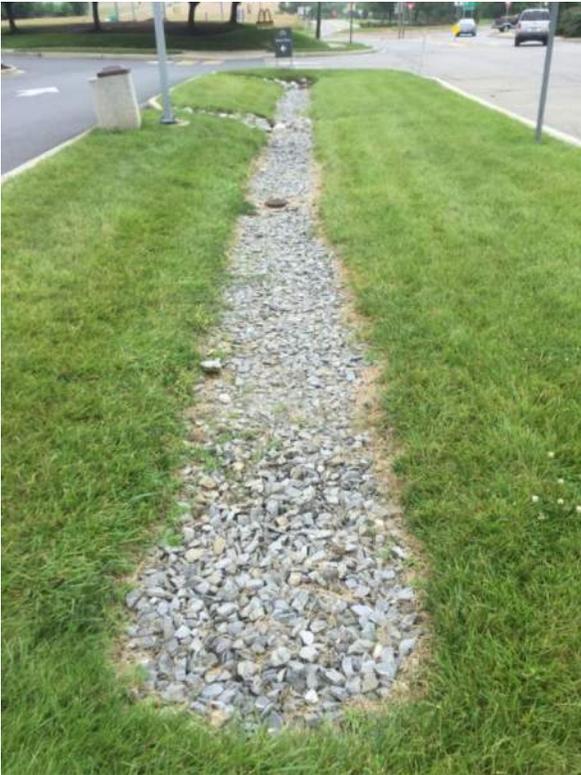
**Photo 6: Overall view of facility looking northeast.**

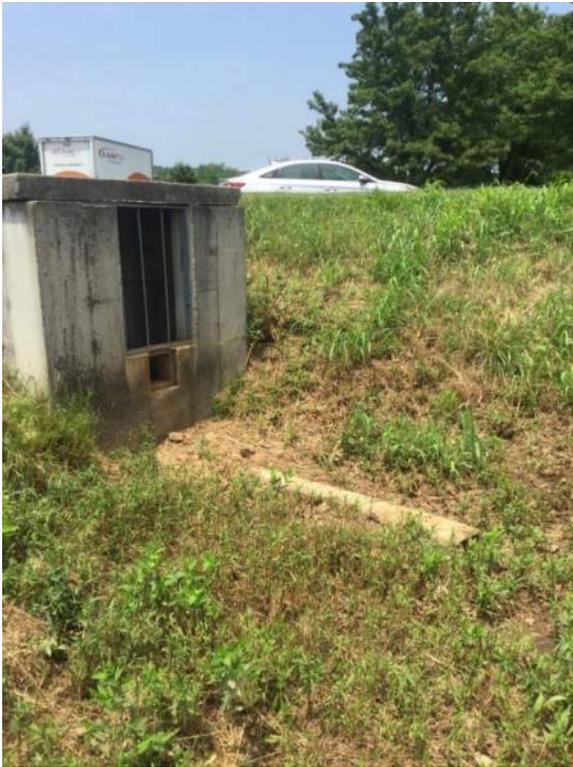
The facility has an existing concrete riser with a low flow pipe covered in stone jacket. The riser appeared to be in good condition during the site visit.

**Photo 1: View of existing concrete riser.**

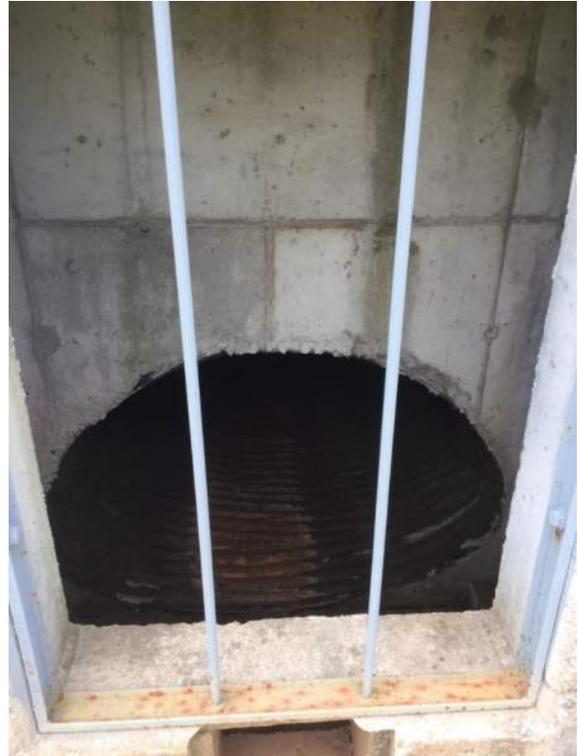
**Photo 2: View of facility's existing outflow CMP.**

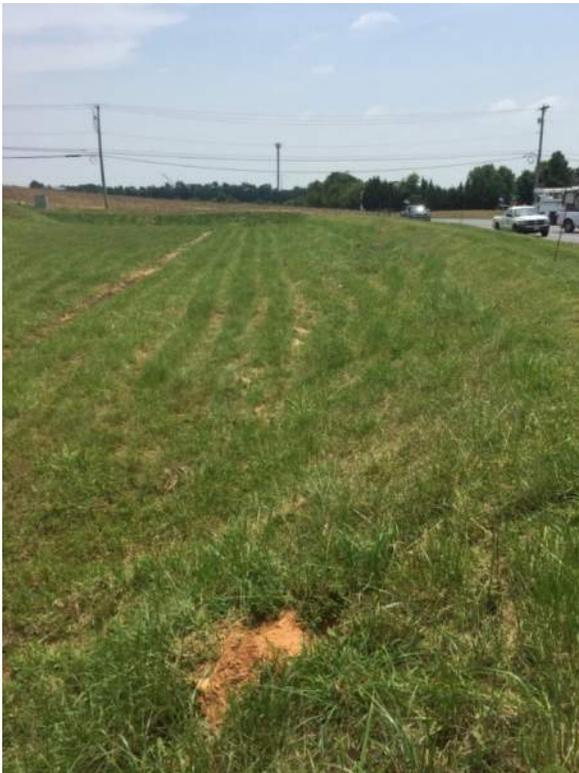
**Photo 3: Overall view of facility looking east**

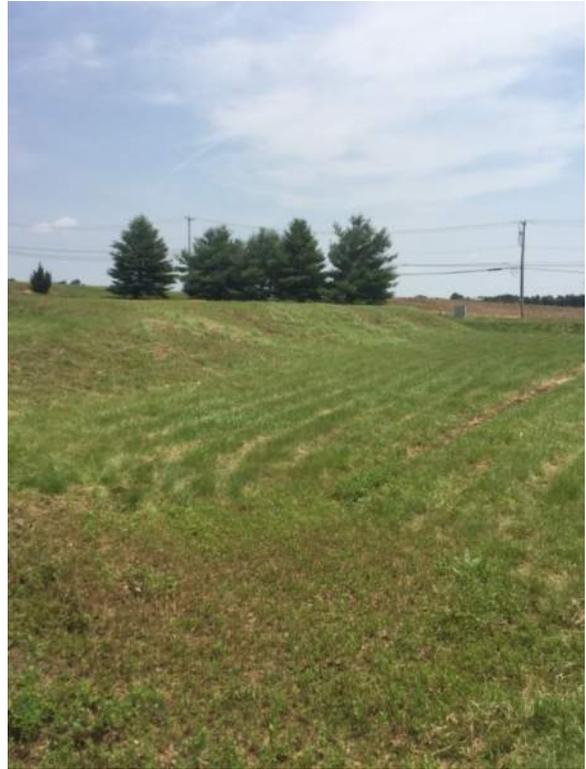
**Photo 4: Overall view of facility looking northeast.**

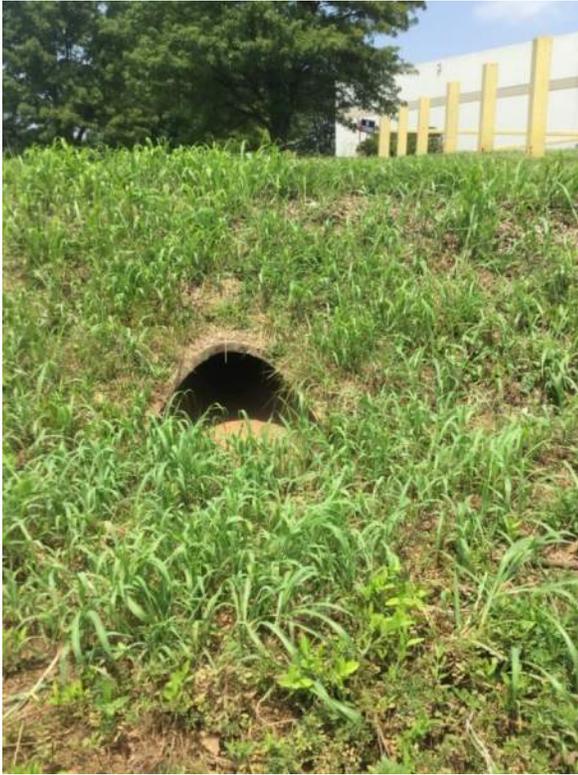
Inflow to the facility consists of sheet flow and two 21" corrugated metal pipes entering the facility in the northwest corner. There is also a grass swale inflow on the eastern side of the facility. The CMP inflows appeared to be in good condition.

**Photo 5: View of existing CMP inflow.**

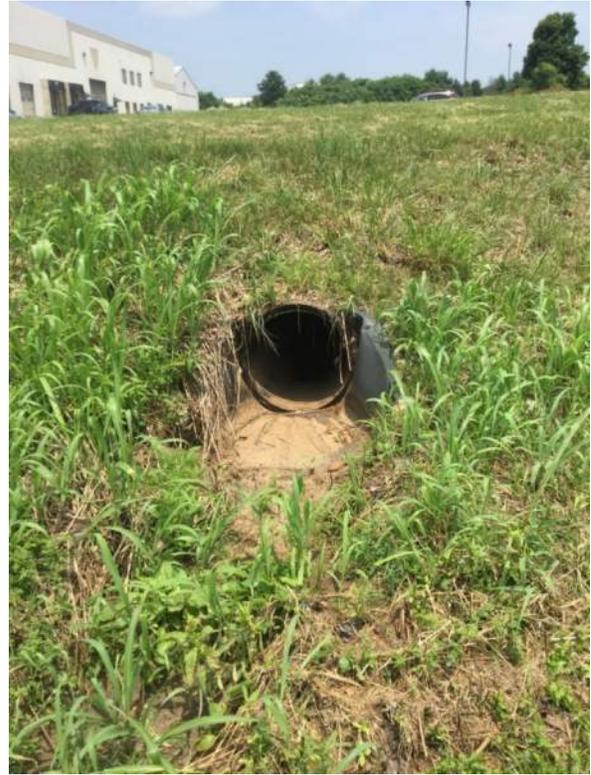
**Photo 6: View of second existing CMP inflow.**

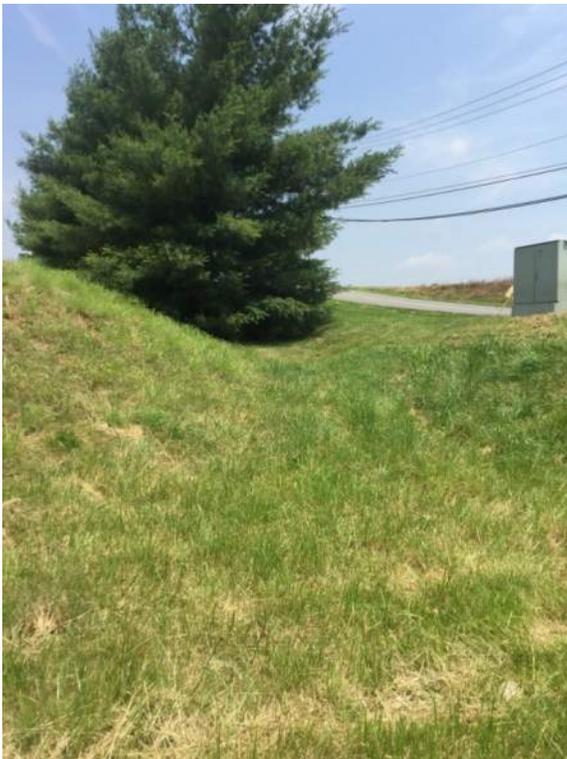
**Photo 7: View of grass swale inflow looking North.**

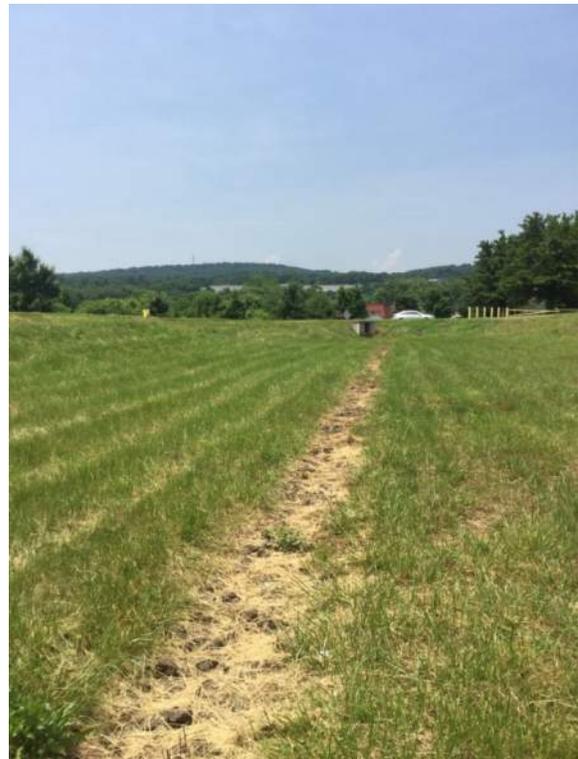
**Photo 8: Overall view of facility looking west.**

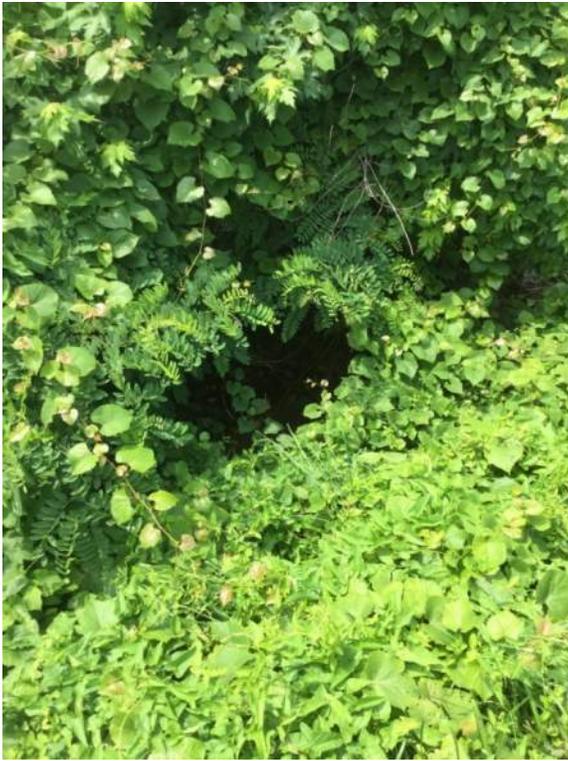
**Photo 9: View of existing RCP outfall.**

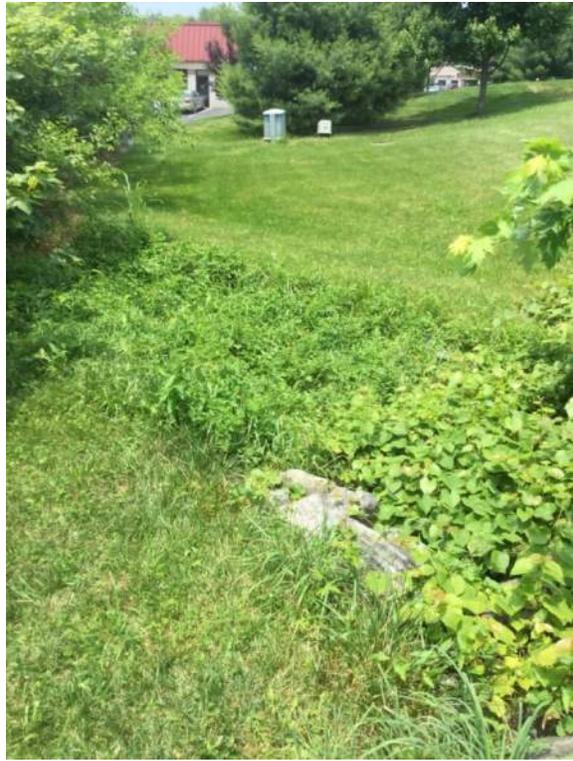
**Photo 10: View of existing outfall channel.**

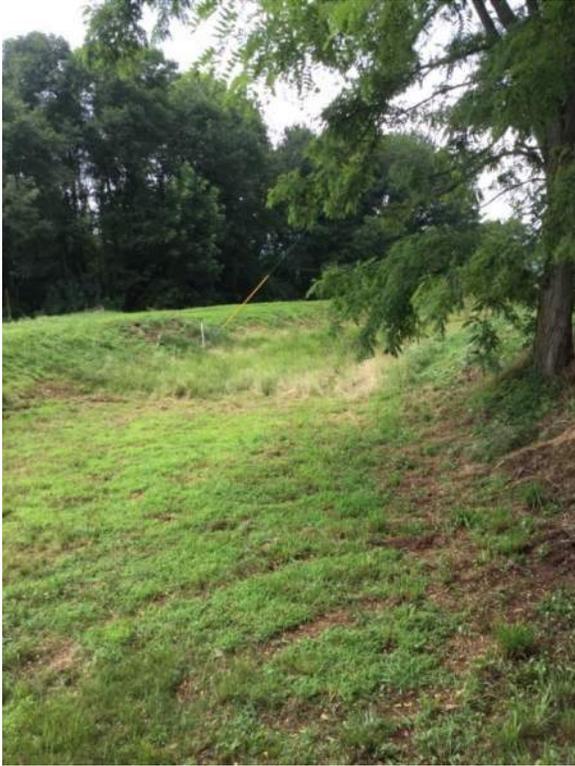
**Photo 1: Overall view of facility looking west.**

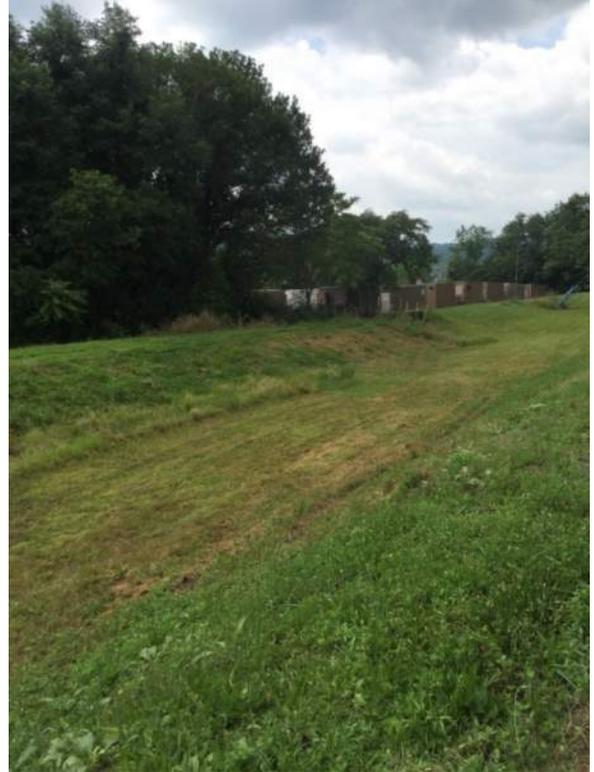
**Photo 2: Overall view of facility looking west.**

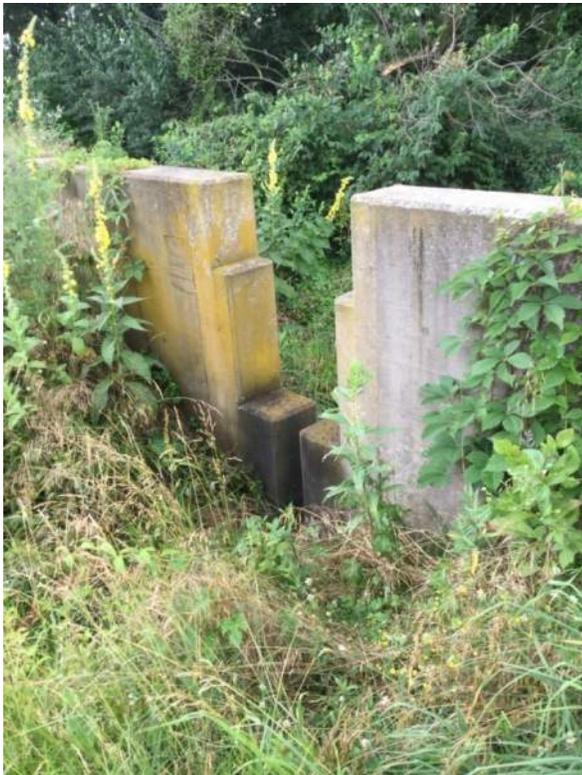
The facility has a notched weir wall on the southern side of the facility. The weir wall was in good condition during the assessment.

**Photo 3: View of existing notched weir wall.**

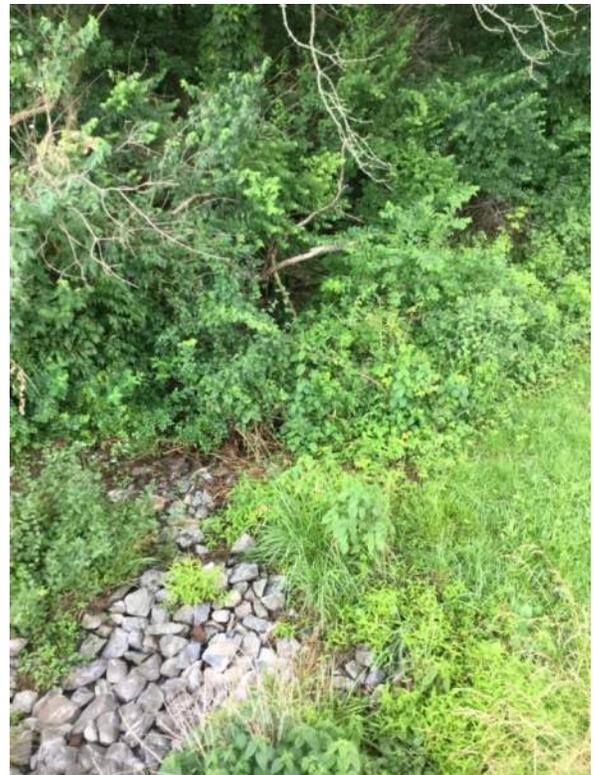
**Photo 4: View of downstream channel.**

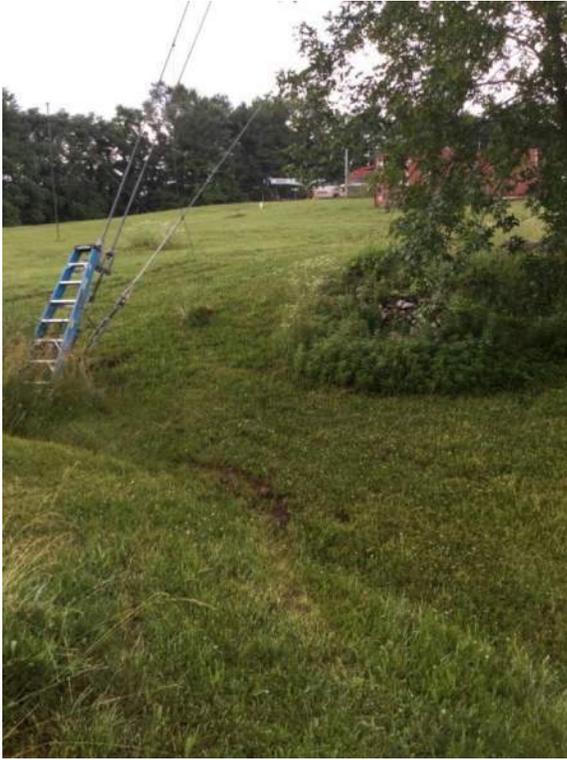
**Photo 5: View of surrounding land use looking west.**

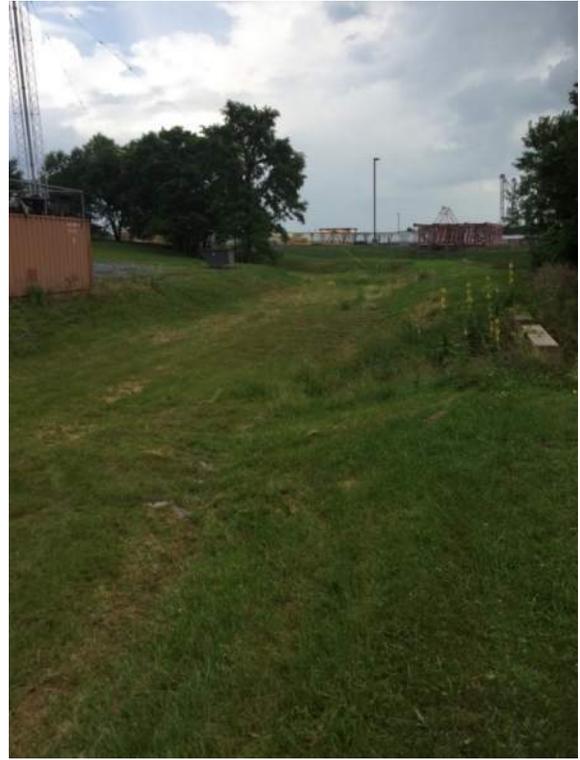
Overall, the facility appears to be in good condition, but does not meet criteria to treat for water quality treatment and is a candidate for retrofit.

**Photo 8: Overall view of facility looking east.**

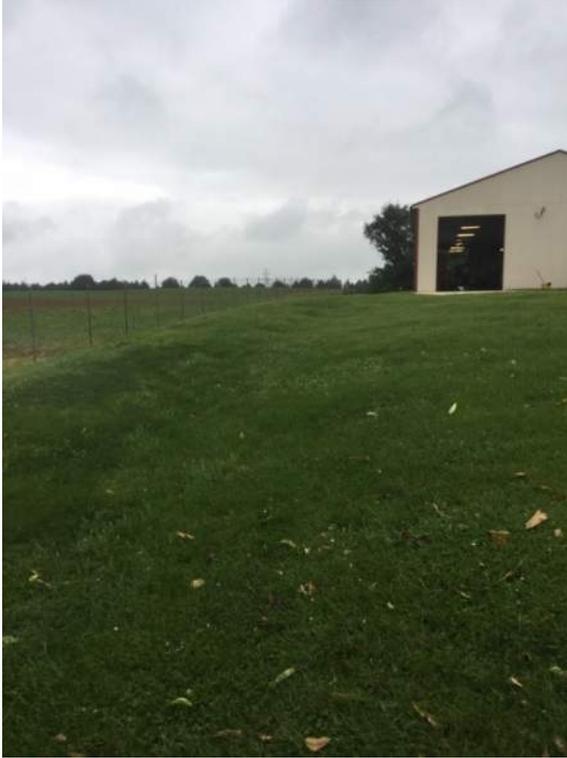
**Photo 1: View of grass swale inflow looking east.**

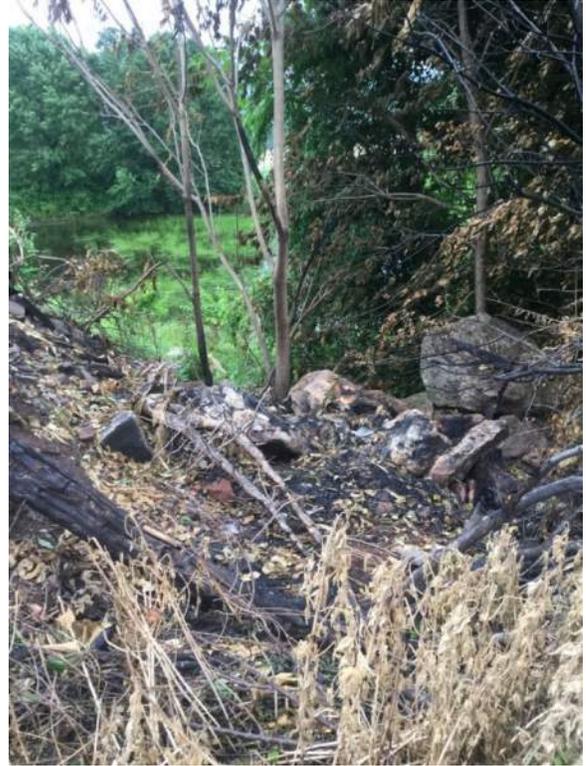
Overall, the facility appears to be in good condition with the exception of an eroded area found on the upstream embankment. The facility is a candidate for retrofit.

**Photo 2: View of eroded and unvegetated area on upstream embankment.**

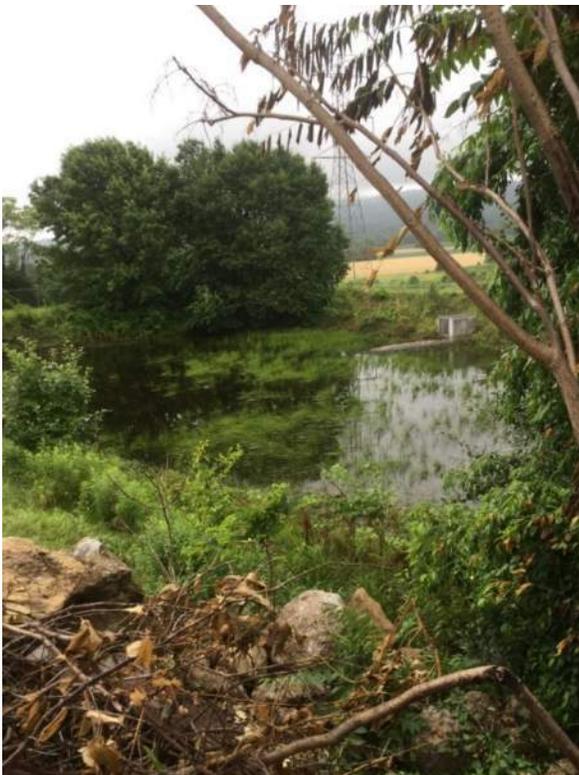
**Photo 3: Overall view of facility looking northeast.**

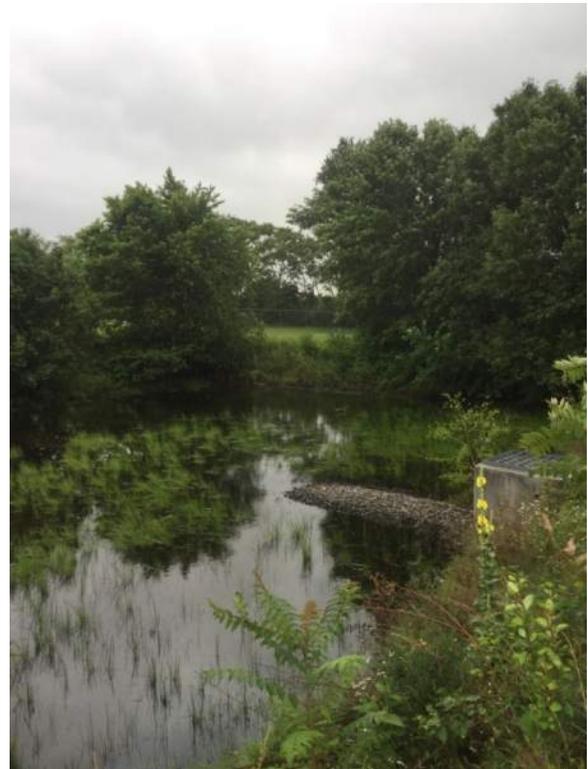
**Photo 4: Overall view of facility looking southeast.**

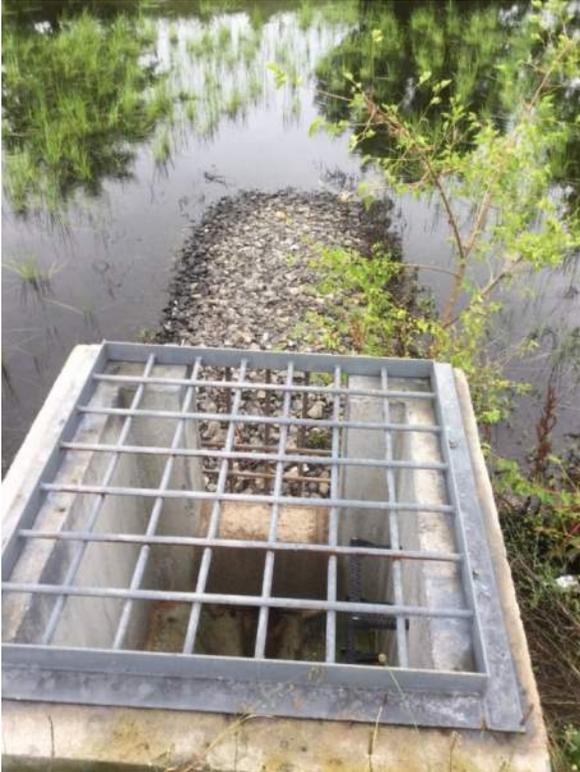
The facility has an existing concrete riser with a low flow pipe covered in a stone jacket. The riser appeared to be in good condition during the site visit.

**Photo 5: View of existing concrete riser.**

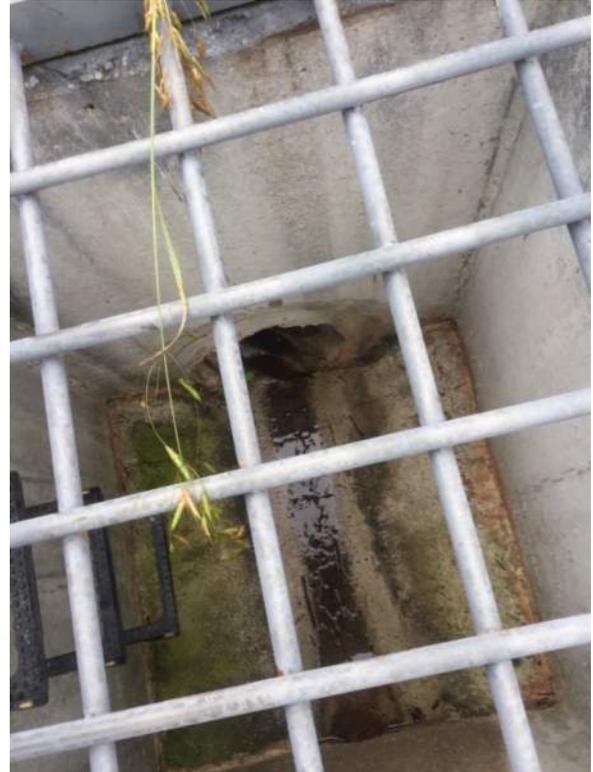
**Photo 6: View of inside existing concrete riser.**

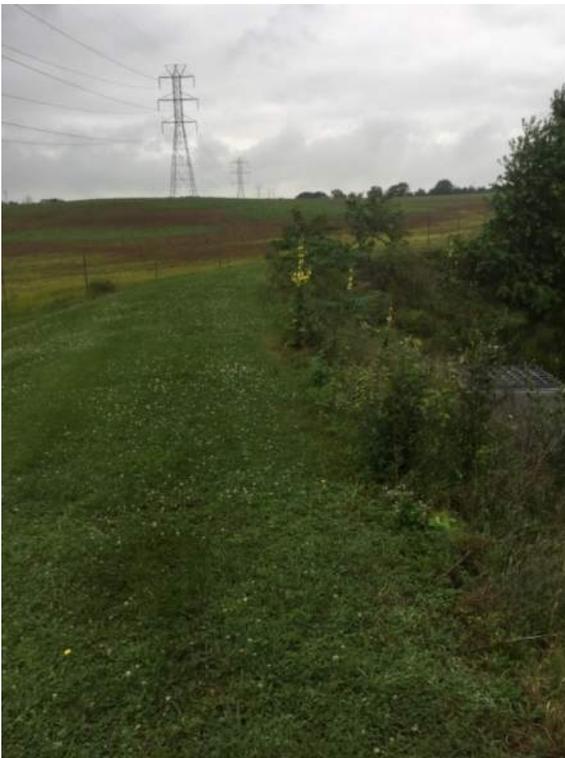
The facility has a four-foot vegetated embankment in good condition.

**Photo 7: View of facility embankment looking north.**

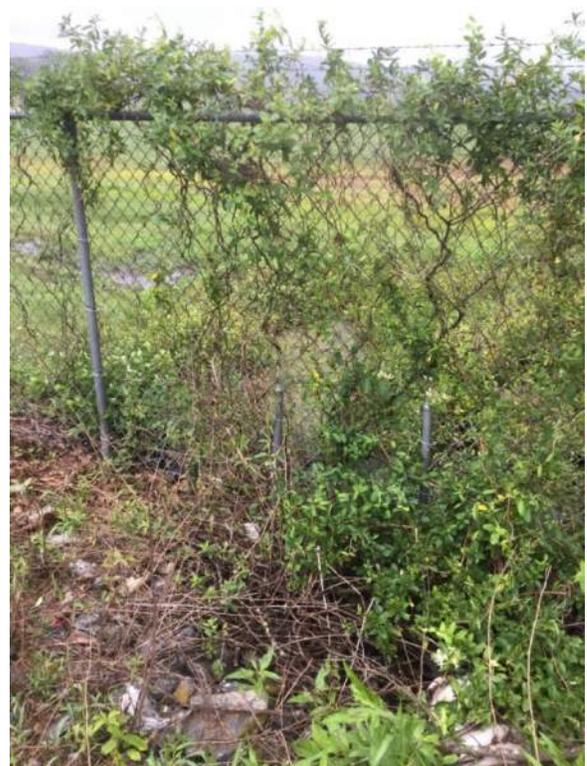
**Photo 8: View of outfall channel looking to the northwest**

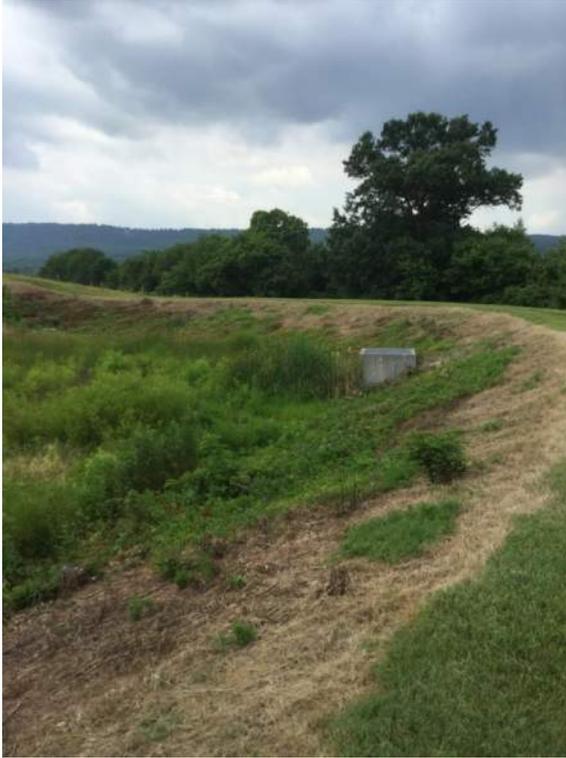
Overall, the facility appears to be in good condition, but does not meet criteria to treat for water quality and is a candidate for retrofit.

**Photo 1: Overall view of facility looking northwest.**

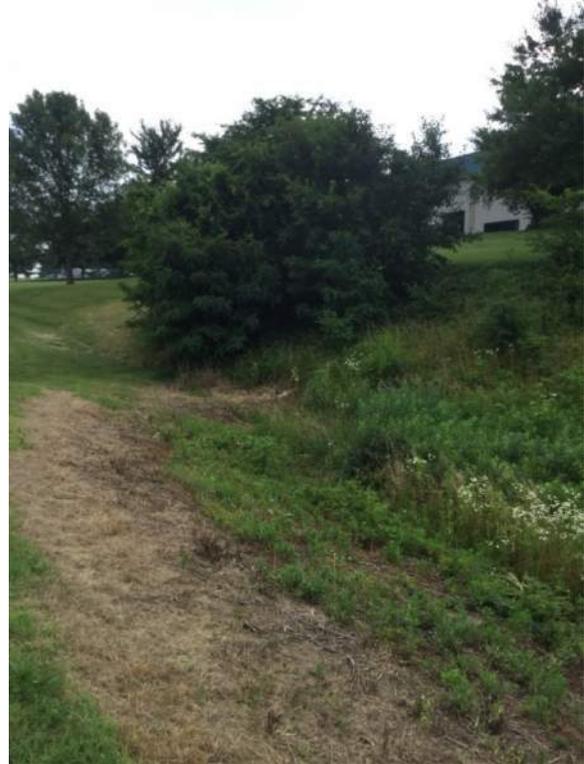
**Photo 2: View of inflow looking to southeast.**

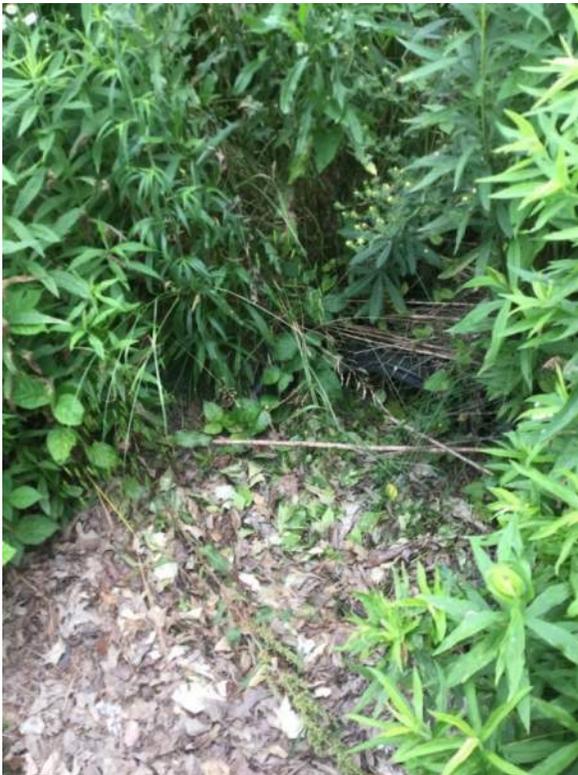
**Photo 3: View of 15" HDP pipe inflow.**

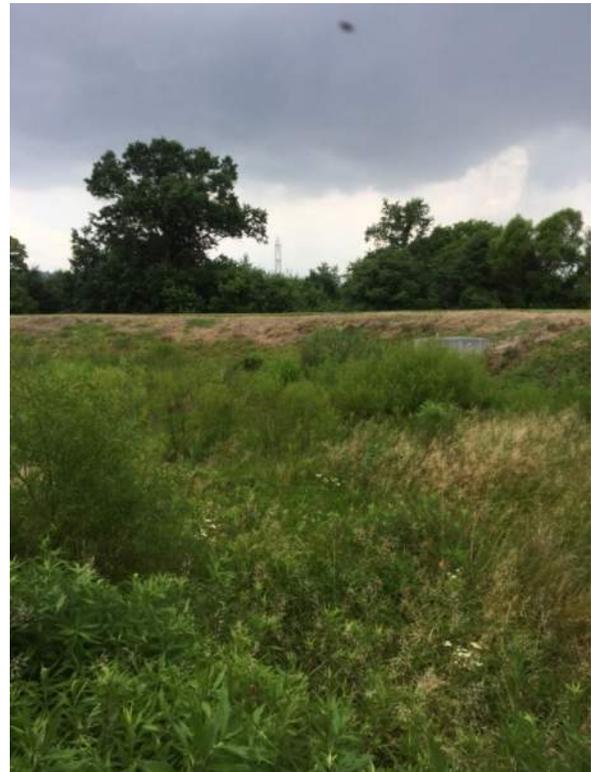
**Photo 4: Overall view of facility looking north.**

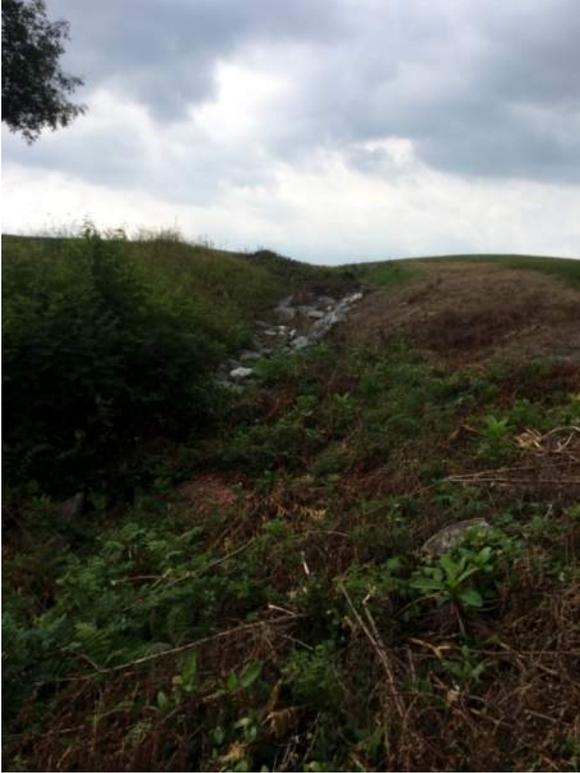
**Photo 5: View of inflow looking southwest.**

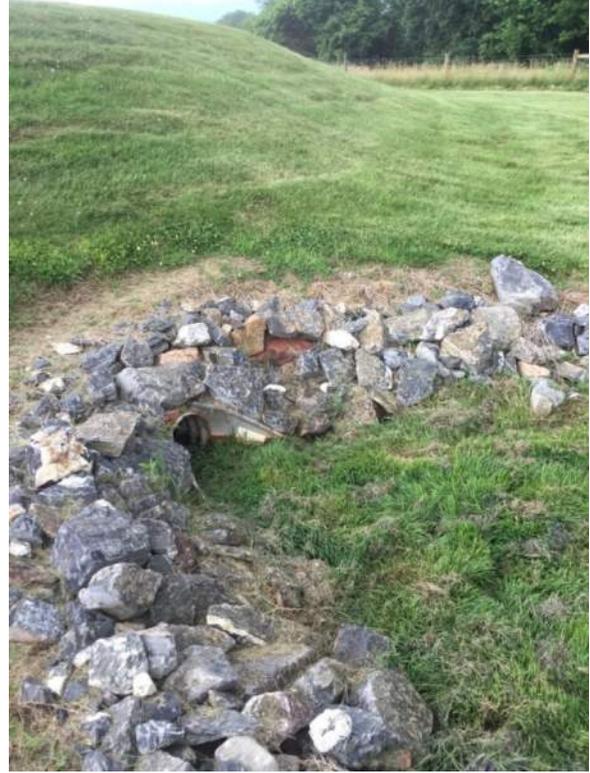
**Photo 6: View of outfall.**

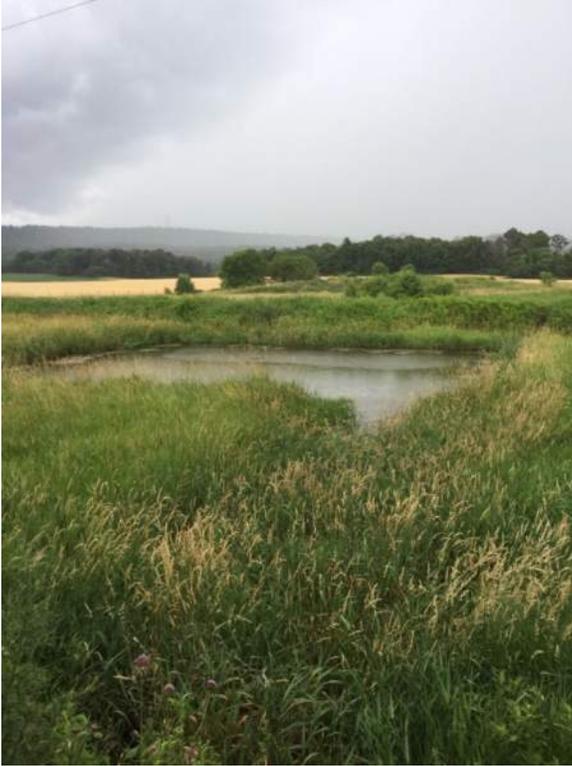
Overall, the facility appears to be in good condition, but does not meet criteria to treat for water quality and is a candidate for retrofit or creating updated as-builts.

**Photo 1: Overall view of facility looking west.**

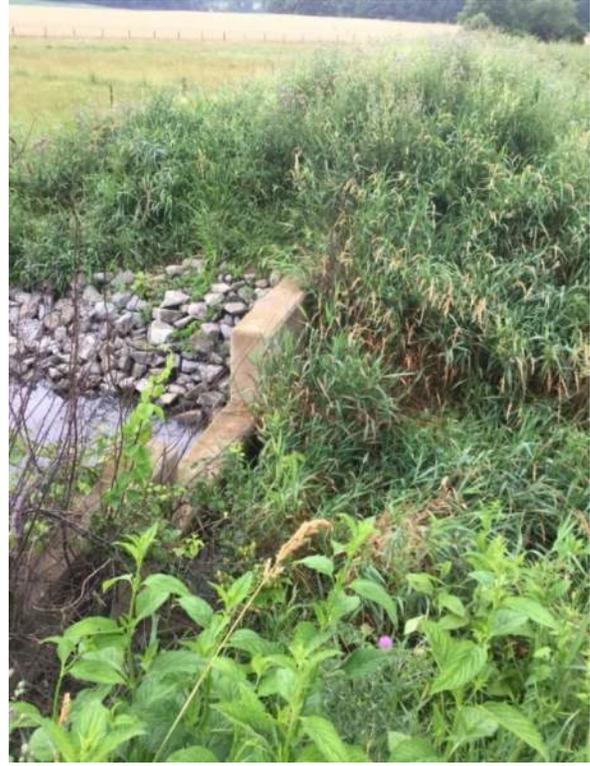
**Photo 2: View of existing notched weir wall.**

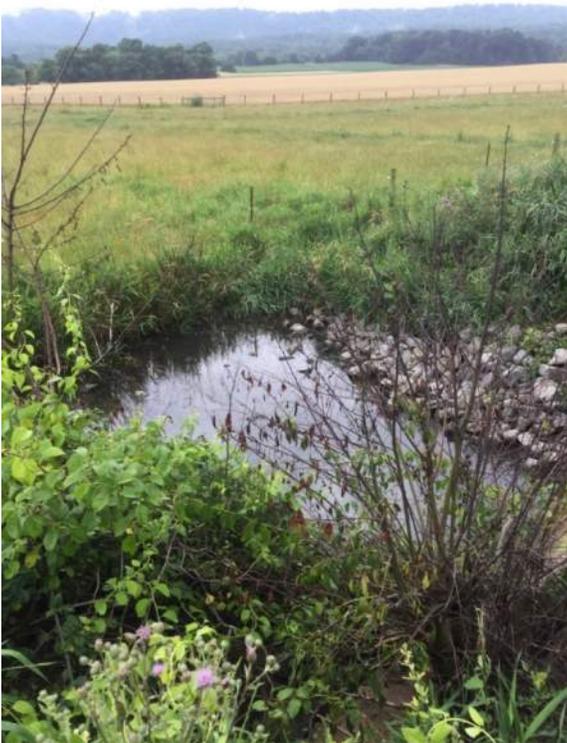
**Photo 3: View of facility outfall channel.**

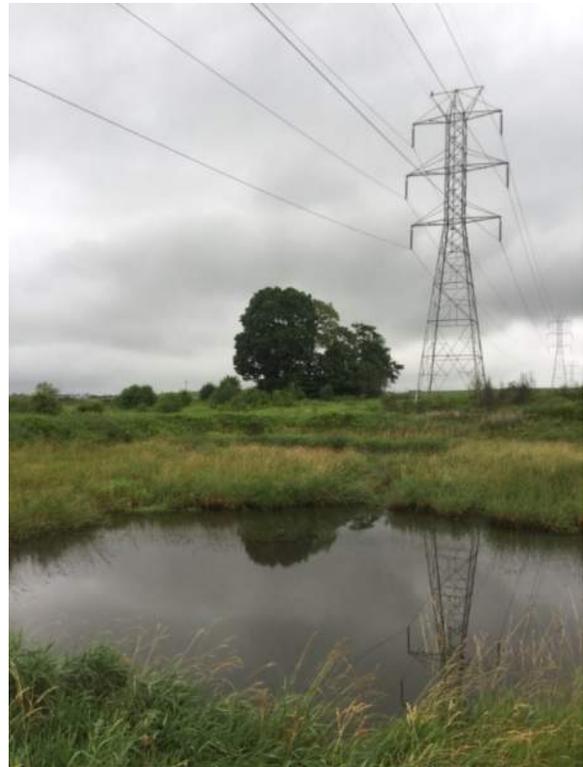
**Photo 4: View of facility forebay looking northwest.**

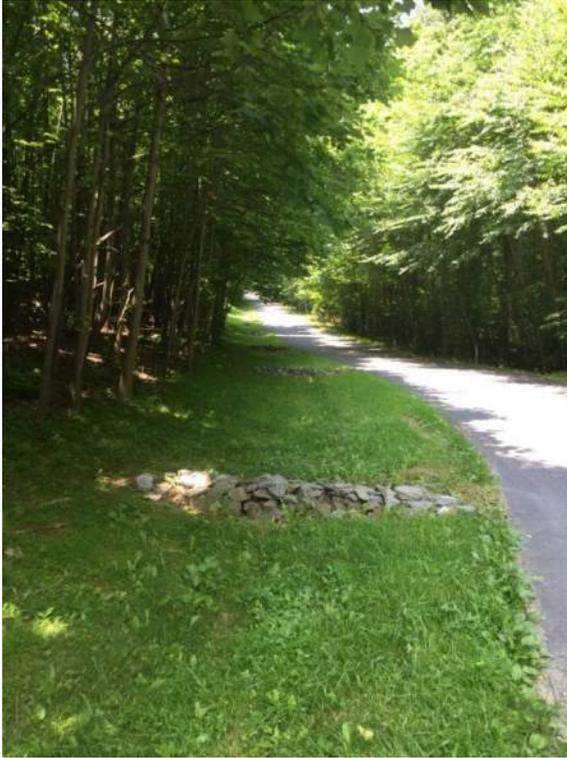
**Photo 1: View of grass swale inflow looking west.**

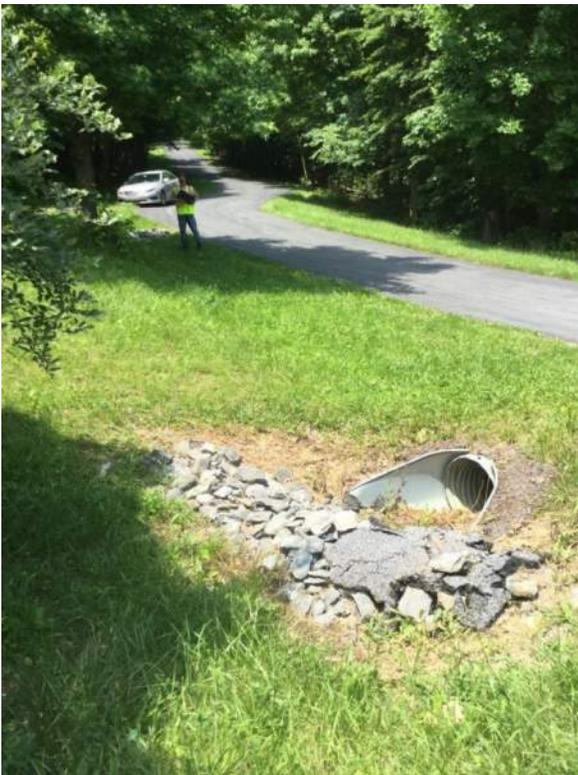
**Photo 3: View of potential outfall area along Basford Road**

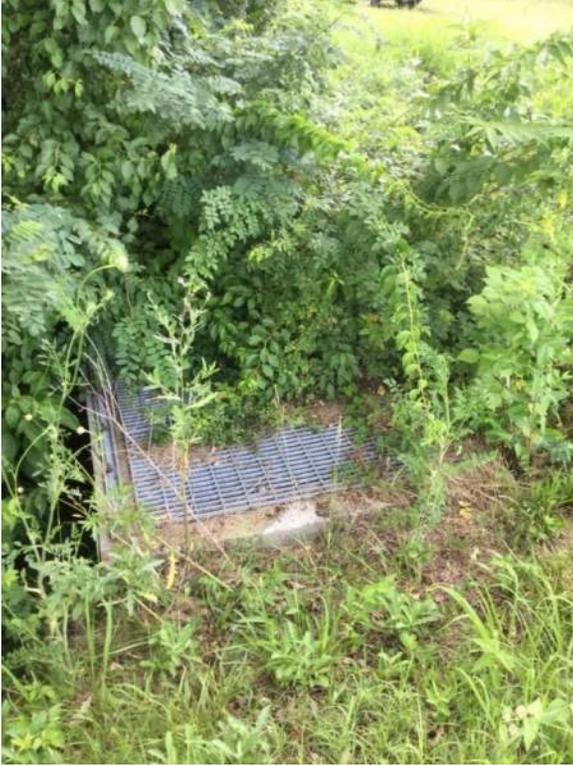
The facility has an existing concrete riser which appeared to be in good condition at the time of the site visit.

**Photo 1: View of existing concrete riser.**

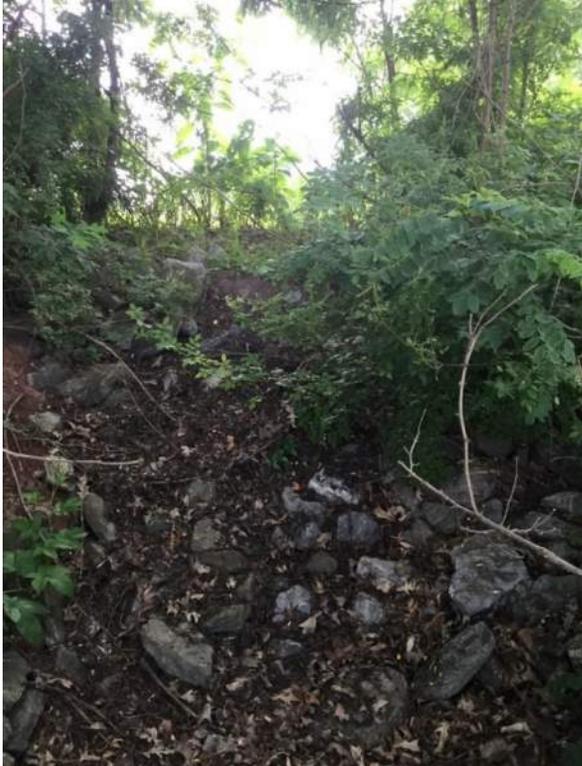
**Photo 2: View of inflow into the facility.**

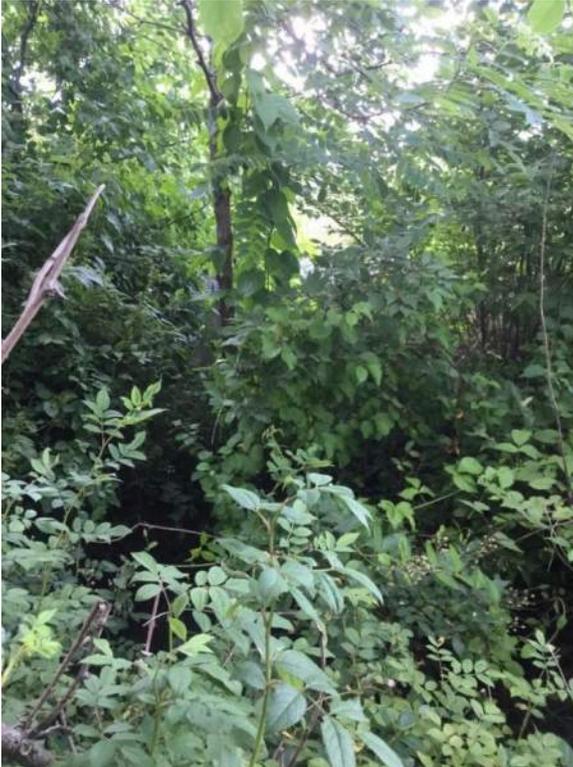
Overall, the facility appears to be in moderate condition. The embankments were lacking vegetation and erosion was visible in several places. The facility does not meet criteria for water quality.

**Photo 3: Overall view of the facility looking north.**

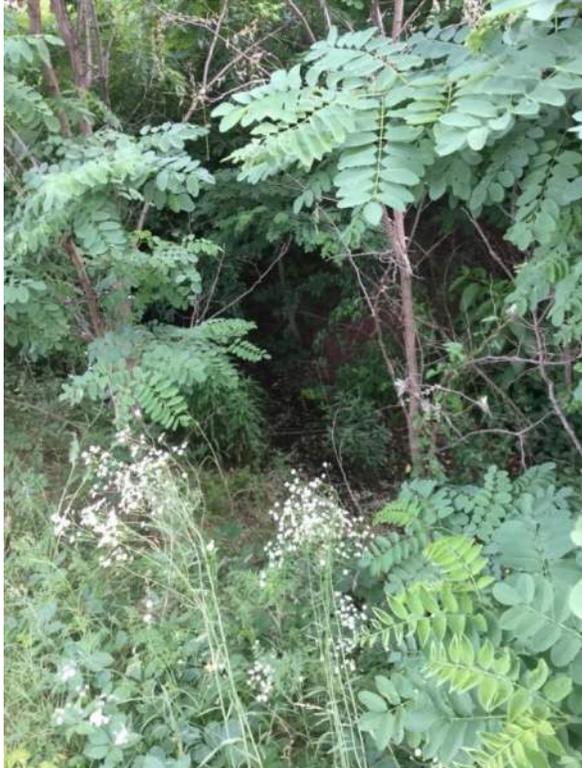
**Photo 4: Overall view of facility looking south.**
