## **Appendix C: Concept Designs**

Brown and Caldwell

Project: Potomac Direct Watershed Assessment

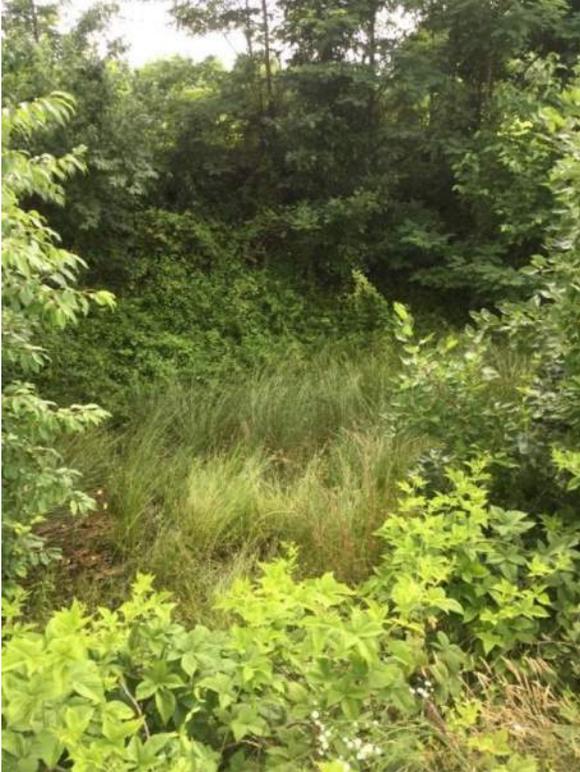
**Photo 5: Overall view of facility looking south.**

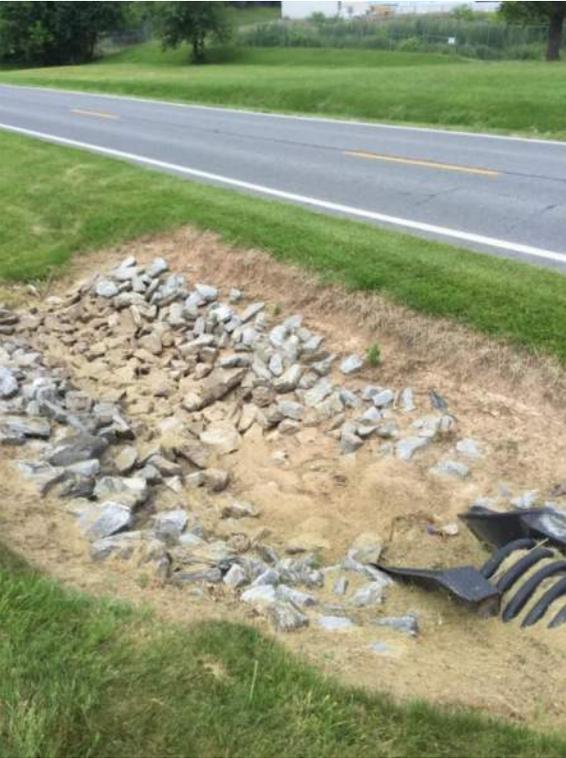
The facility outfalls downstream to a roadside swale that appeared to be in good condition.

**Photo 6: View of facility outfall swale.**

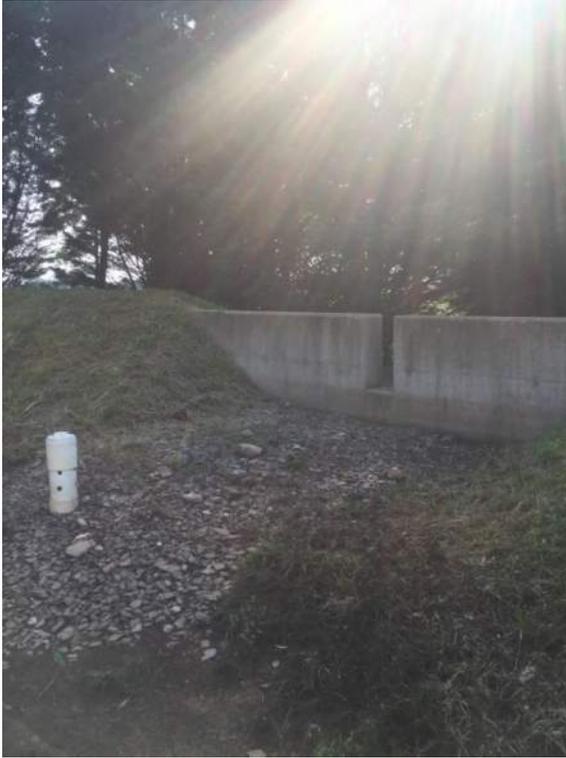
The facility has an existing notched weir wall which appeared to be in good condition at the time of the site visit.

**Photo 1: View of existing weir wall.**

The retrofit includes excavating three feet below the existing facility bottom and backfilling with bioretention mix. A 2-foot fill embankment will be constructed to make a sediment forebay and the existing notched weir wall will be removed and replaced with a concrete riser with a perforated PVC underdrain. The downstream stream use is I-P so thermal impacts are a limited concern.

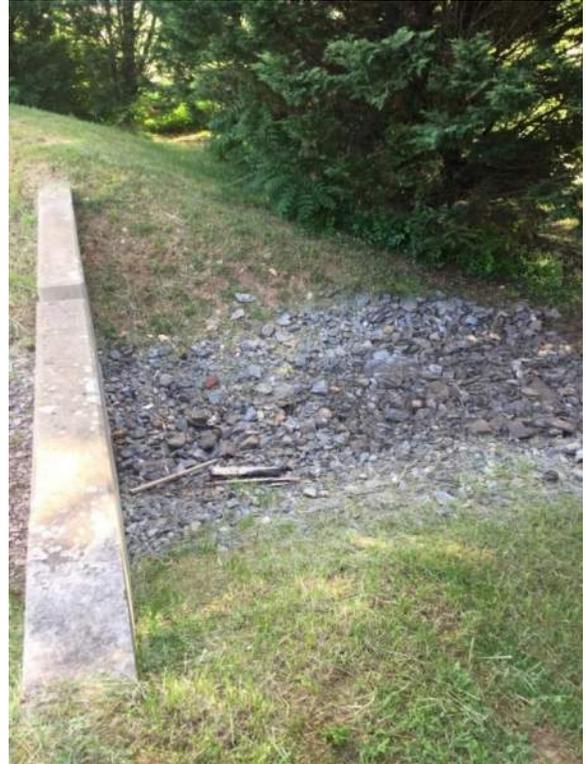
**Photo 2: View of riprap outfall channel.**

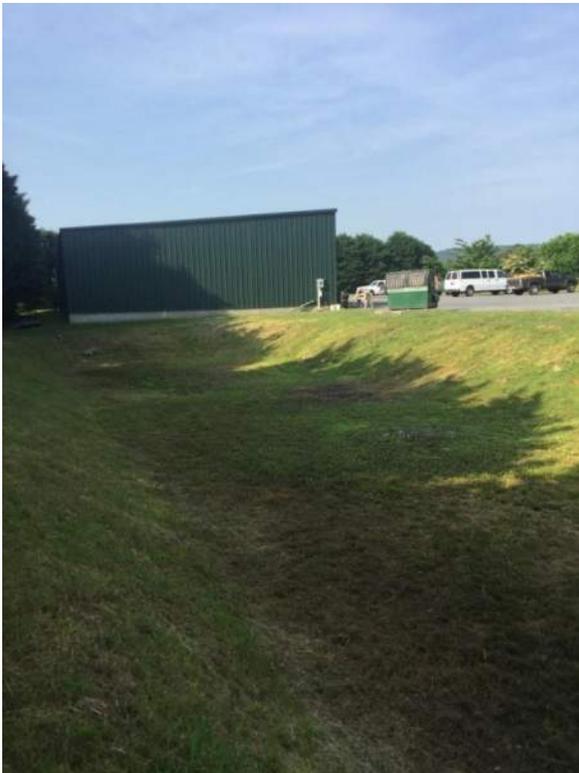
**Photo 3: Overall view of facility looking south.**

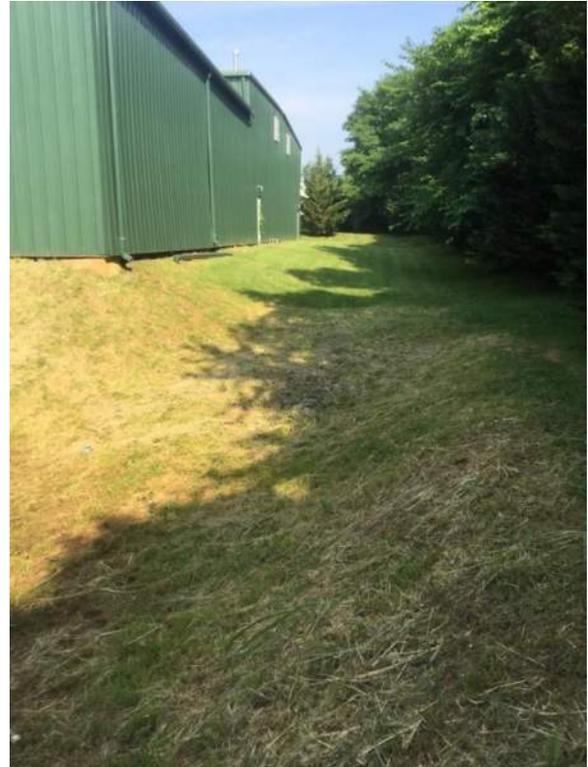
**Photo 4: View of grass swale inflow looking west.**

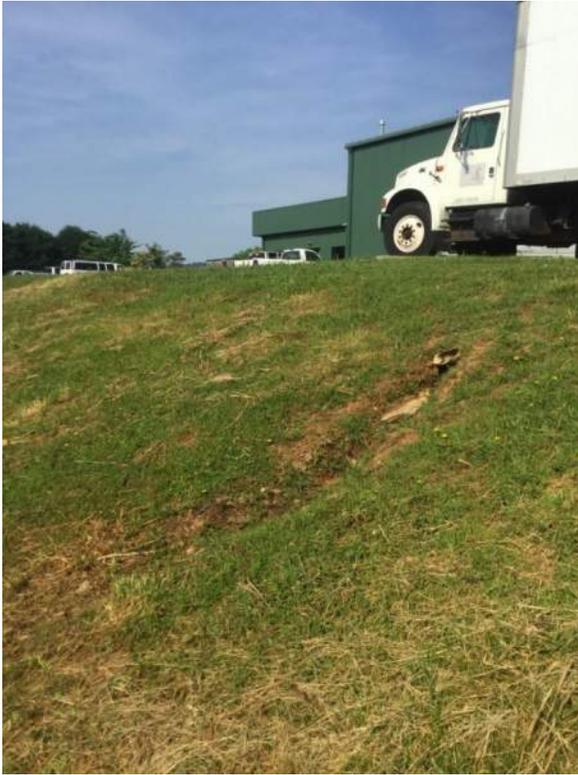
**Photo 5: View of rooftop downspout outflow.**

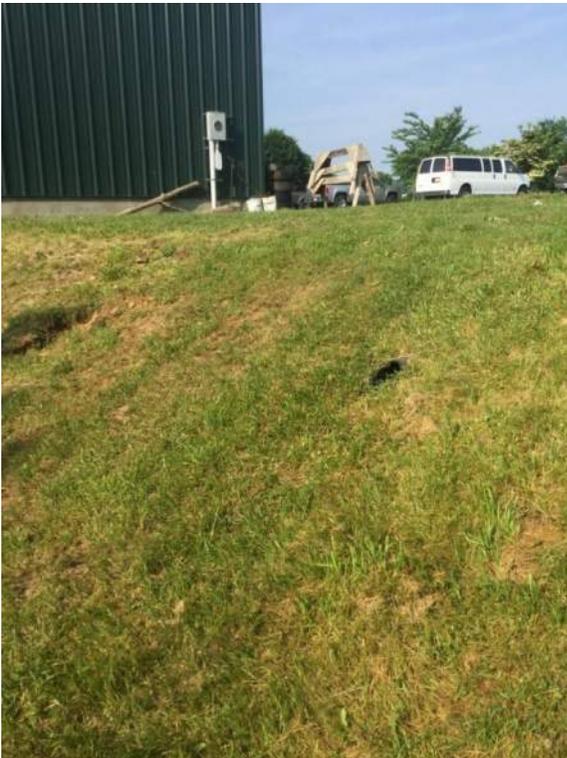
**Photo 7: View of rooftop downspout outflow.**

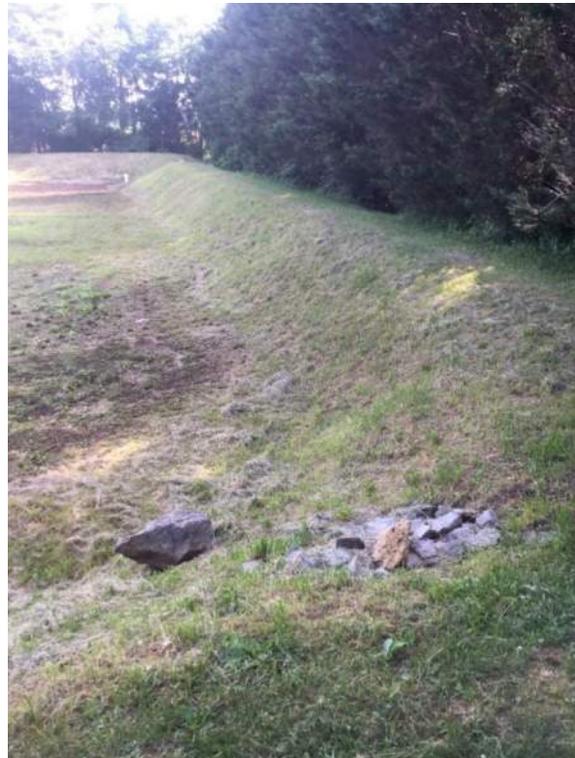
The facility has a 2-foot vegetated embankment in moderate condition due to a few animal burrows were observed in the embankment.

Overall, the facility appears to be in moderate condition, the embankment has good vegetative cover, though a few animal burrows are present that need repair. The facility does not meet criteria for water quality due to stormwater era making it a good candidate for a retrofit.

**Photo 8: View of facility embankment, looking north.**

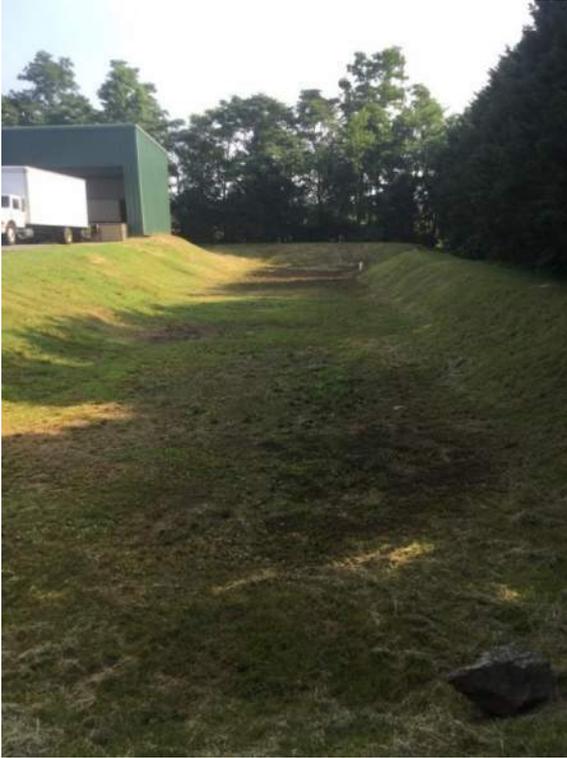
**Photo 9: Overall view of facility looking north.**

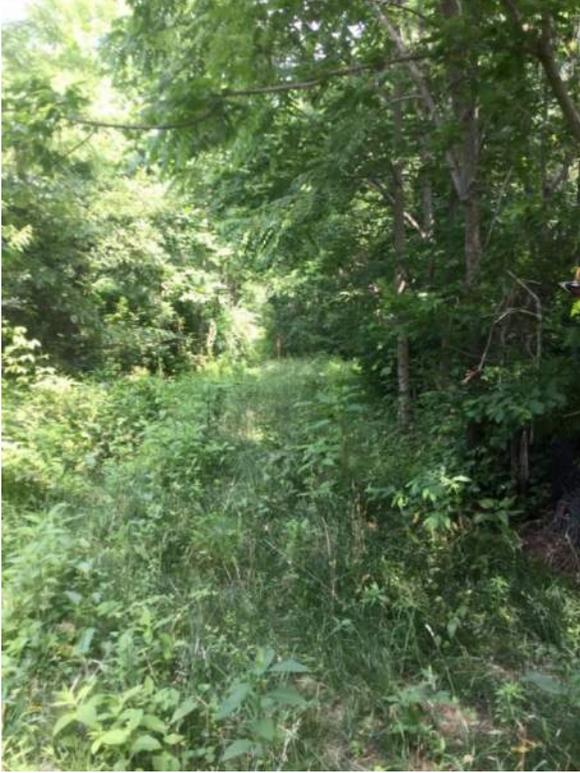
**Photo 4: Overall view of facility looking to the north**

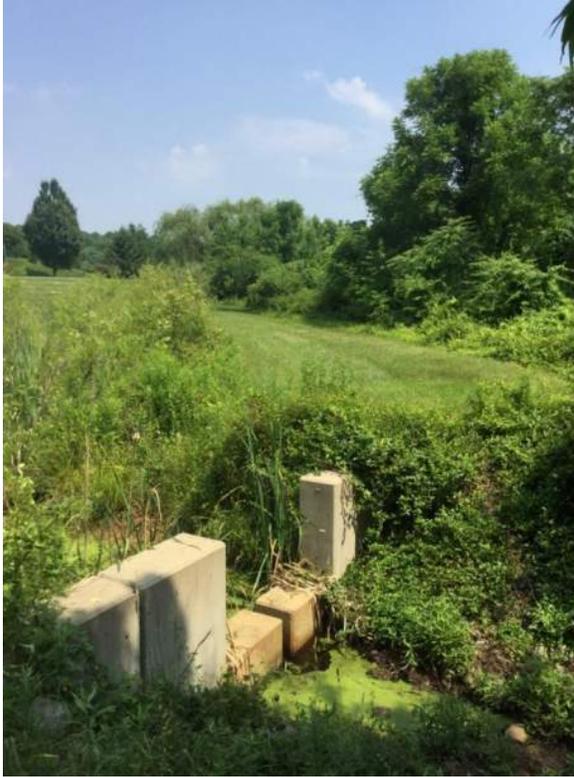
According to the site visit notes, the control structure consists of a 2-stage notch weir and a spillway in good condition.

**Photo 1: View of existing weir wall structure looking east**

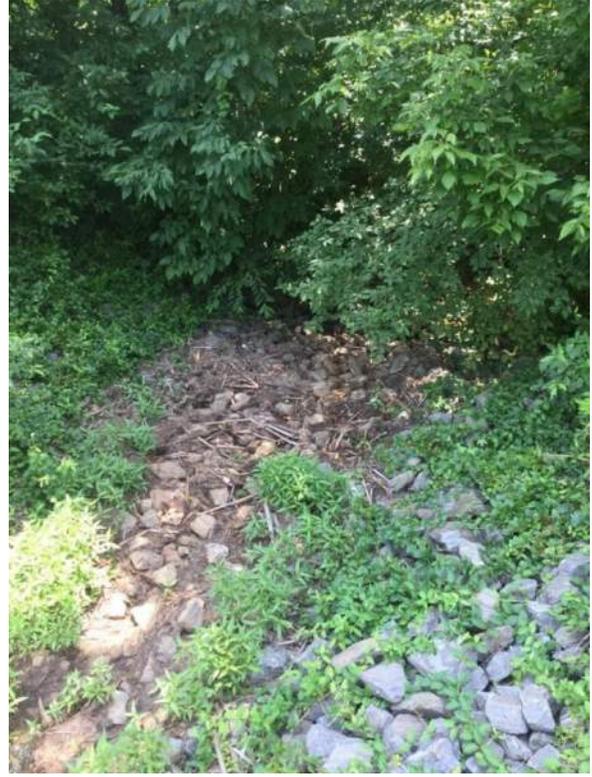
The outfall was observed to be in good condition with minor debris in the riprap channel.

**Photo 2: View of outfall channel looking south**

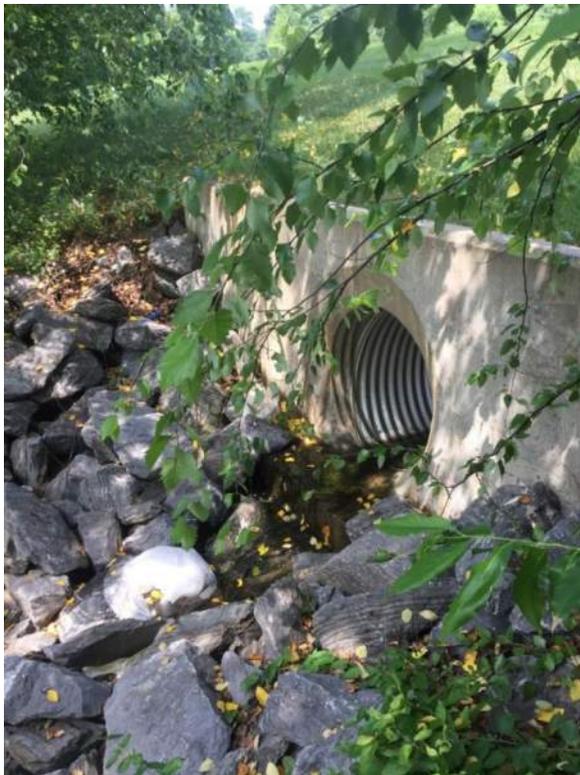
The facility has one inflow point consisting of a 36" inflow pipe with a riprap channel in good condition.

**Photo 3: View of inflow looking west**

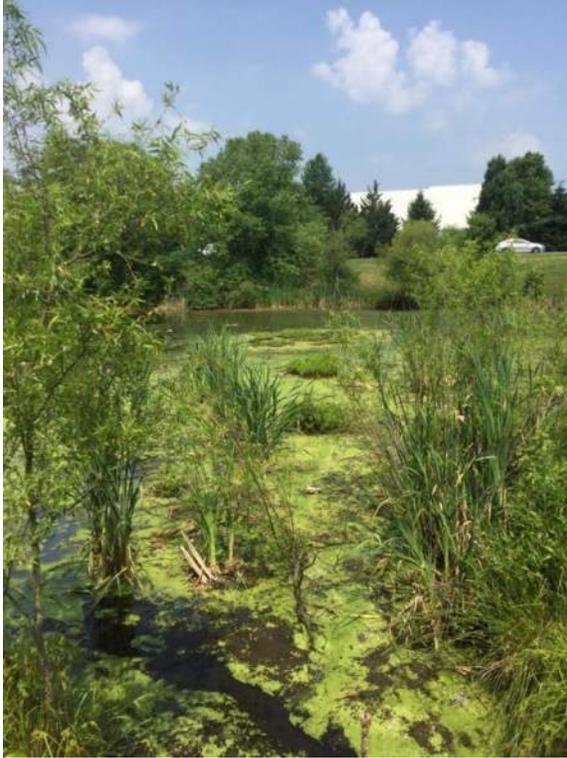
Overall, the facility appears to be in good condition, but does not meet criteria for water quality treatment due to lack of current as-builts.

**Photo 5: Overall view of pond looking northwest**

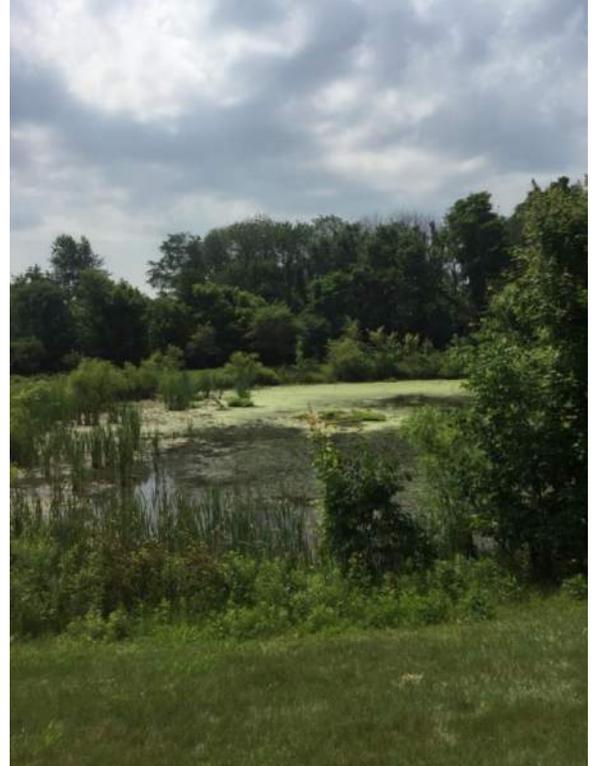
**Photo 6: Overall view of pond looking south**

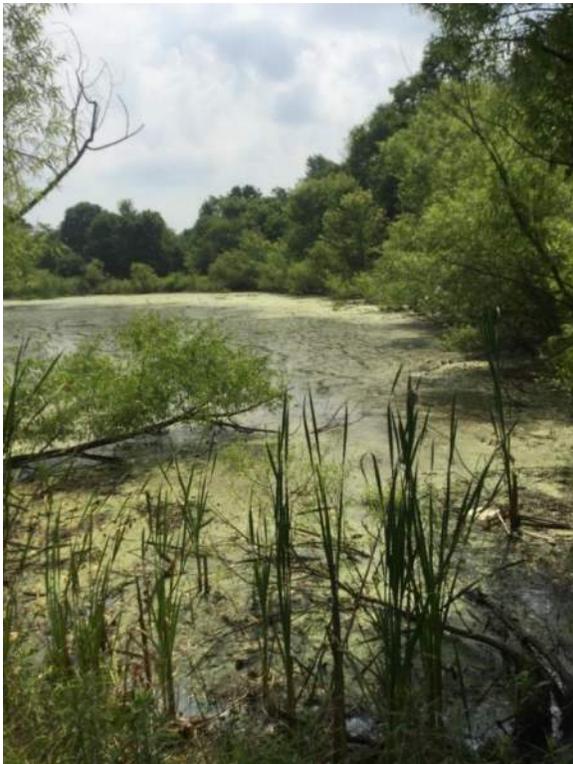
**Photo 7: Overall view of facility looking southeast**

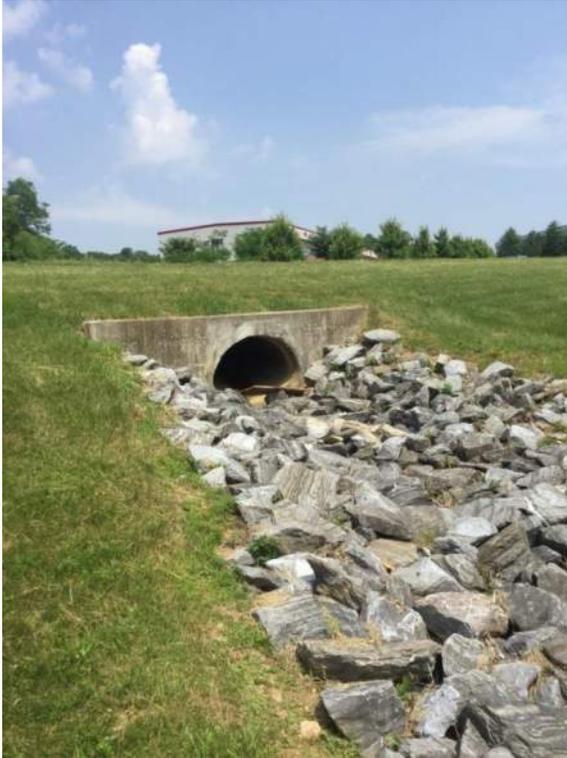
The facility has one inflow point consisting of an elliptical CMP pipe with a riprap channel in good condition.

**Photo 1: View of inflow looking north**

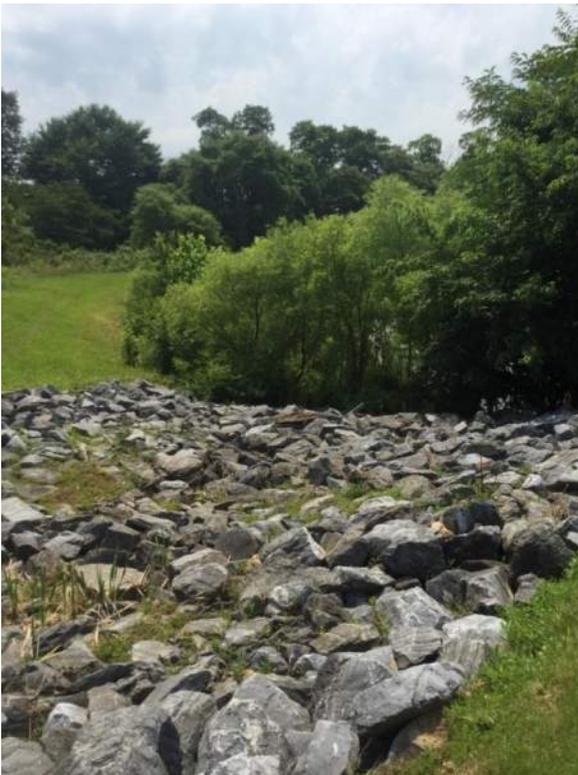
**Photo 3: View of inflow channel looking south**

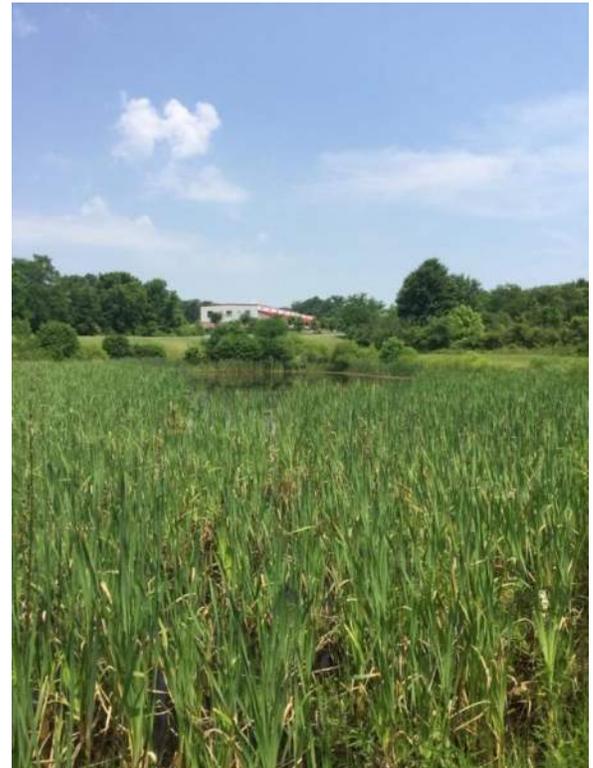
Overall, the facility appears to be in good condition, but does not meet criteria to treat for water quality due to lack of current as-builts. Flow could not be observed entering the facility during the site visit but was observed at the facility's outfall. The downstream channel was in moderate condition with small portions of erosion. No major problems were observed in the BMP.

**Photo 4: Overall view of facility**

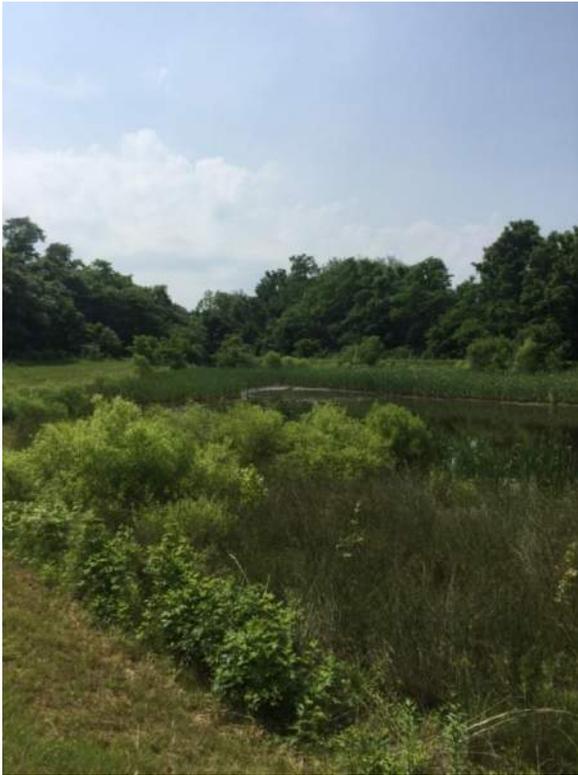
**Photo 5: Overall view of facility looking south**

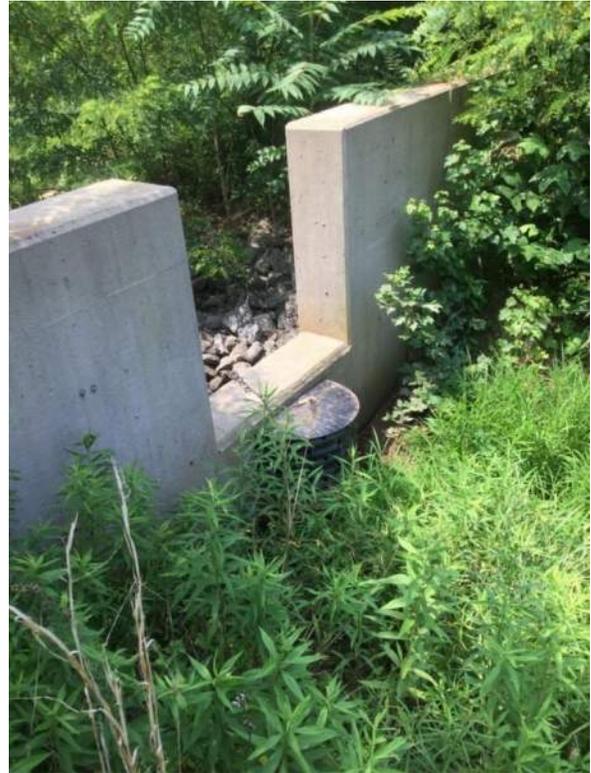
**Photo 6: View of existing weir wall**

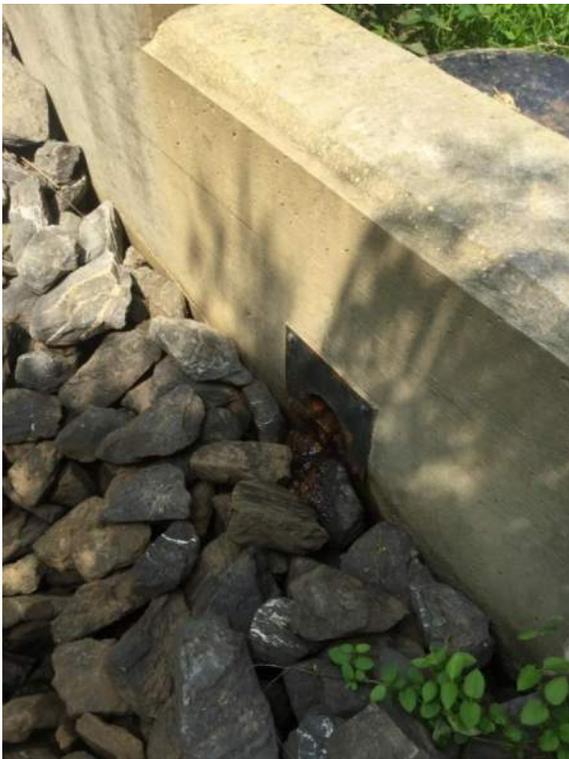
**Photo 7: View of existing low flow orifice**

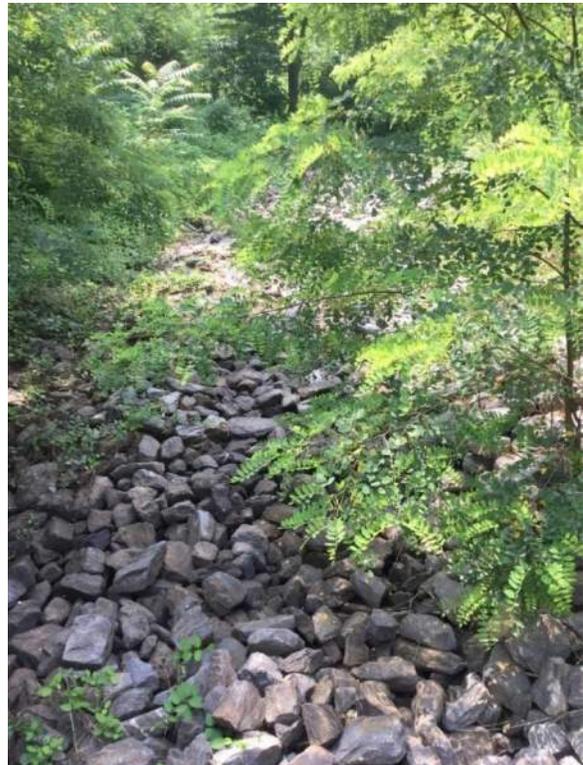
The outfall was observed to be in good condition with minor debris in the riprap channel.

**Photo 8: View of outfall channel**

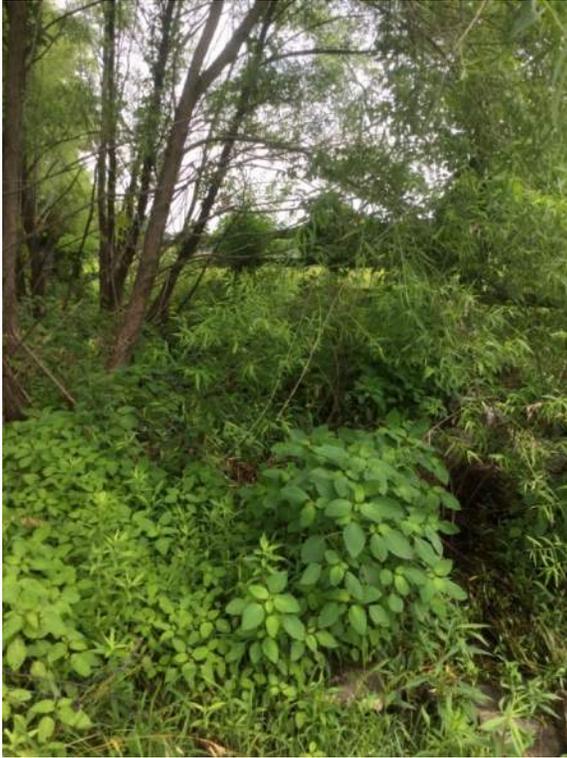
**Photo 1: View of inflow looking north.**

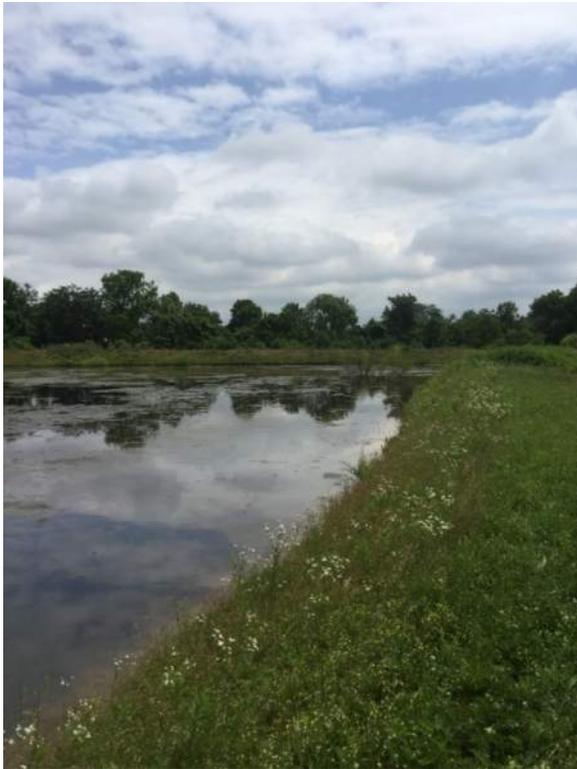
Overall, the facility appears to be in good condition but does not meet criteria to treat for water quality as the county does not have the required as-builts.

**Photo 3: Overall view of facility looking east .**

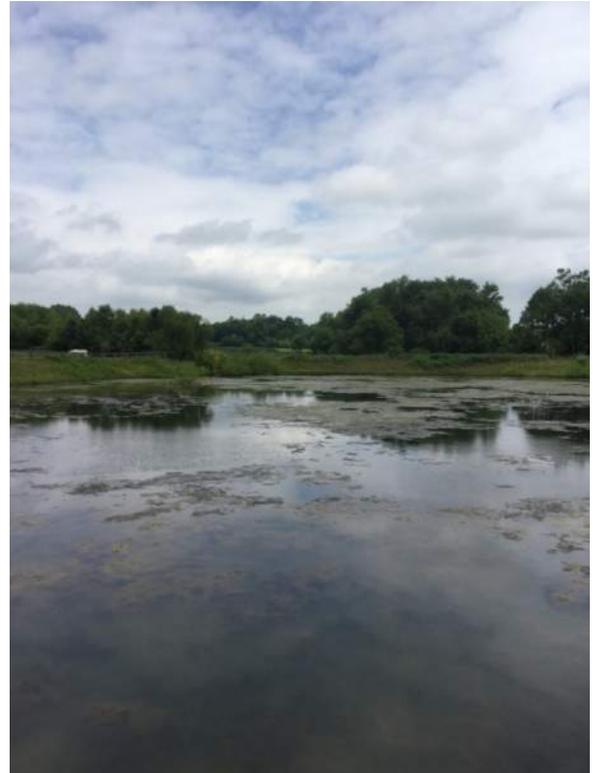
**Photo 4: Overall view of facility looking east.**

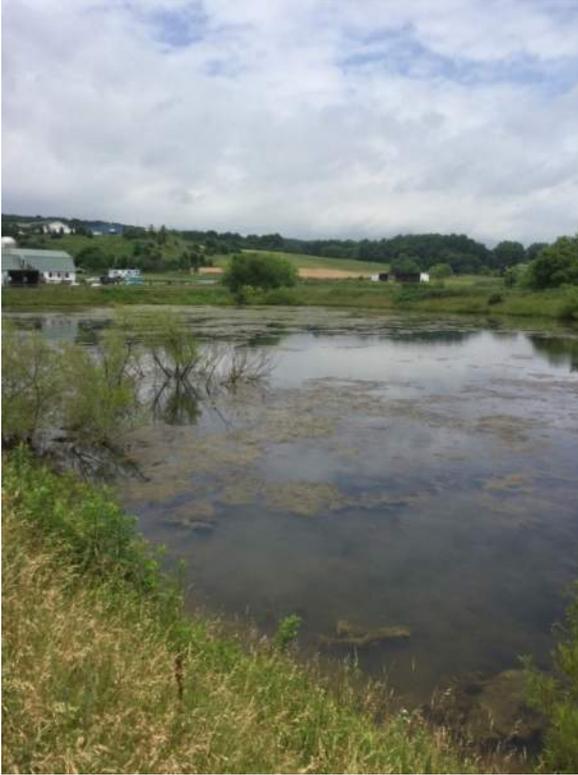
**Photo 5: Overall view of facility looking west.**

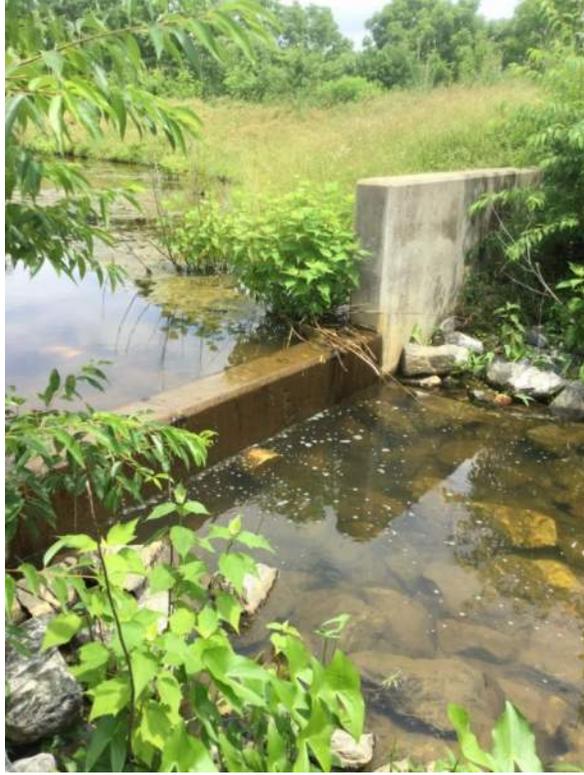
**Photo 6: View of existing weir wall.**

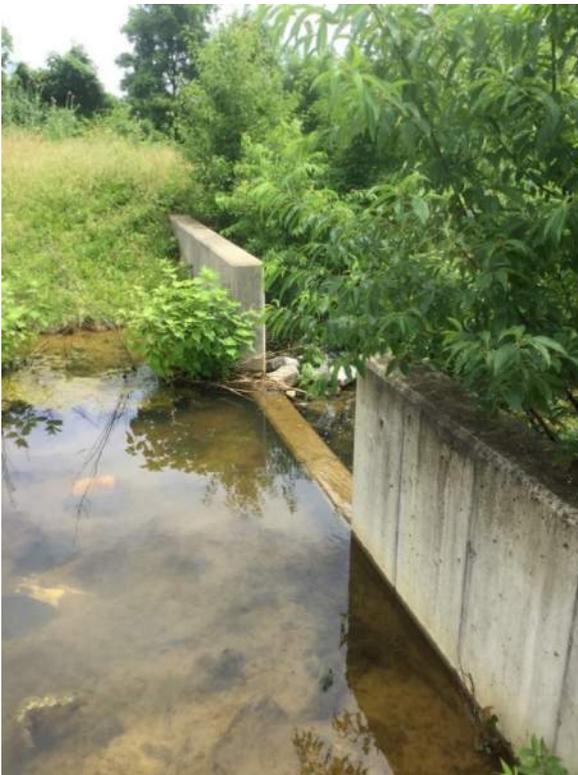
**Photo 7: View of existing weir wall, looking northeast.**

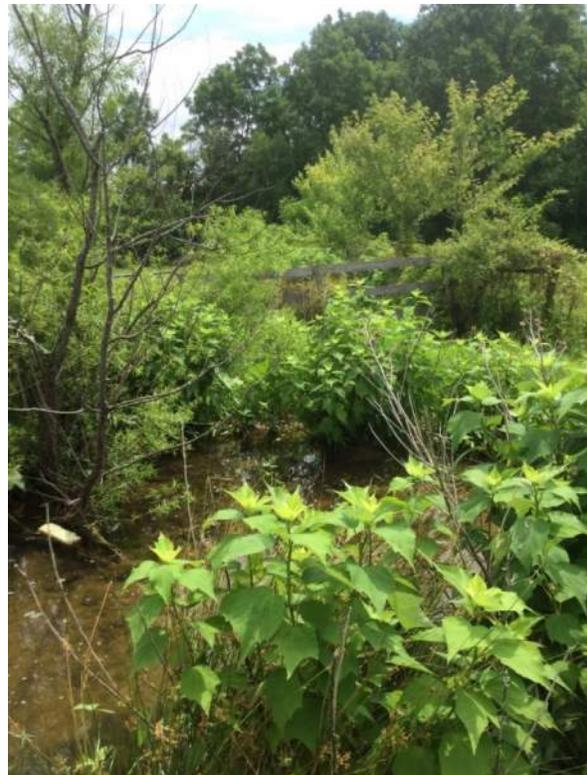
**Photo 8: View of outfall channel .**

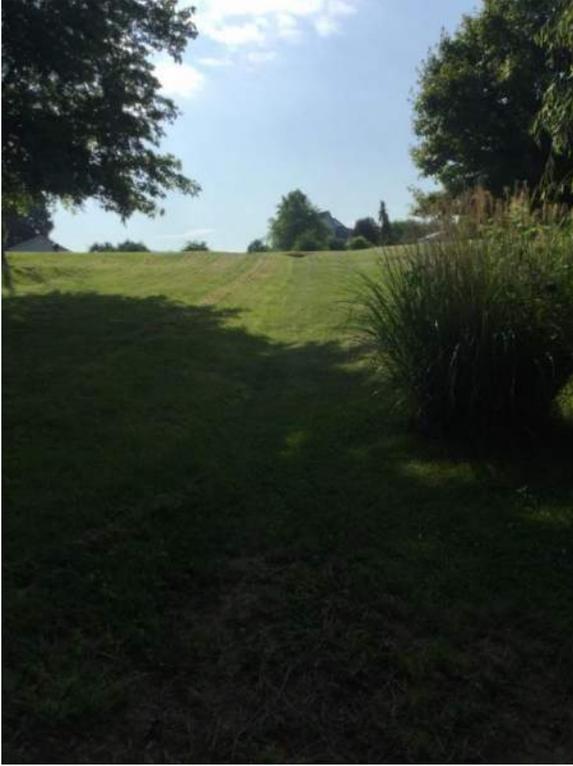
**Photo 1: View of eastern grass swale inflow.**

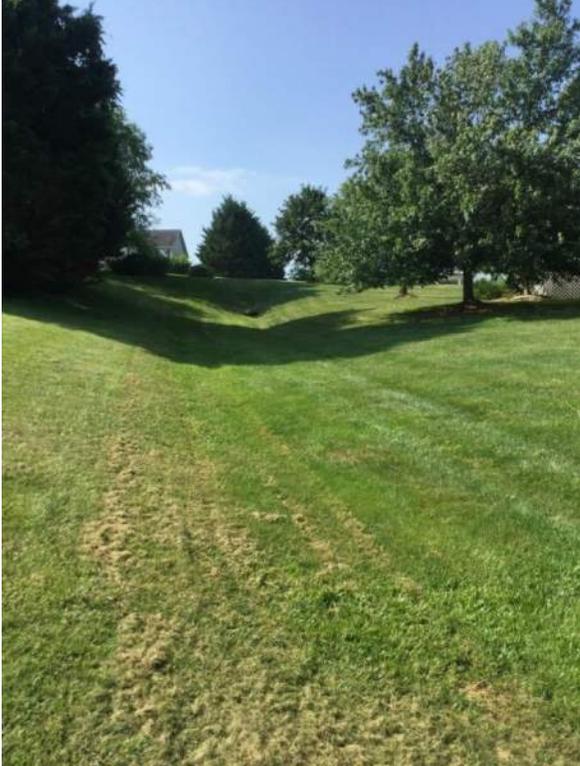
**Photo 2: View of southern grass swale inflow.**

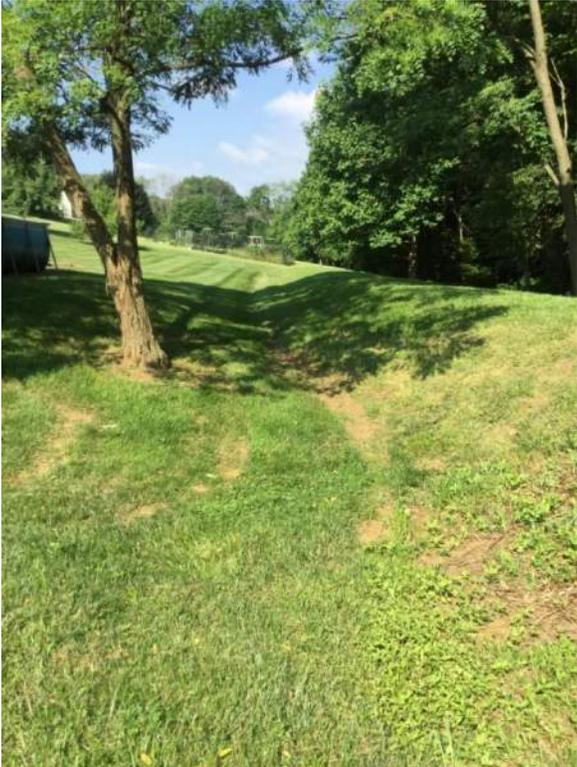
**Photo 3: View of western grass swale inflow.**

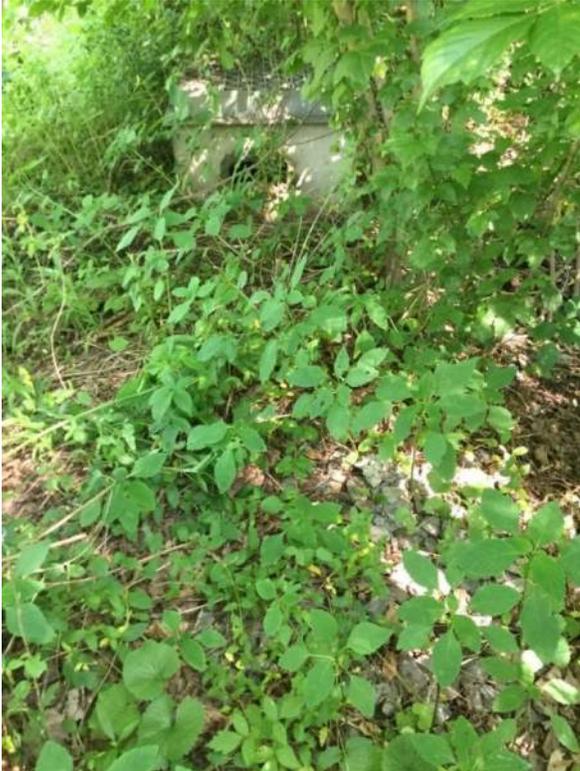
**Photo 4: View of existing concrete riser.**

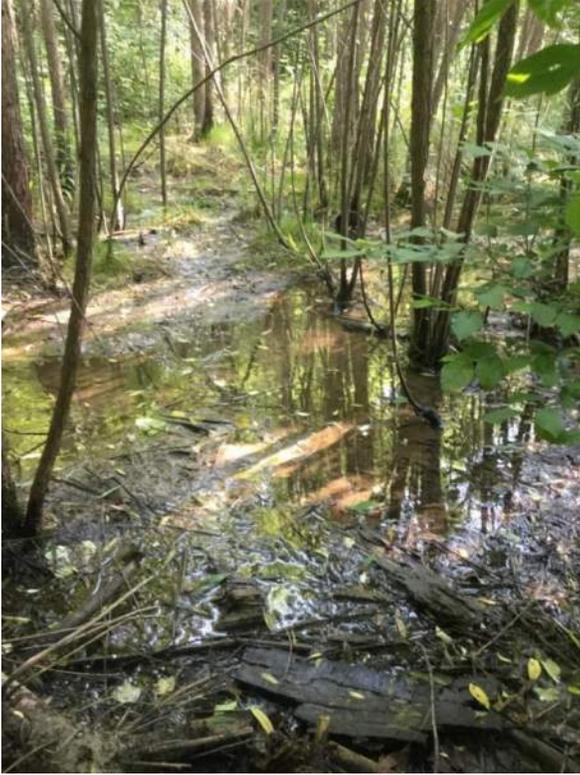
Overall, the facility appears to be in moderate condition. The facility was graded unevenly, was ponding during the time of the site visit and has become overgrown.

**Photo 5: Overall view of facility looking east.**

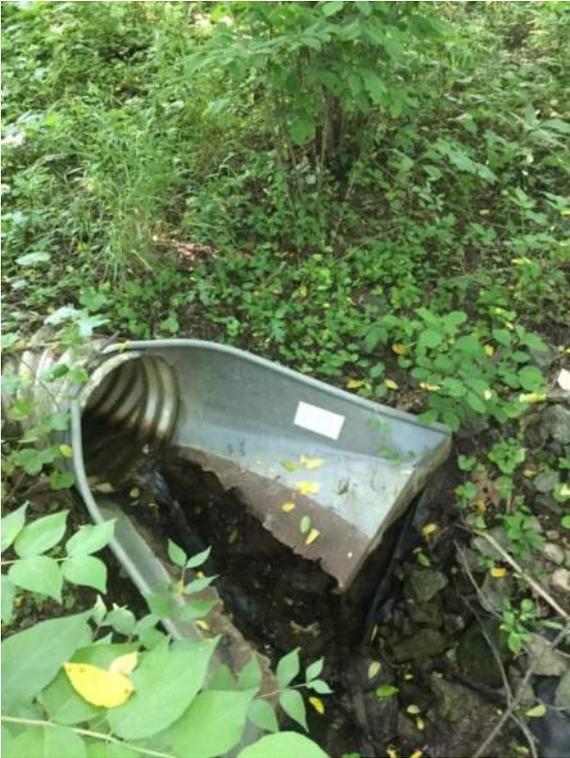
**Photo 6: View of facility CMP outfall.**

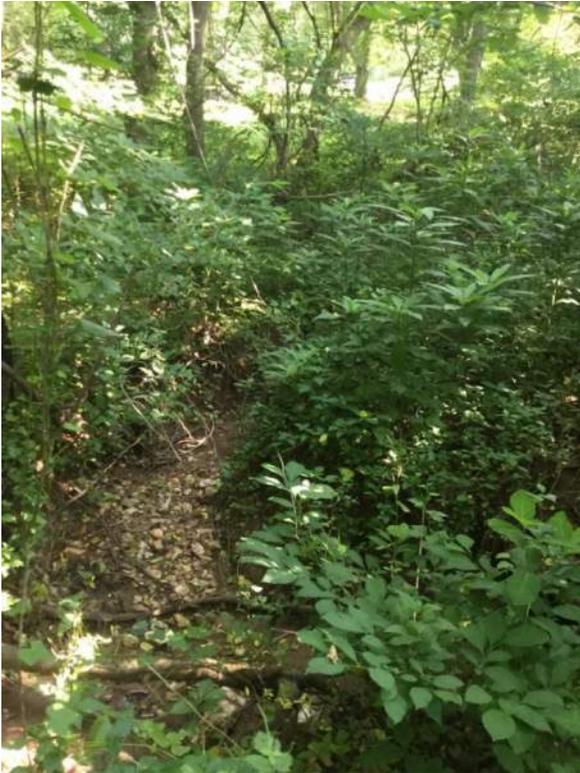
**Photo 7: View of outfall channel targeted for step pool system.**

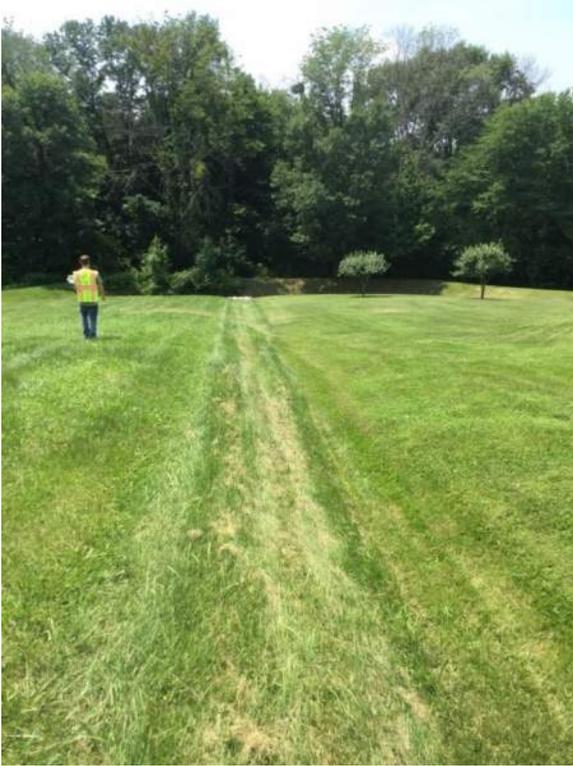
**Photo 1: View of eastern grass swale inflow.**

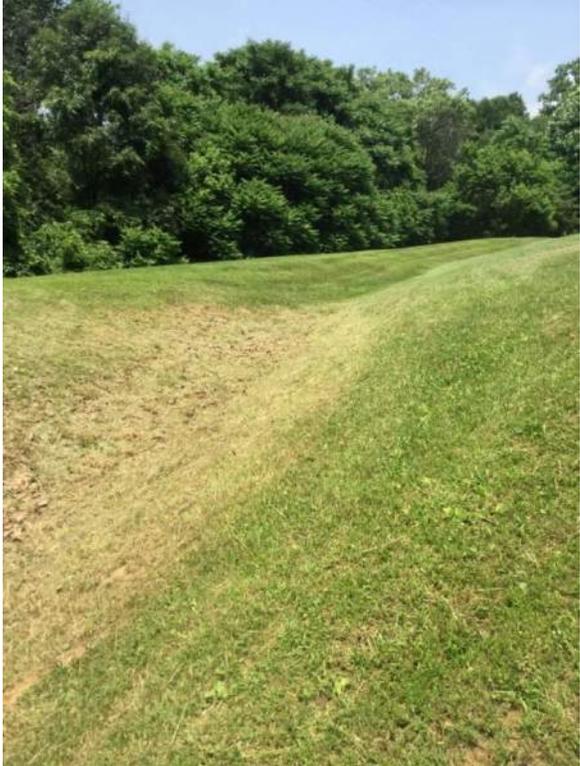
**Photo 2: View of northern grass swale inflow.**

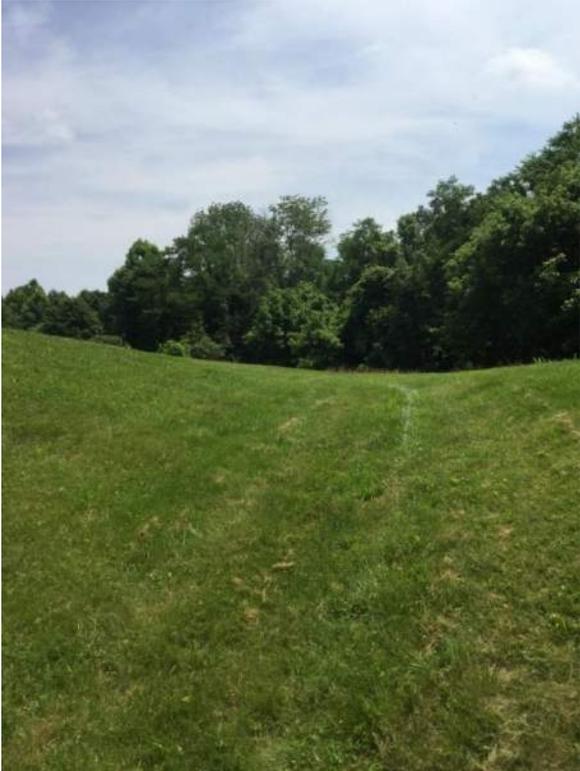
**Photo 3: View of southern grass swale inflow.**

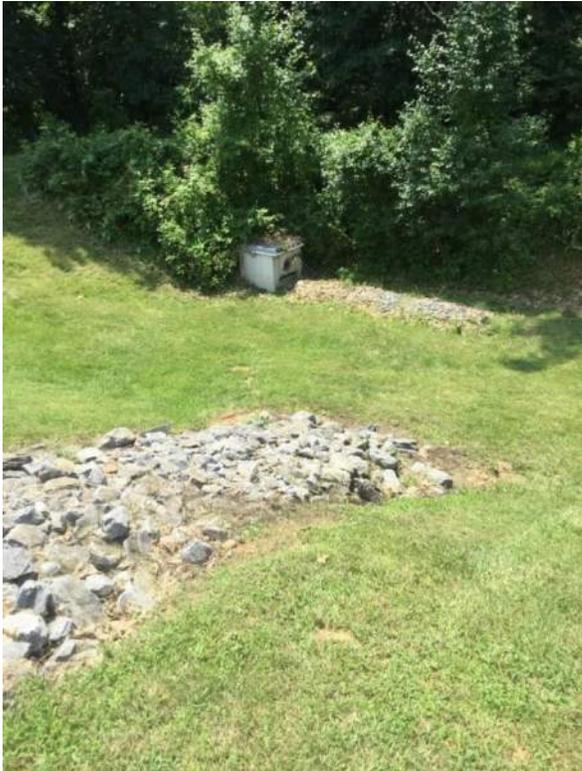
Overall, the facility appears to be in good condition but does not meet criteria to treat for water quality.

**Photo 4: Overall view of facility looking southwest.**

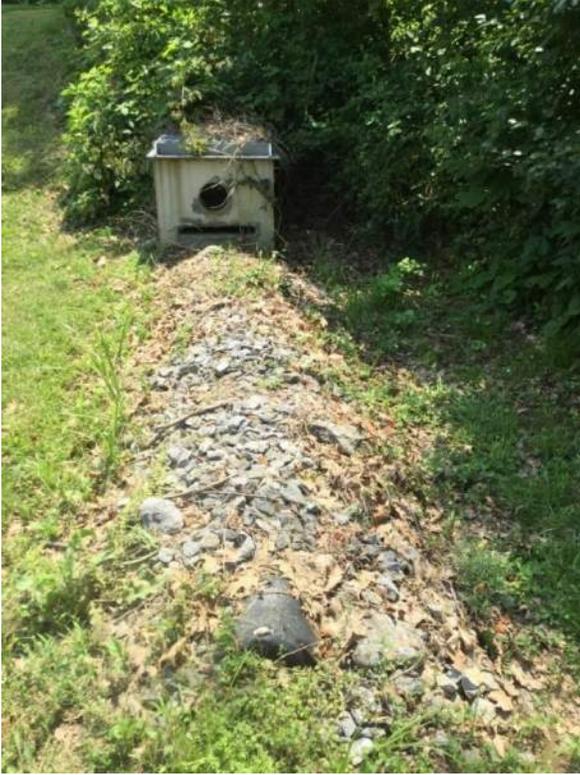
**Photo 5: View of facility existing concrete riser.**

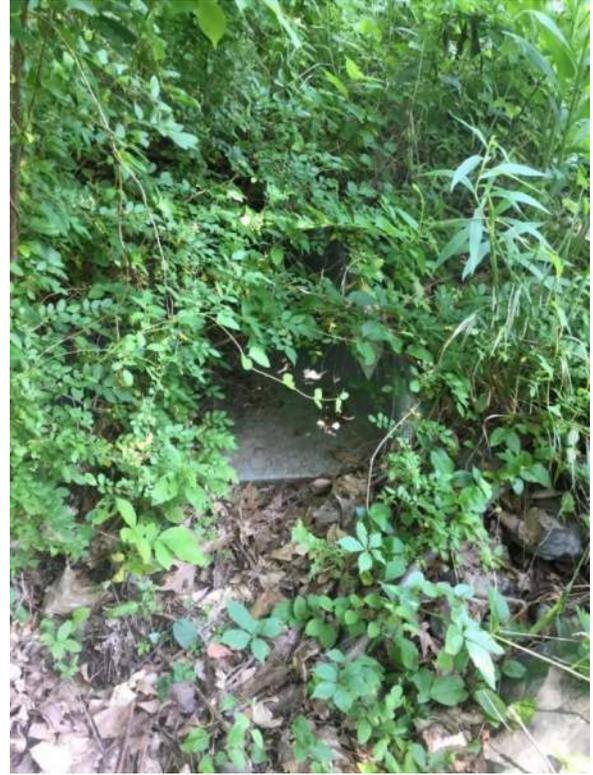
**Photo 6: View facility CMP outfall.**

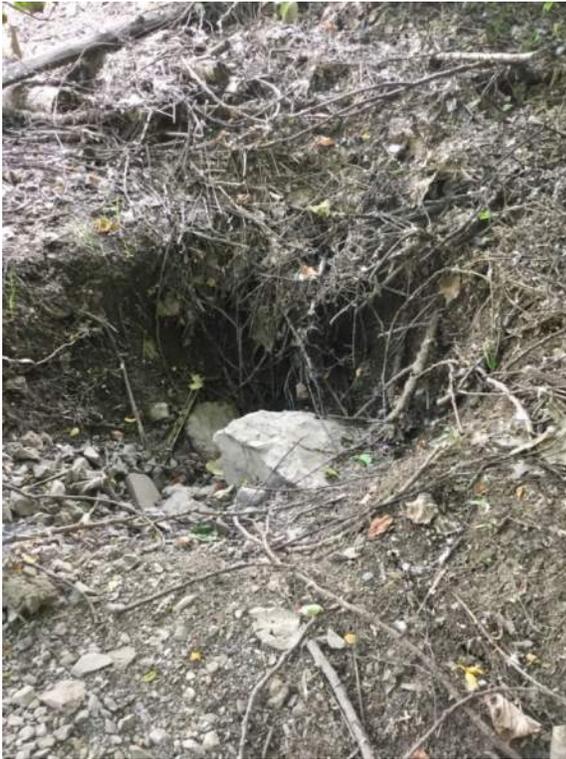
**Photo 1: View of assumed inflow location.**

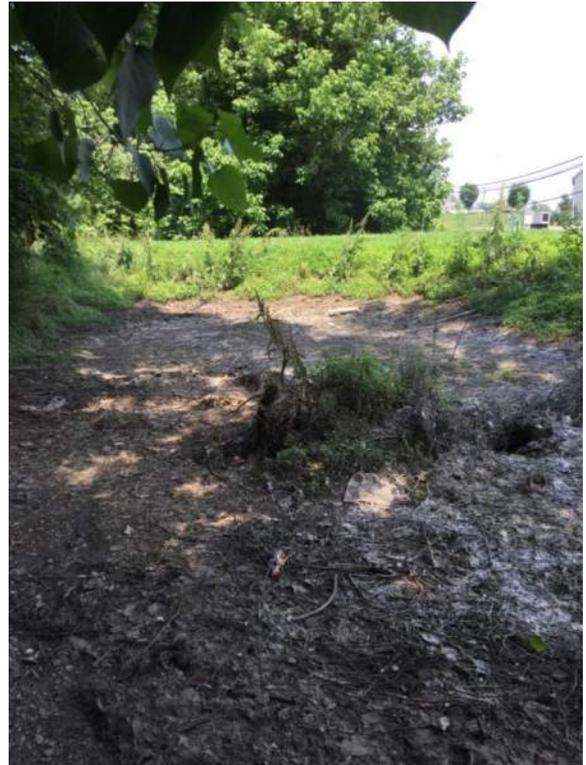
Overall, the facility appears to be in poor condition with limited ground cover and large amounts of debris and does not meet criteria to treat for water quality.

**Photo 2: Overall view of facility looking north.**

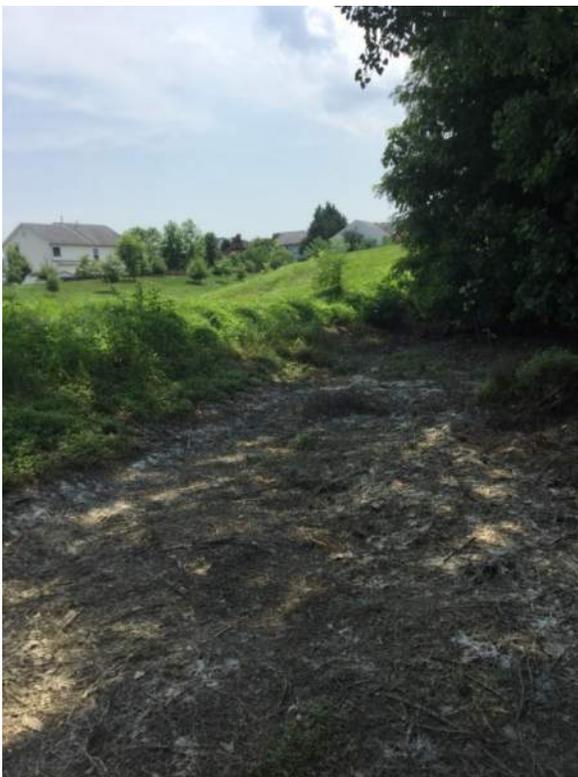
**Photo 3: Overall view of facility looking south.**

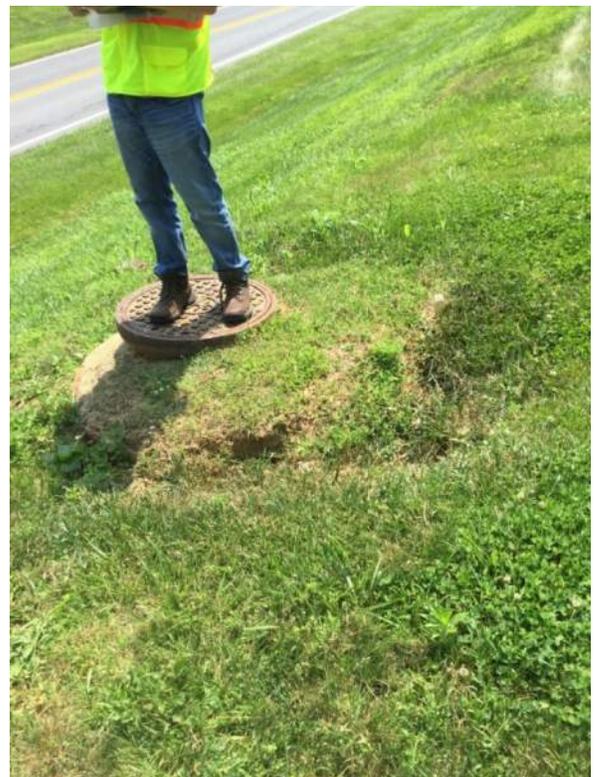
**Photo 4: View of stormdrain manhole connection east of the facility.**

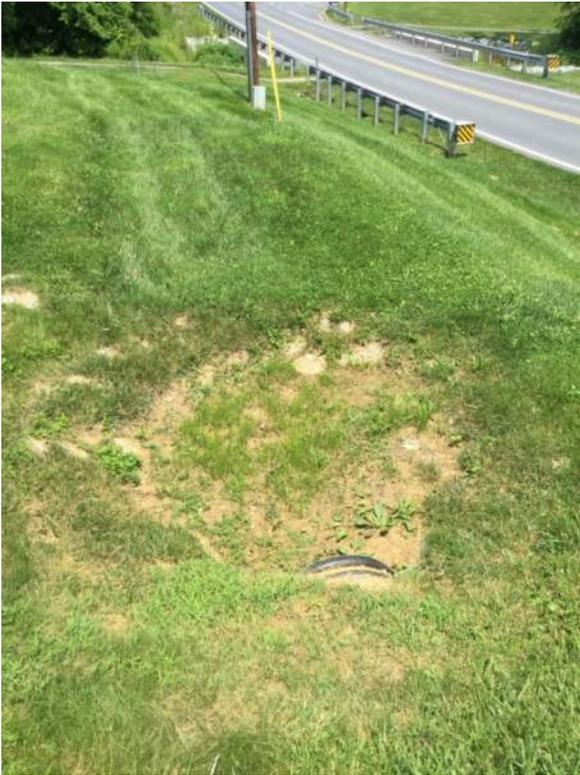
**Photo 5: View of roadside swale east of the facility.**
