## **Appendix C: Concept Designs**

Brown and Caldwell

Project: Potomac Direct Watershed Assessment

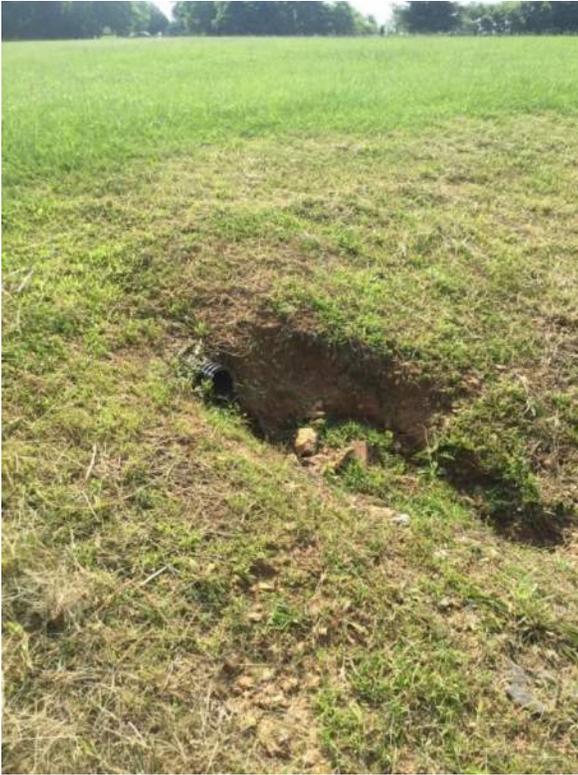
**Photo 1: View of inflow into the facility.**

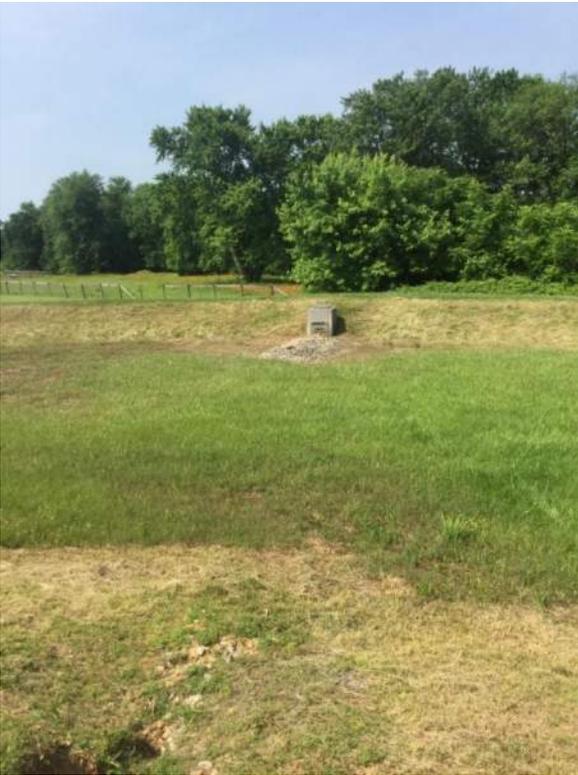
**Photo 2: Overall view of facility looking to the southwest.**

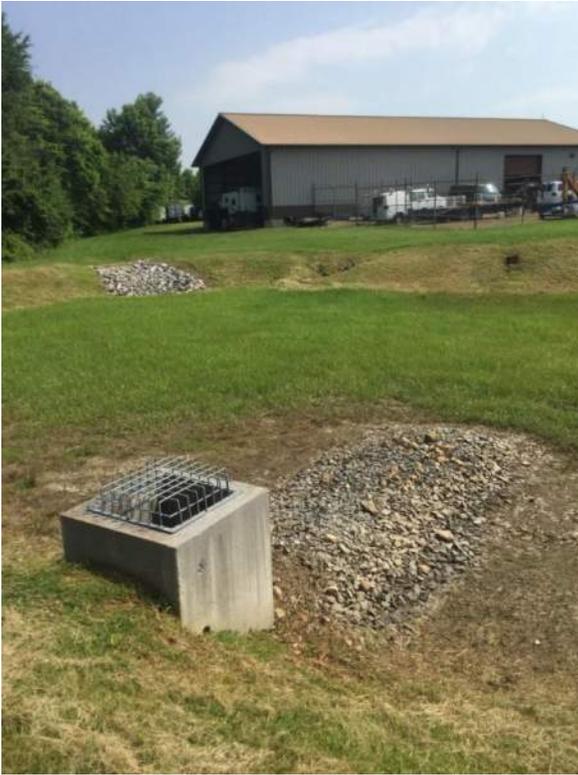
**Photo 3: Overall view of facility looking north.**

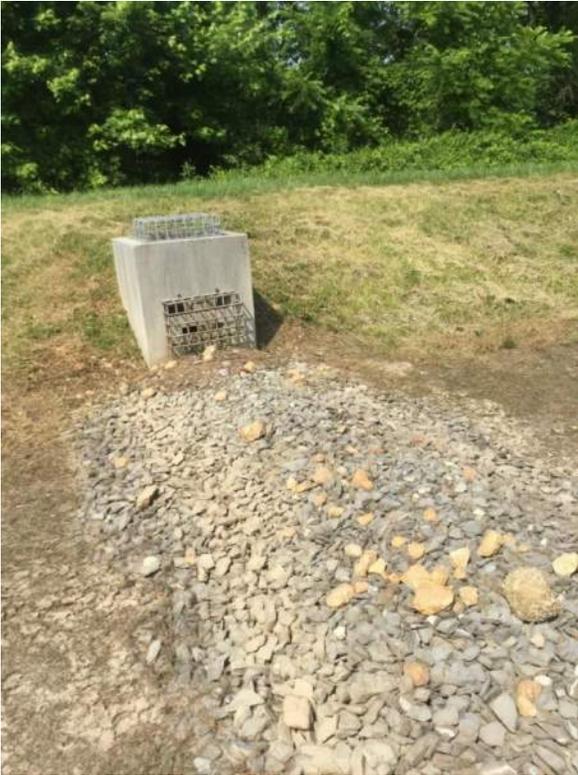
**Photo 4: View of existing concrete riser.**

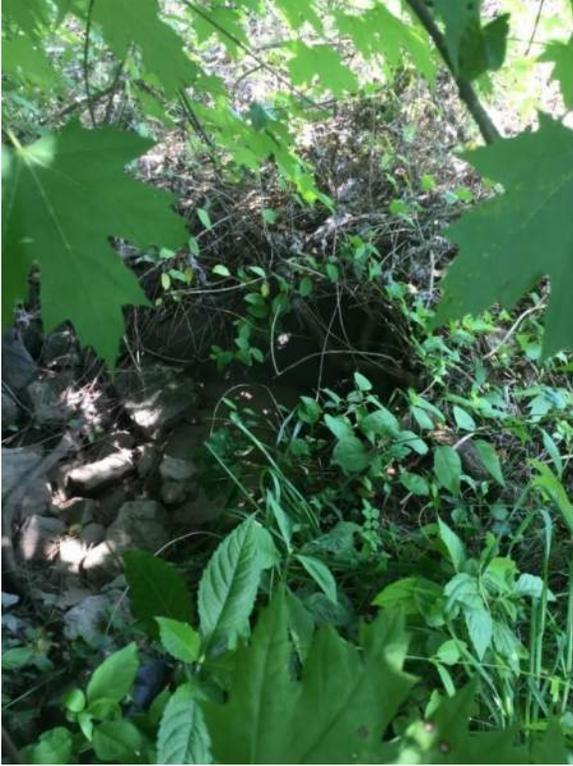
**Photo 5: View of existing outfall.**

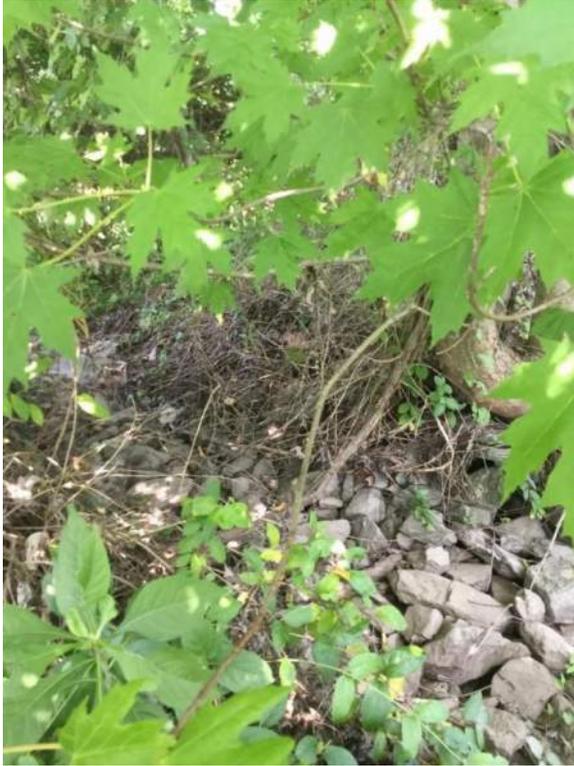
**Photo 6: View of existing outfall channel.**

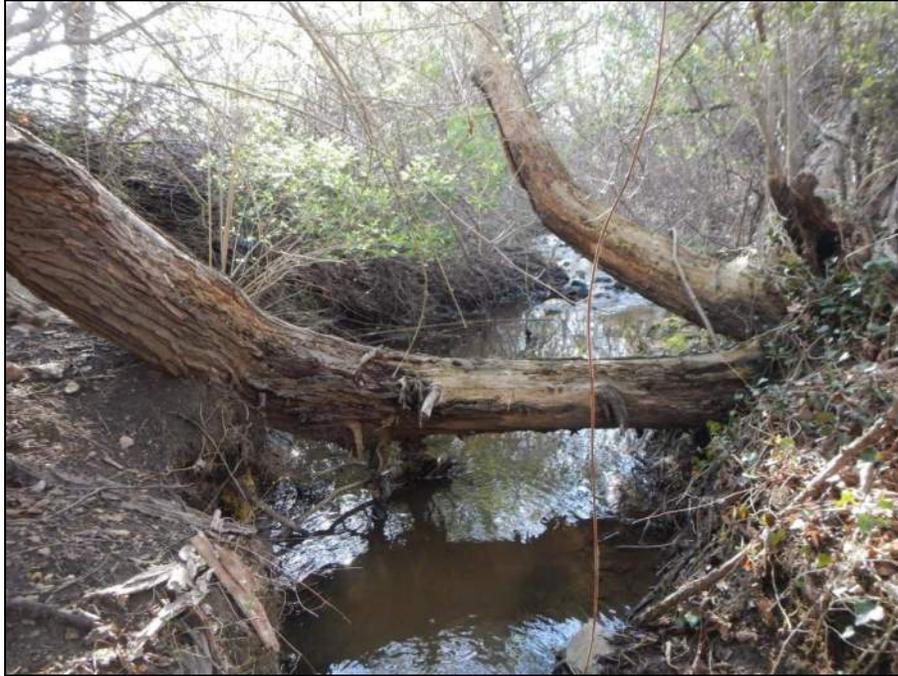
**Photo 1: Looking downstream at 3' tall, raw, actively eroding banks with exposed roots and large wood debris littered across the stream.**

Given the extent of channel instability and bank erosion, full restoration of this stream is recommended. The proposed stream restoration will follow the principles of Natural Channel Design (NCD), and establish long-term, self-maintaining stream stability. The design will re-establish a stable cross section, planform, and profile throughout the reach. A floodplain connection will be reestablished either by raising the channel invert to access the existing floodplain or by constructing a bankfull bench at a lower elevation; this will reduce flood flow velocity, facilitate deposition of fine grain sediments in the floodplain, increase local groundwater levels, and facilitate subsurface nutrient processing in the riparian area. Stable riffles will be created within the restored channel using reinforced bed material, sized to transport sediment and enhance hyporheic flow. Geomorphic structures, such as step pools, cross vanes, and sills, may be incorporated into the design to provide grade control, energy dissipation, and bank protection if conditions warrant. These geomorphic structures will also facilitate nitrogen load reduction and increase hydraulic diversity. Log structures and woody debris will provide habitat diversity and a carbon source to facilitate in-stream nitrogen processing.

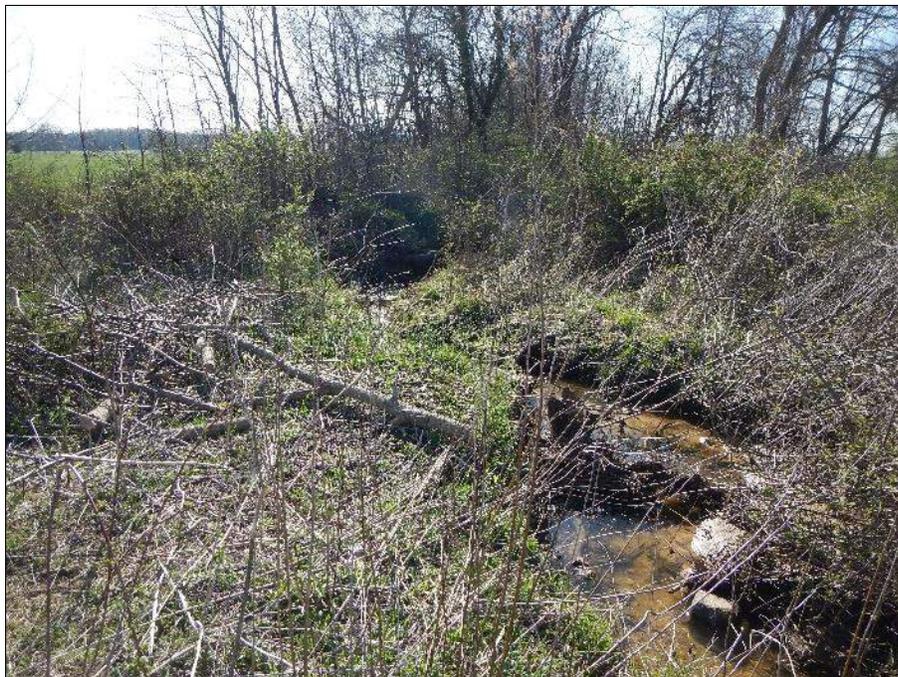
**Photo 2: Looking downstream at a tortuous meander with a 3' tall, undercut, actively eroding bank with exposed tree roots and falling trees**

The existing channel is primarily straight and lacks natural meanders; therefore, a more stable planform and meander pattern will be established to reduce flow velocities and increase hydraulic diversity. Culverts located under driveways will be resized to convey appropriate stream flows, and an imbricated headwall may be placed around the culverts to prevent further erosion. Geomorphic structures will be placed at critical points such as the upstream and downstream ends of the restoration and at culvert outfalls; these structures may also be placed along the reach where conditions warrant.

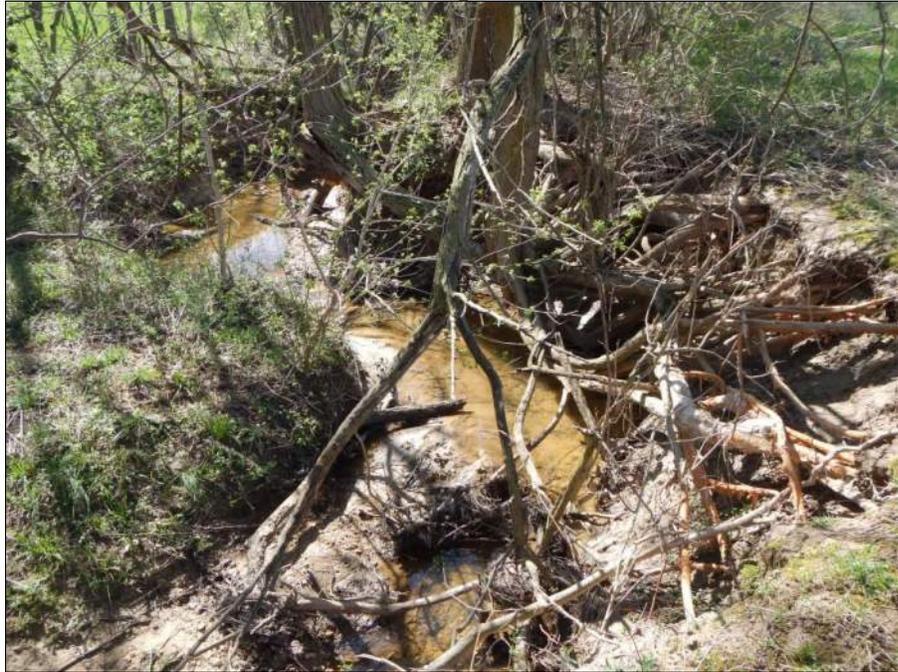
**Photo 3: Looking downstream at a 3' tall, incised, actively eroding bank with exposed roots and woody debris littered across the stream**

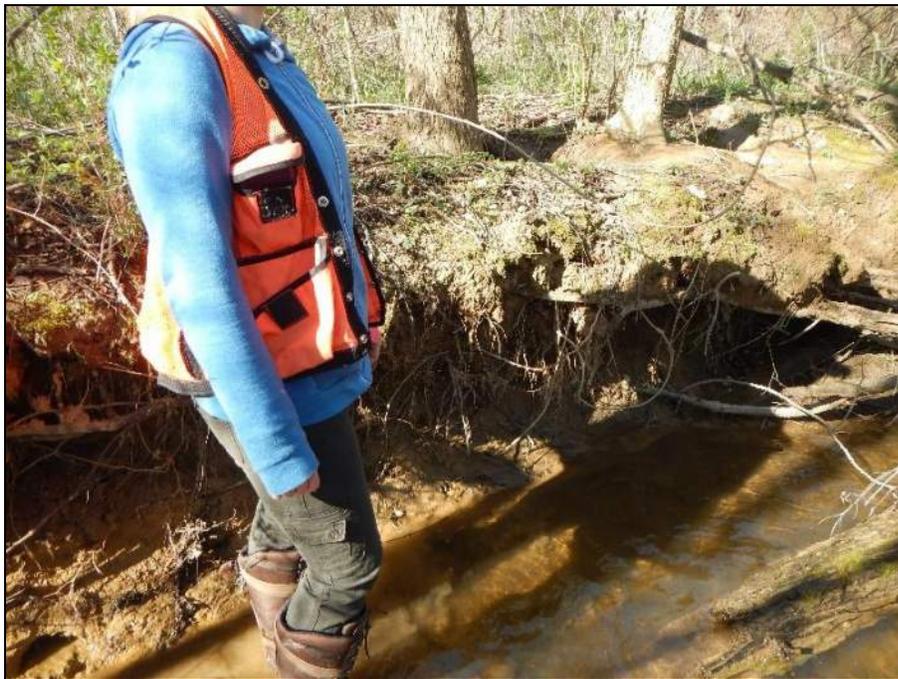
**Photo 4: Looking across the stream at a 3' tall, incised, raw, actively eroding bank with exposed roots and no connection to floodplain**

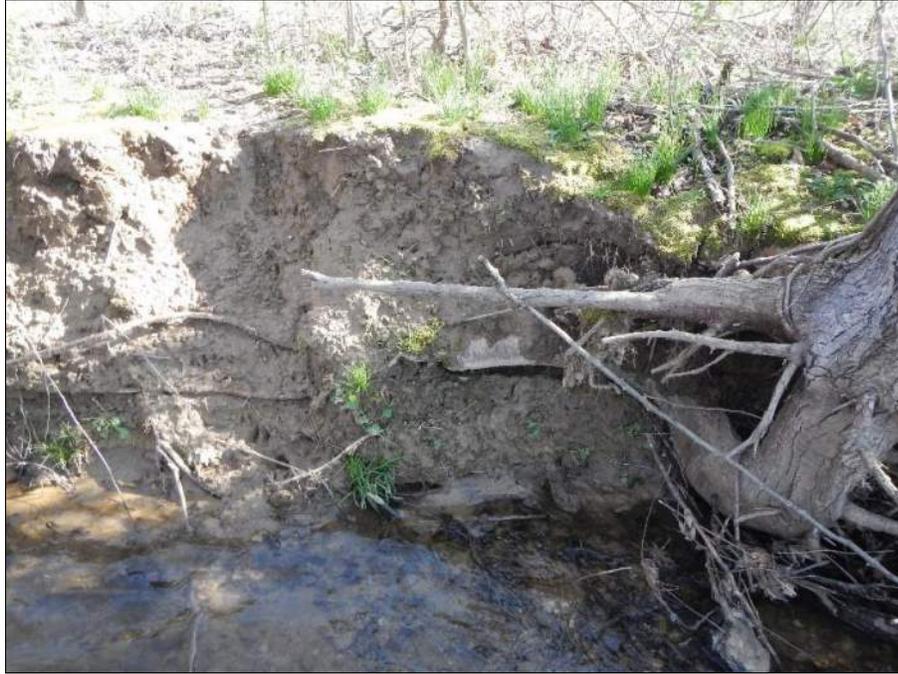
**Photo 5: Looking across the stream at a 4' tall, vertical, raw, actively with a falling tree and minimal riparian vegetation**

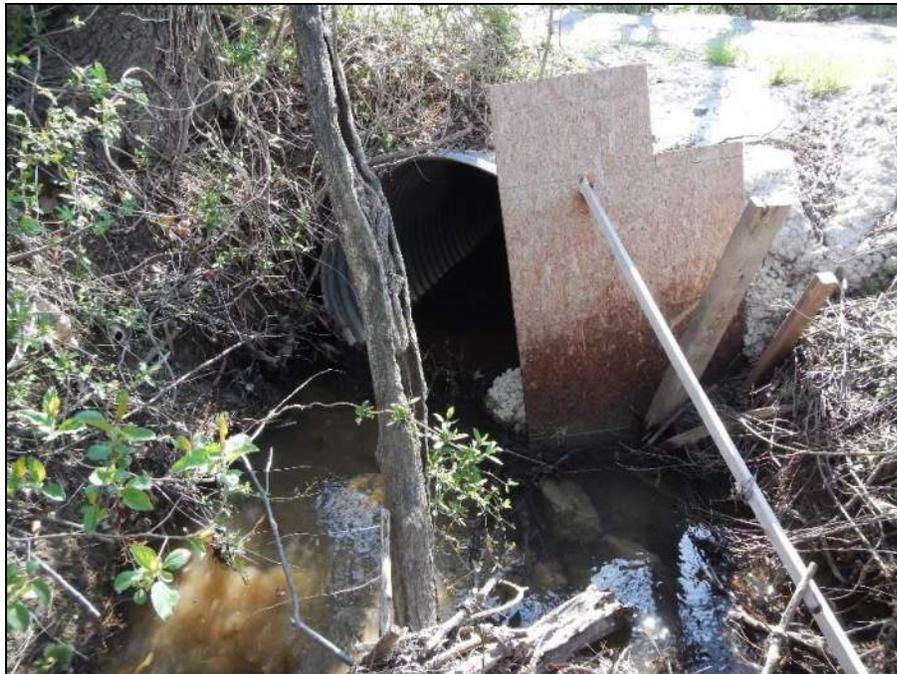
**Photo 6: Looking downstream at an undersized culvert exhibiting over-road flow and active erosion on the road banks**

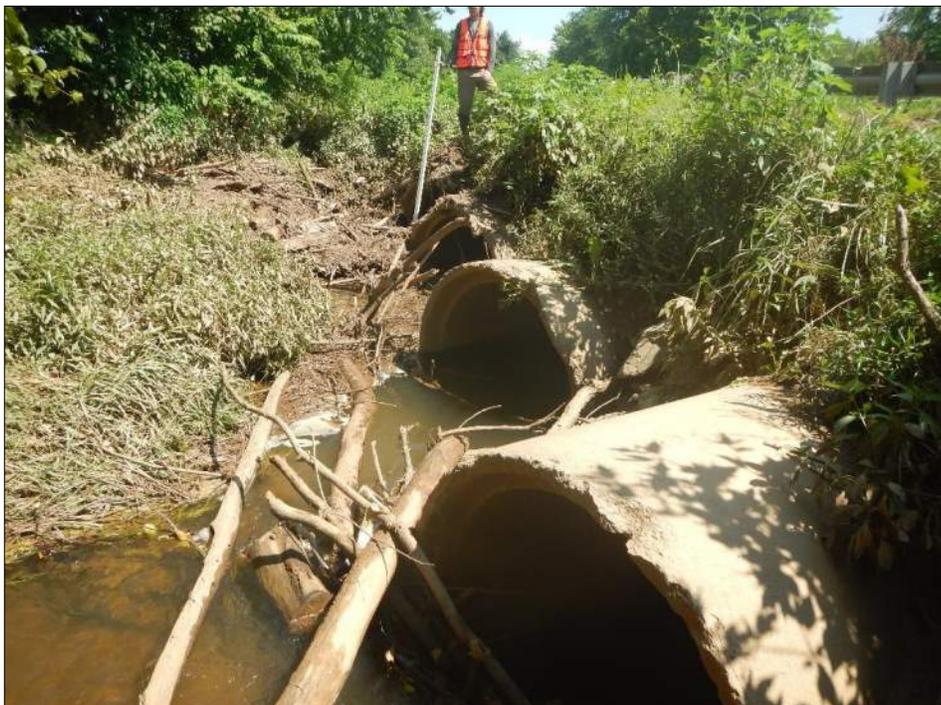
**Photo 8: Looking downstream at four culverts in parallel that exhibit active erosion and overflow – this is the downstream limit of restoration**

In areas where tortuous meanders are proposed to be abandoned, such as the upstream end of the northwestern reach, oxbow channels will be established to provide alternative flow paths and habitat diversity. The northeastern channel will be realigned to increase sinuosity. Geomorphic structures will be placed at critical points such as the upstream and downstream ends of the restoration, at culvert outfalls, and at the stream confluence; these structures may also be placed along the reach where conditions warrant. The confluence of the two upstream reaches will be re-aligned and stabilized. At the entrance to the culverts under Manor Woods Road the channel will be re-aligned and widened to improve conveyance through the culverts and reduce sediment deposition. An imbricated rock headwall will be placed around the culverts to prevent further erosion.

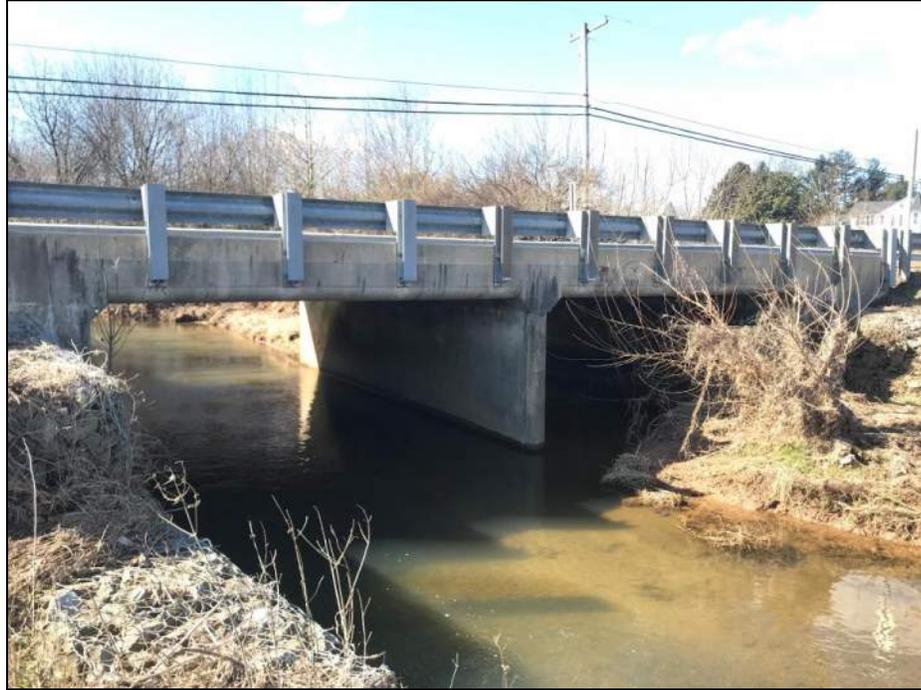
**Photo 1: Looking downstream at bridge opening beneath Mountville Road, which is the upstream start of the reach.**

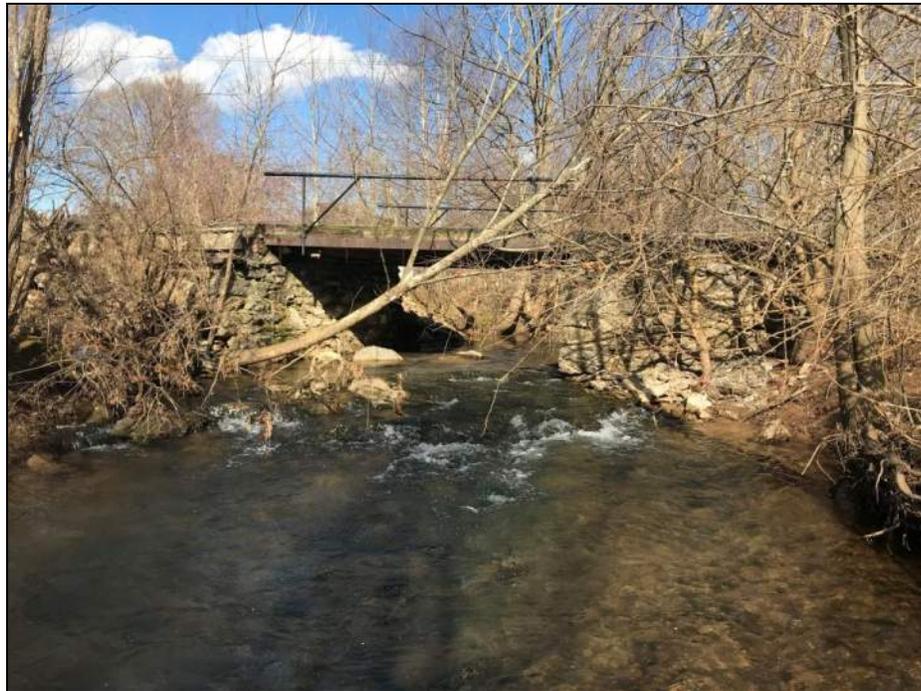
**Photo 2: Looking upstream at driveway bridge opening, which will be maintained in proposed condition.**

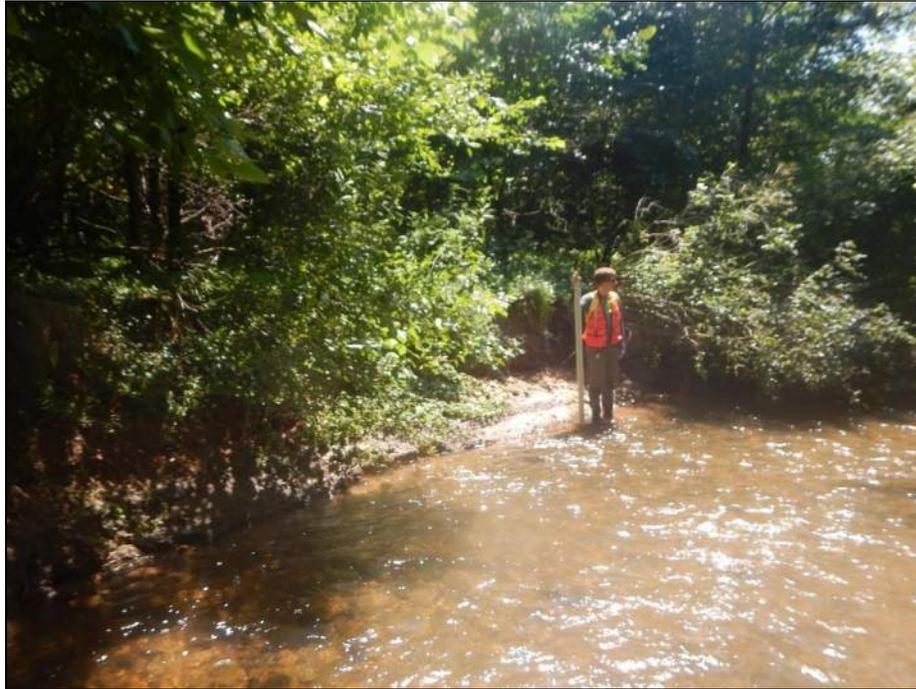
**Photo 3: Looking upstream at 4' tall vertical, raw, actively eroding banks with vegetation collapsing into stream**

Due to the large size of the existing channel, channel relocation may be expensive; therefore, the proposed restoration and stabilization will occur mostly along the existing stream. Bank stabilization will prevent lateral erosion and future widening of the stream. Geomorphic structures will be placed at critical points such as the upstream and downstream ends of the restoration and at culvert outfalls; these structures may also be placed along the reach where conditions warrant. In areas where tortuous meanders are proposed to be abandoned, such as the in the center of the reach in the vicinity of Photo 5, a stable planform will be established and oxbow channels will be established to provide alternative flow paths and habitat diversity.

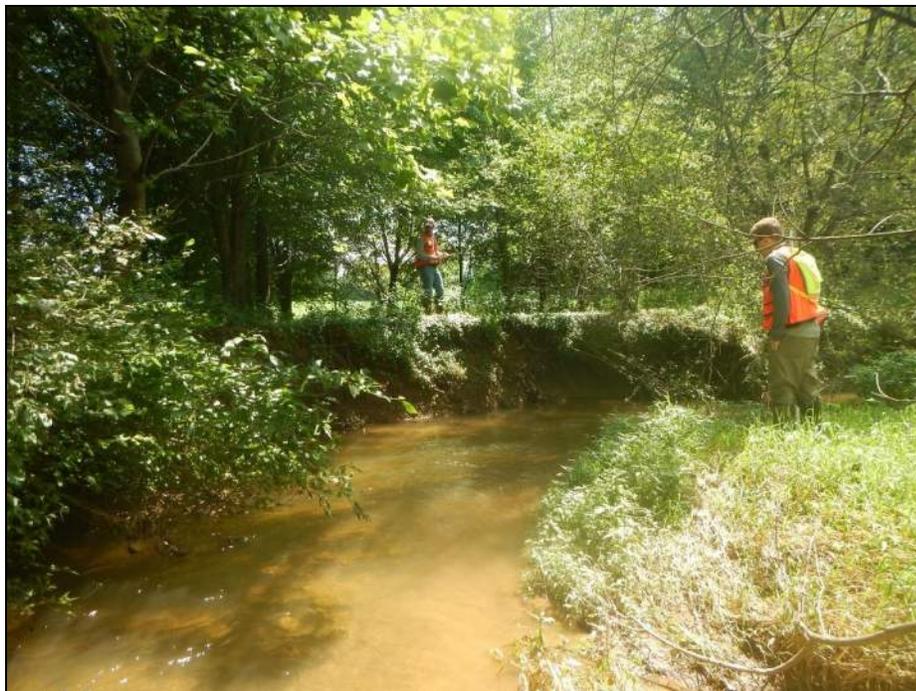
**Photo 4: Looking downstream at a tortuous meander with 3' tall, raw, actively eroding banks with minimal riparian vegetation and no connection to floodplain**

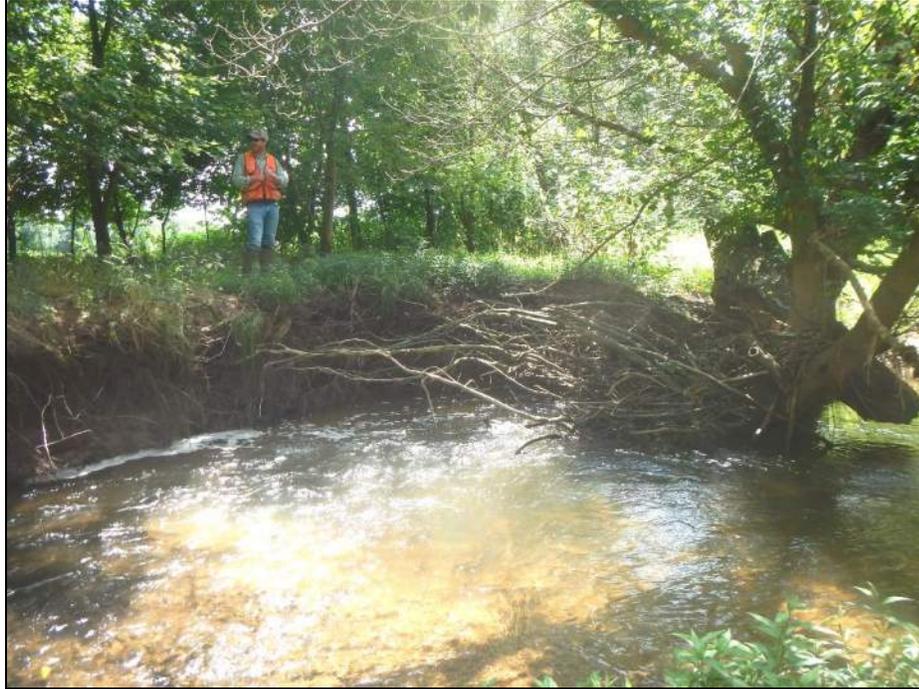
**Photo 5: Looking across stream at a 4' tall, incised, actively eroding bank with exposed roots and a large tree collapsing into the stream**

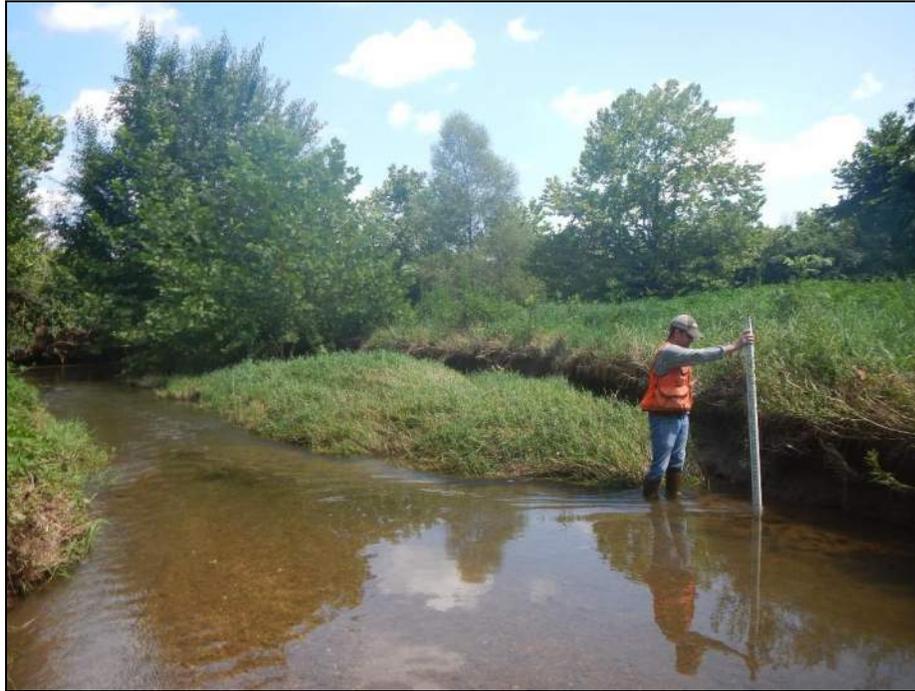
**Photo 7: Looking downstream at a 3' tall, vertical, actively eroding bank with sloughed vegetation and minimal riparian corridor**

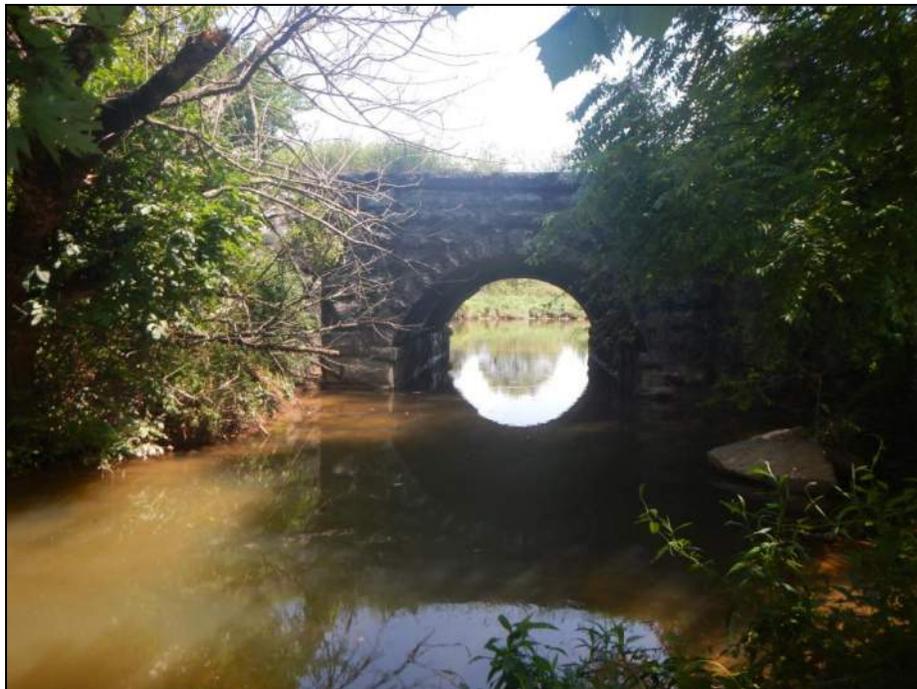
**Photo 8: Looking downstream at downstream bridge where railroad tracks cross the stream – this is the downstream limit of restoration**

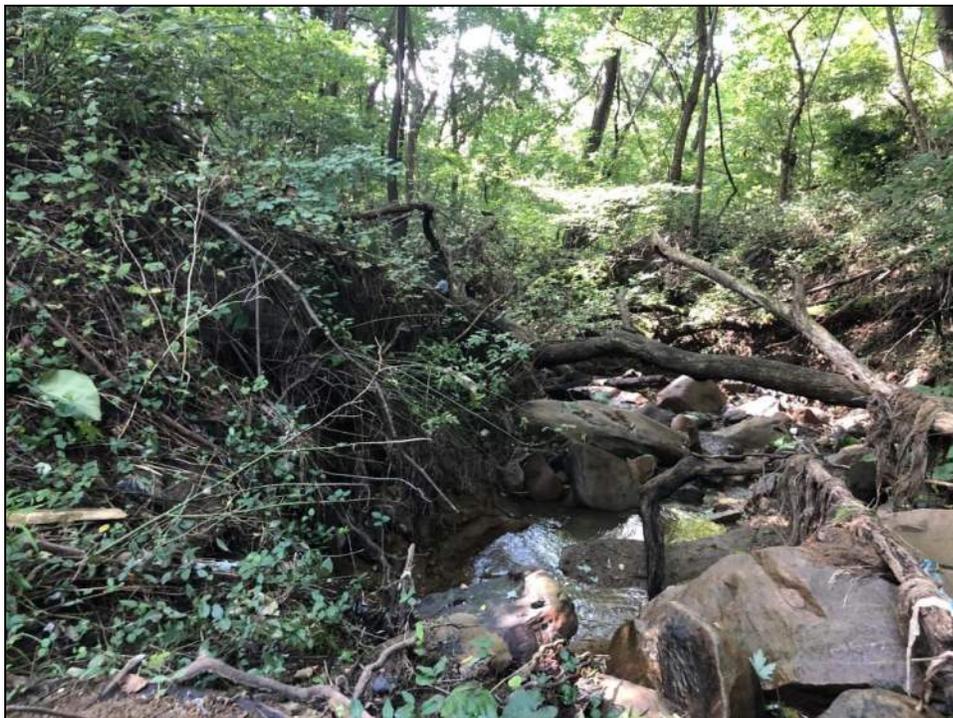
**Photo 8: Looking downstream from under the road at incised, vertical, actively eroding banks – this is the limit of restoration.**

The current channel fits narrowly between houses and yard structures, so the stream will be restored in the current planform with minor modifications. Due to the steep channel slope and limited space to relocate the stream, the channel will be restored as a Rosgen type A/B channel with low sinuosity and a low width to depth ratio. Fencing surrounding culverts needs to be redesigned and replaced to reduce build-up of debris, and structures on properties such as footbridges and sheds should be relocated to less vulnerable locations. Imbricated rock wingwalls may be placed around the headwall to prevent further erosion.

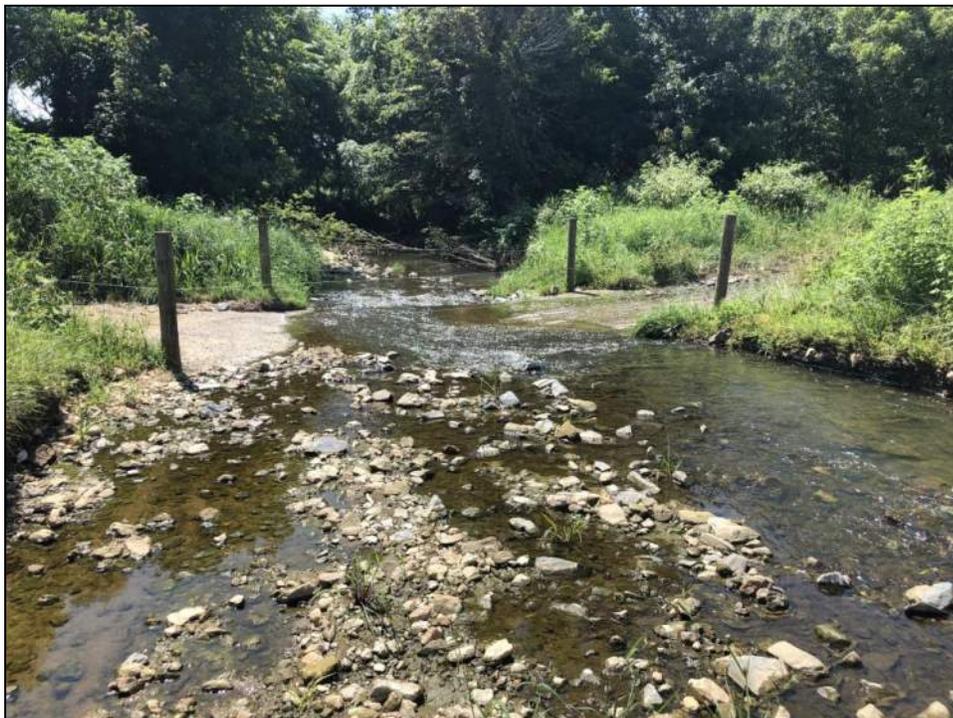
**Photo 6: Looking downstream at a cattle crossing that indicates the end of the restoration site.**
